Jeep Wrangler

Diagnosis & Repair Manual

Water Leaks

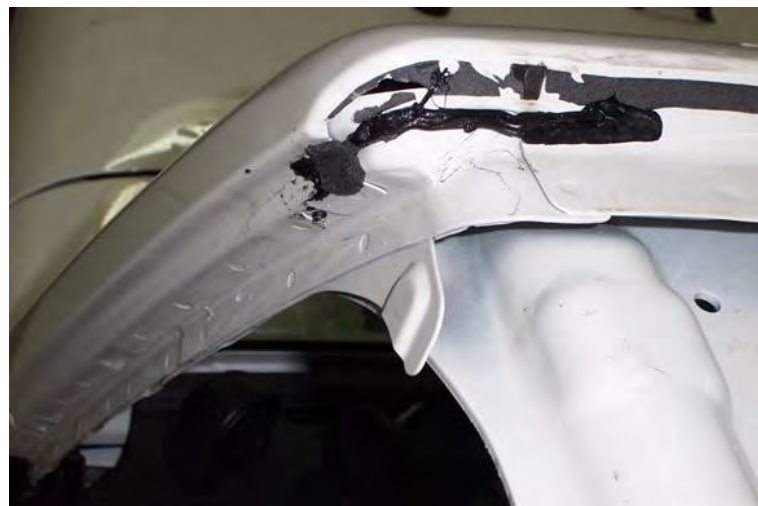
Figure 2

- Remove all butyl and tape residue
- A rubber wheel bit can be used
- Clean surface with 3M adhesive cleaner
- Alcohol wipe entire surface and allow to dry

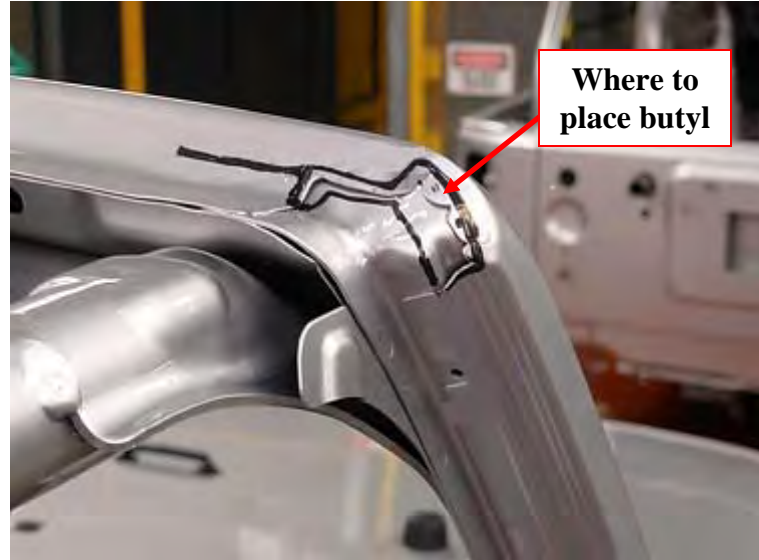
Figure 3

- **NOTE:** This operation is only applicable for vehicles built before 6/1/2008. Vehicles built after this date, should already have sealer present in this area.
- Install 4mm butyl (68027813AA) as shown (Figure 4)
- Make sure to fill in all holes, wrinkles and step offs to allow for a smooth surface to bond the tape/butyl from the new seal
- **NOTE:** Excessive amount of butyl can cause transition voids/leaks. Make sure to smooth out butyl.

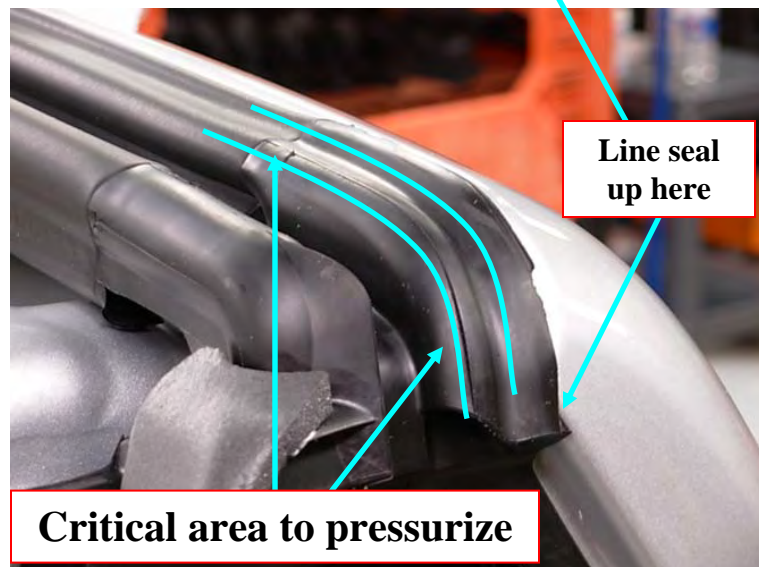
Figure 5

- Locate and install new seal, Pt #: 55397454AE
- Remove release tape and pressurize seal firmly in contact with header sheet metal to smooth out adhesive tape and butyl, starting at the ends and working toward the center. A small roller or firm finger pressure should be used to insure the tape is adhered completely from side to side, **THIS STEP IS CRITICAL**

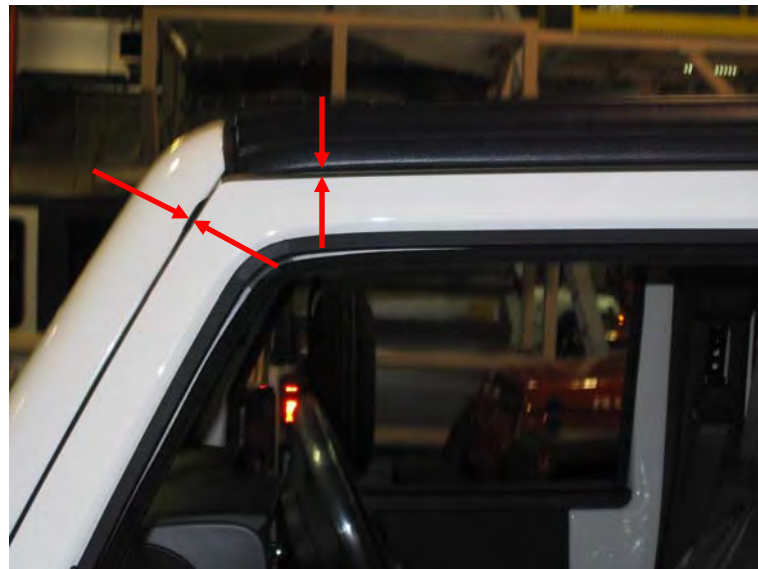
Figure 6

- If the doors are adjusted, the door seal must be replaced
- Part #: 55395274/5AN

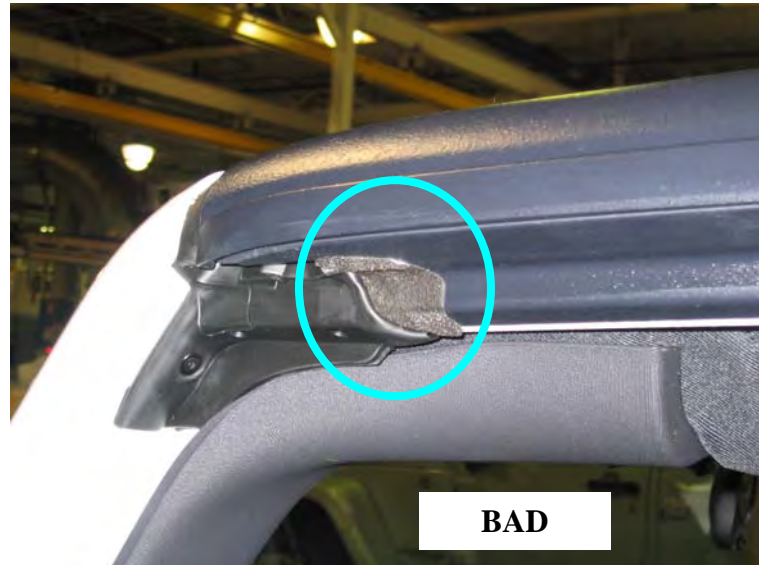
Figure 8

- NOTE: This issue/repair applies to both hard and soft top vehicles
- Inspect the header seal mocket for the seal rolled under the freedom panel or side rail. (Figure 8)
- If the seal is folded under, remove the freedom panel or side rail and re-install making sure not to distort the mocket (Figure 9)

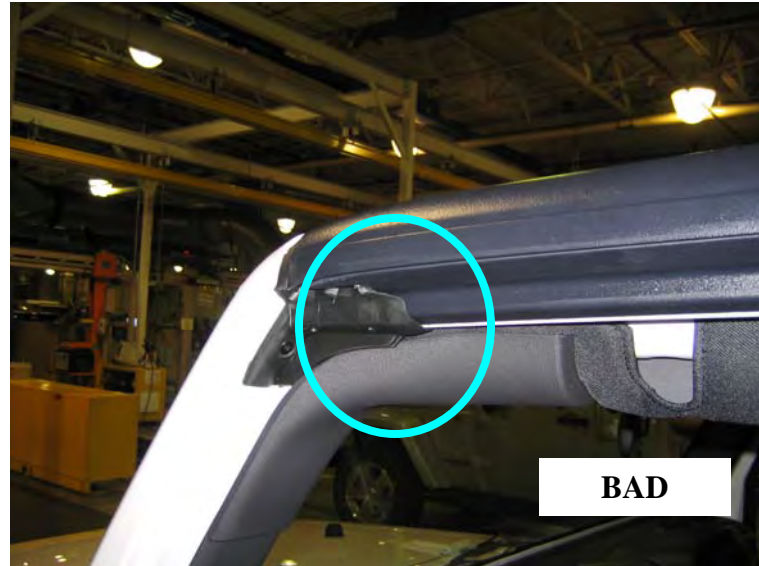
Figure 10

- NOTE: This issue/repair applies to both hard and soft top vehicles
- Inspect the freedom panel or side rail for damaged/missing foam (Figure 10)
- If the foam is damaged or missing, replace the foam using the foam kit (68026937AB)

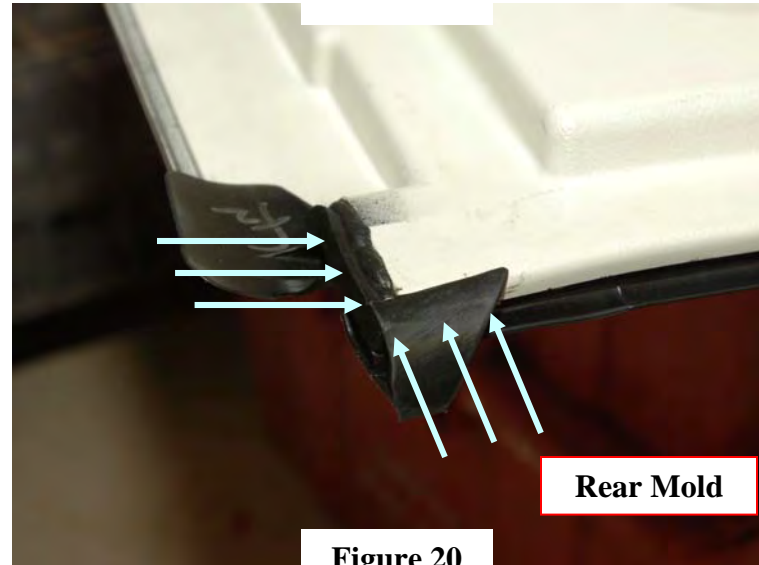
Figure 20

- Align **REAR** edge of NEW seal, Pt # 55397095AG to Right Freedom Panel Notch.
- Compress butyl by installing seal in direction of arrows (Figure 20)
- Note: No gap between installed seal and outer edge of freedom panels. (Figure 20)

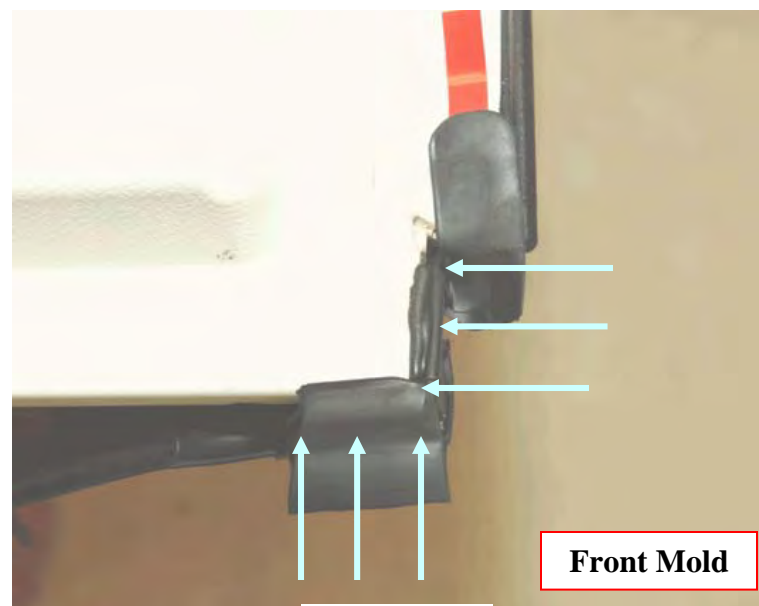
Figure 21

- Align **FRONT** edge of NEW seal, Pt # 55397095AG to Right Freedom Panel Notch
- Compress butyl by installing seal in direction of arrows (Figure 21)
- Note: No gap between installed seal and outer edge of freedom panels. (Figure 21)

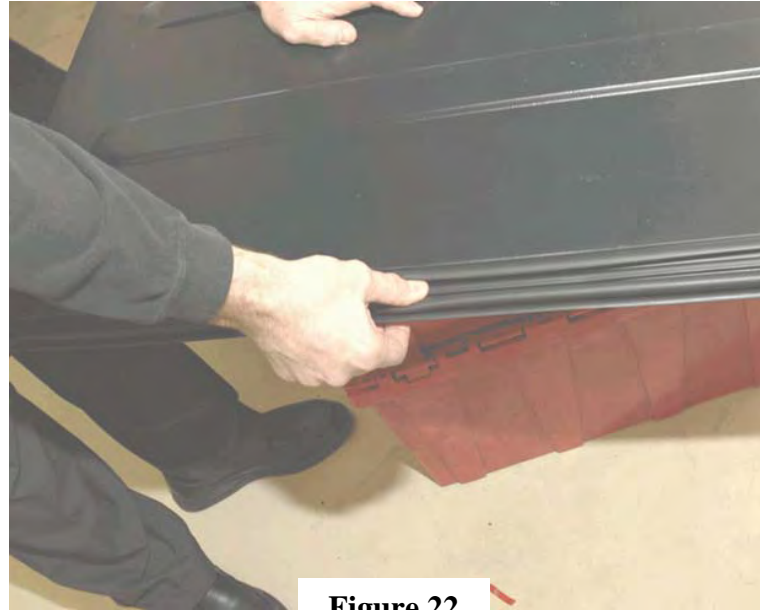
Figure 22

- Flip panel back over to complete the seal installation
- Locate seal cross car against the middle rib in the freedom panel and pressurize starting at the ends and working toward the center
- A small roller or firm finger pressure should be used to insure the seal tape is adhered from front to rear, **THIS STEP IS CRITICAL**

This photo is for reference only. Panel was cut to show rib.

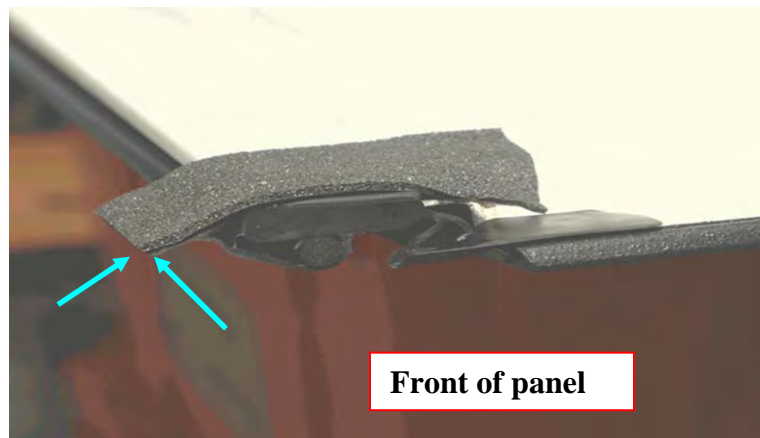
Figure 24

- Install **GREY** 30 X 75 mm Foam from kit (68026937AB) along trim lines of flame tip (Figure 24)
- **NOTE:** Make sure foam covers butyl completely

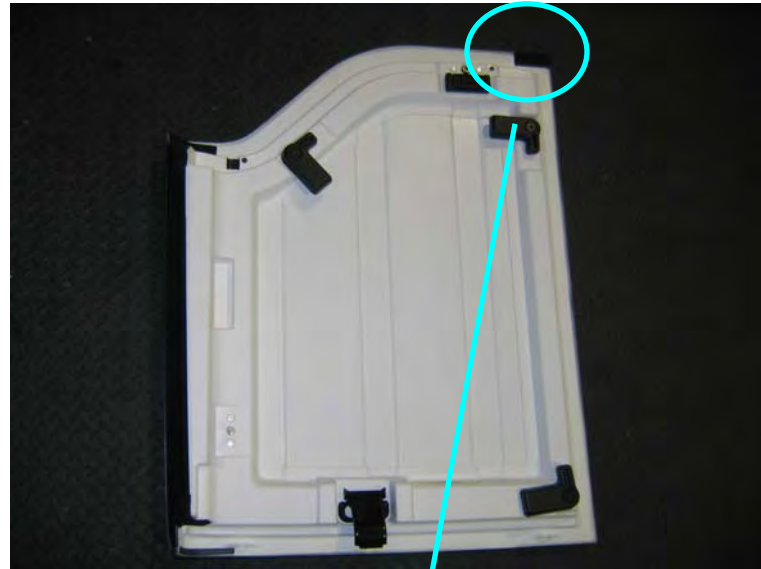
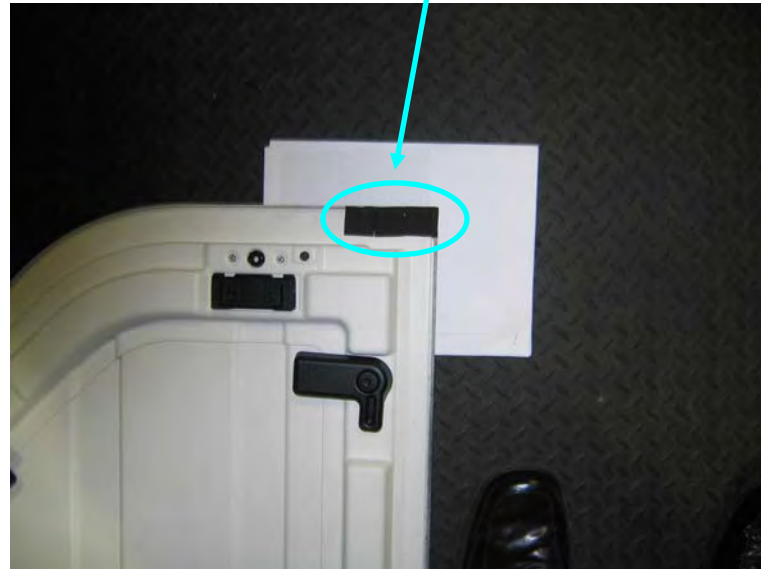
Figure 28

- Add 30 X 75 mm Black Foam from Kit (68026937AB) to cover butyl (Figure 28)
- NOTE: Make sure foam covers butyl completely

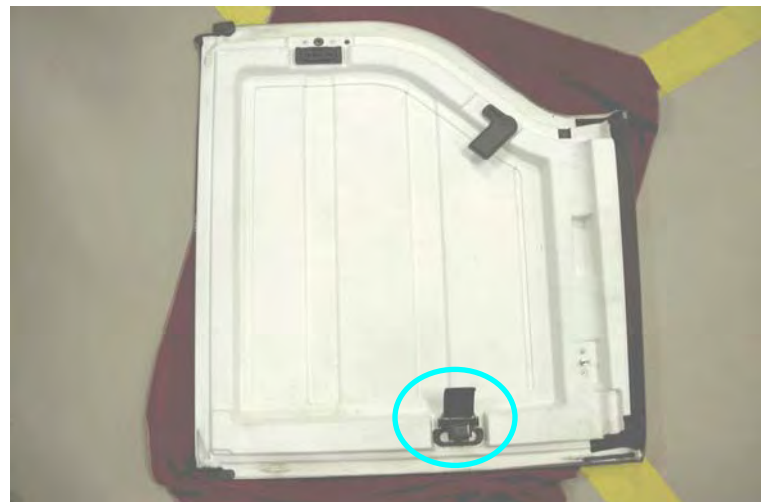
Figure 29

- NOTE: This applies to both Right and Left panels
- If the vehicle MDH is prior to 12/07/07, replace the front latches with part number 68004562AB (Figure 29)

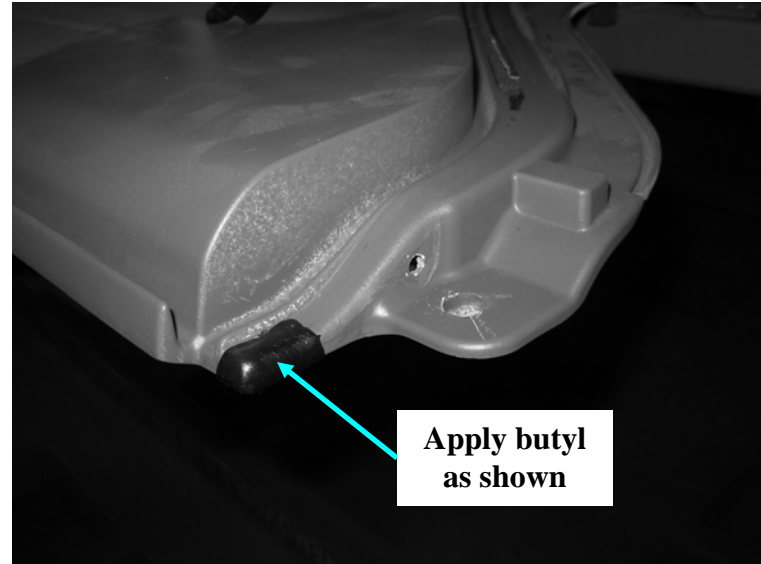
Figure 36

- If there are multiple skips or the leak cannot be stopped, replace seal.
- Remove all tape/butyl and clean with alcohol prior to installation
- A rubber wheel bit can be used to remove the tape
- Pre-apply butyl (68027813AA) on hard top prior to installing the seal (Figure 36)
- It is critical that the end molds are installed correctly and sufficient pressure is applied to wet out the butyl/tape (Figure 36)

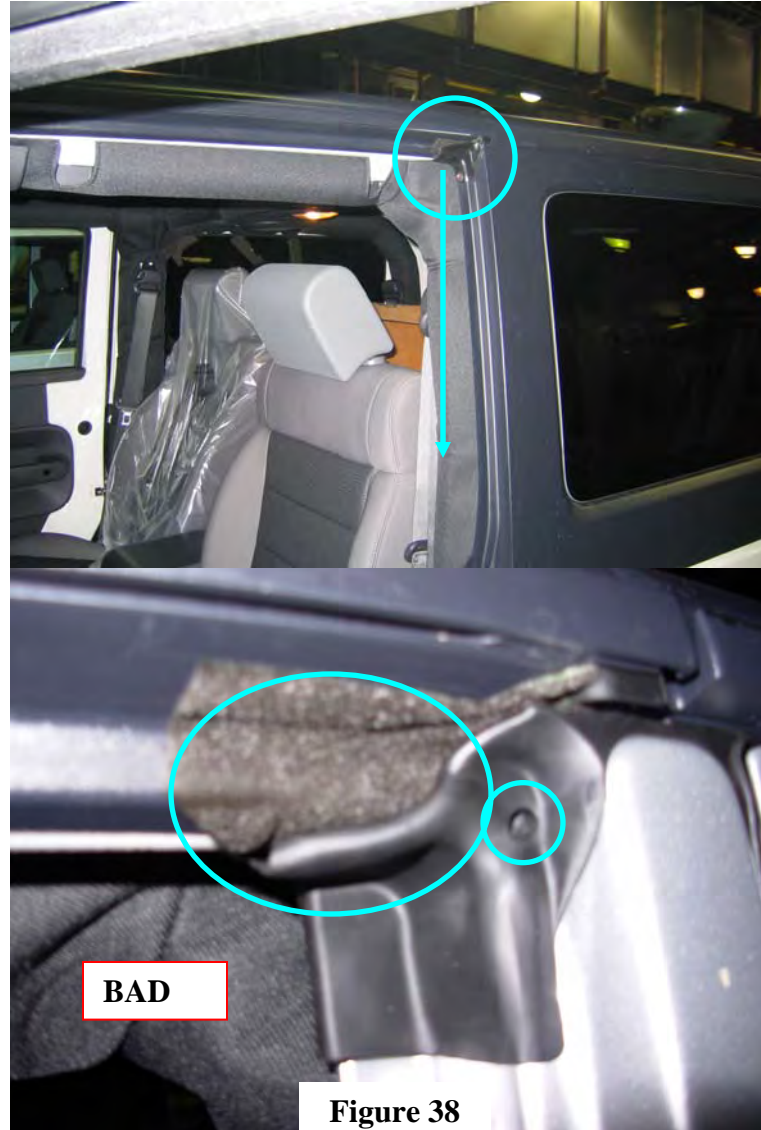
Figure 39

- Inspect the mocket for a rolled under condition (Figure 38)
- Inspect the mocket for a missing drain hole

- If either of these conditions exist, replace the mocket detail (Part #:55395708/9AE)
- Reinstall the panel or side rail making sure not to distort the mocket

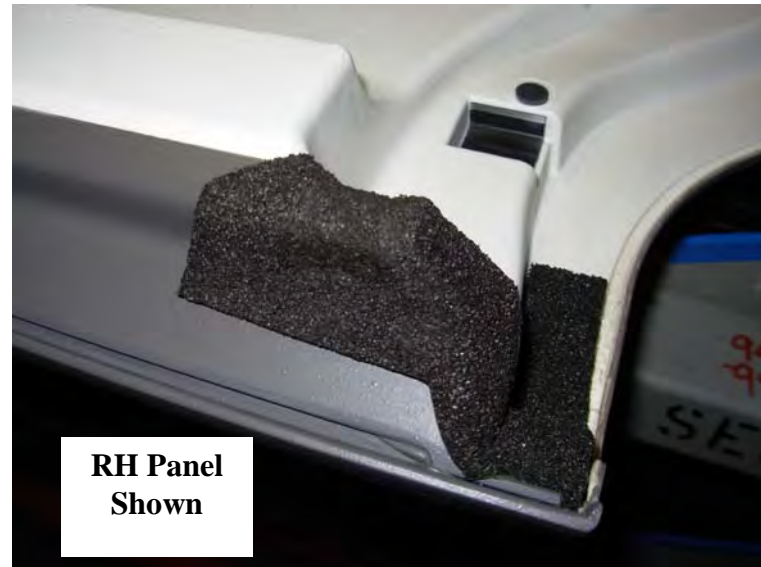
Figure 40

STEP 3: Inspect Freedom Panel for damaged or missing foam

- If the foam is damaged or missing, replace the foam using the foam kit (68026937AB)

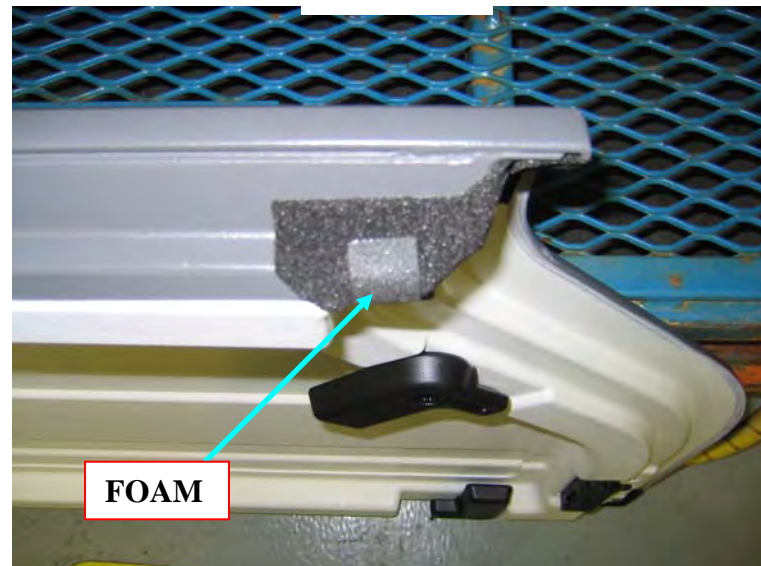
- Add a piece of foam to the freedom panel as shown in Figure 41. This foam can be created by cutting the 30 x 75mm GREY foam in half from the foam kit (68026937AB)
- Figure 41

NOTE: This foam is in addition to the foam that is already on the panel

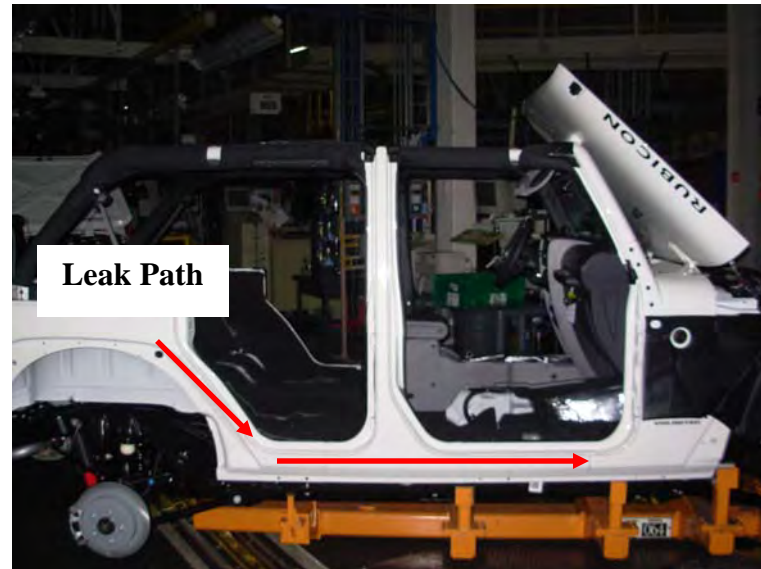
Figure 42

- Inspect the body for missing or mis-aligned tape over the hole as seen in Figure 43
- Add/Replace a tape patch over the hole

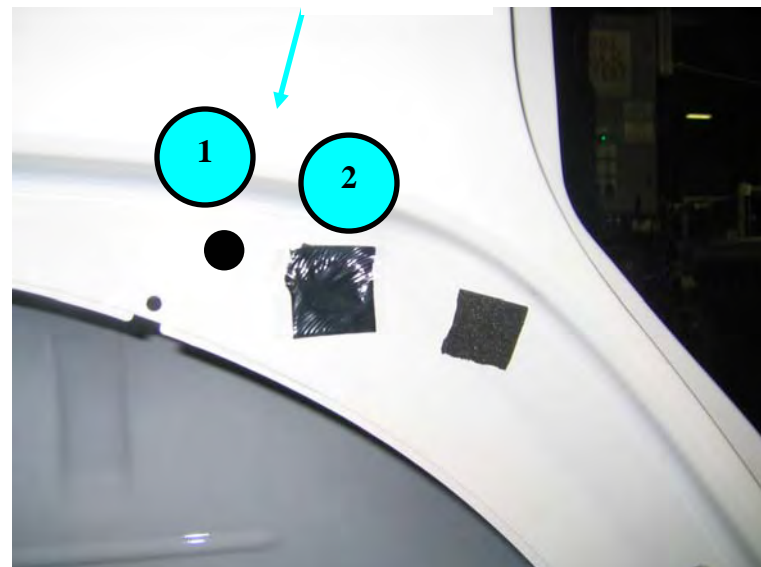
- Inspect the body for missing or mis-aligned tape over the hole as seen in Figure 43
- Add/Replace a tape patch over the hole

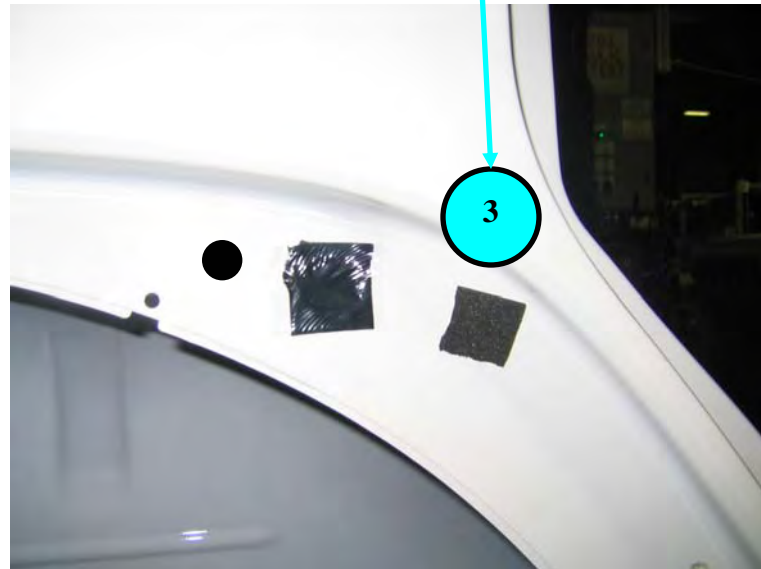
Figure 45

- Cut the BLACK 30 x 75 foam from the foam kit (68026937AB) in half and apply over this hole (Figure 45)
- Make sure the foam does not extend past the flare trim line (appearance issue)
- Re-install flare

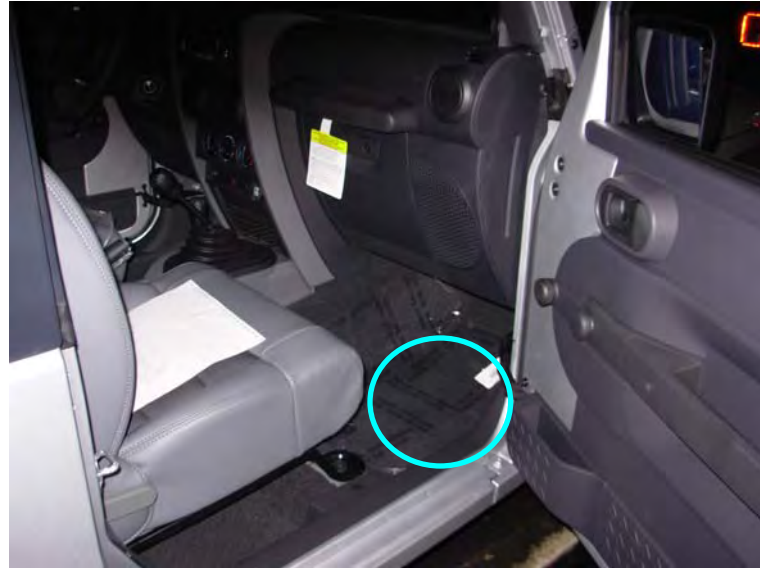
Figure 46

NOTE: These leaks can be diagnosed by applying a hose in the cowl panel (Figure 47).

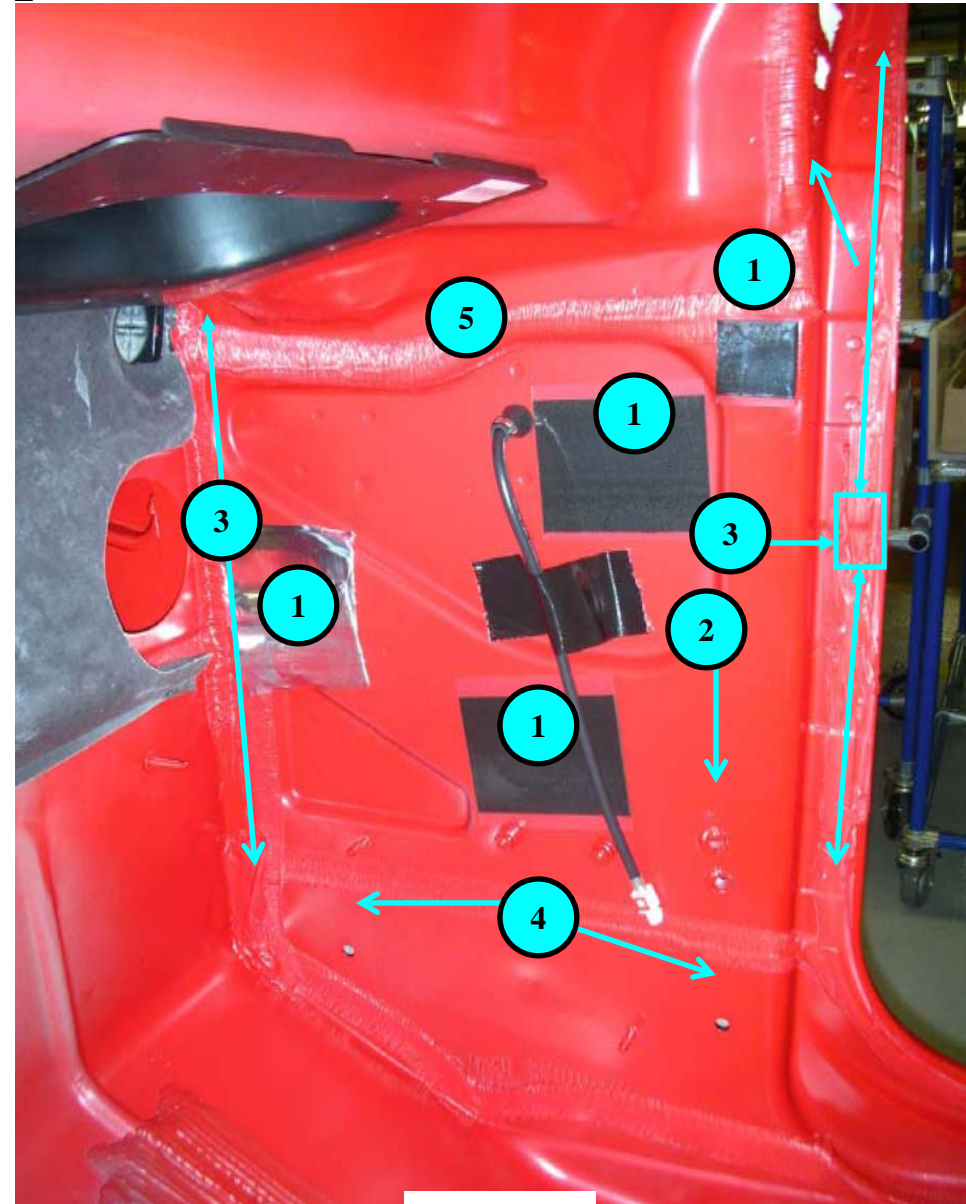
Figure 48

Condition 1: Mastic patches/Plugs

Condition 2: Check strap bracket

Condition 3: Seam sealer skips

Condition 4: Scuff trim foam damaged/missing

Condition 5: Antenna grommet not seated

Repair 1: Replace patch/plug

Repair 2: Remove bracket and apply a butyl to holes

Repair 3: Apply clear sealer (part #: 04467708) to skip

Repair 4: Replace trim clips

Repair 5: Re-install grommet

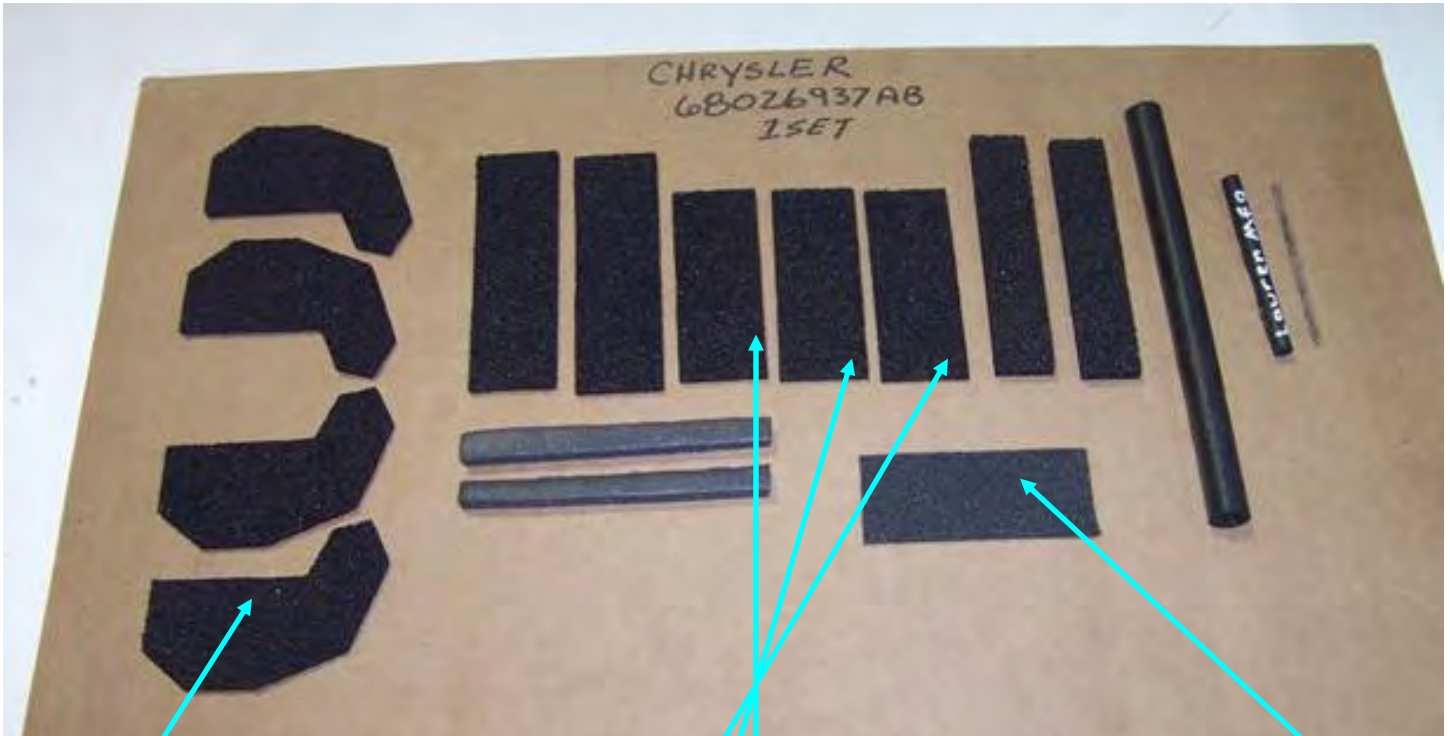
Foam Kit: 68026937AB

A/B-Pillar Foam

- Used on Pages (5,16,)

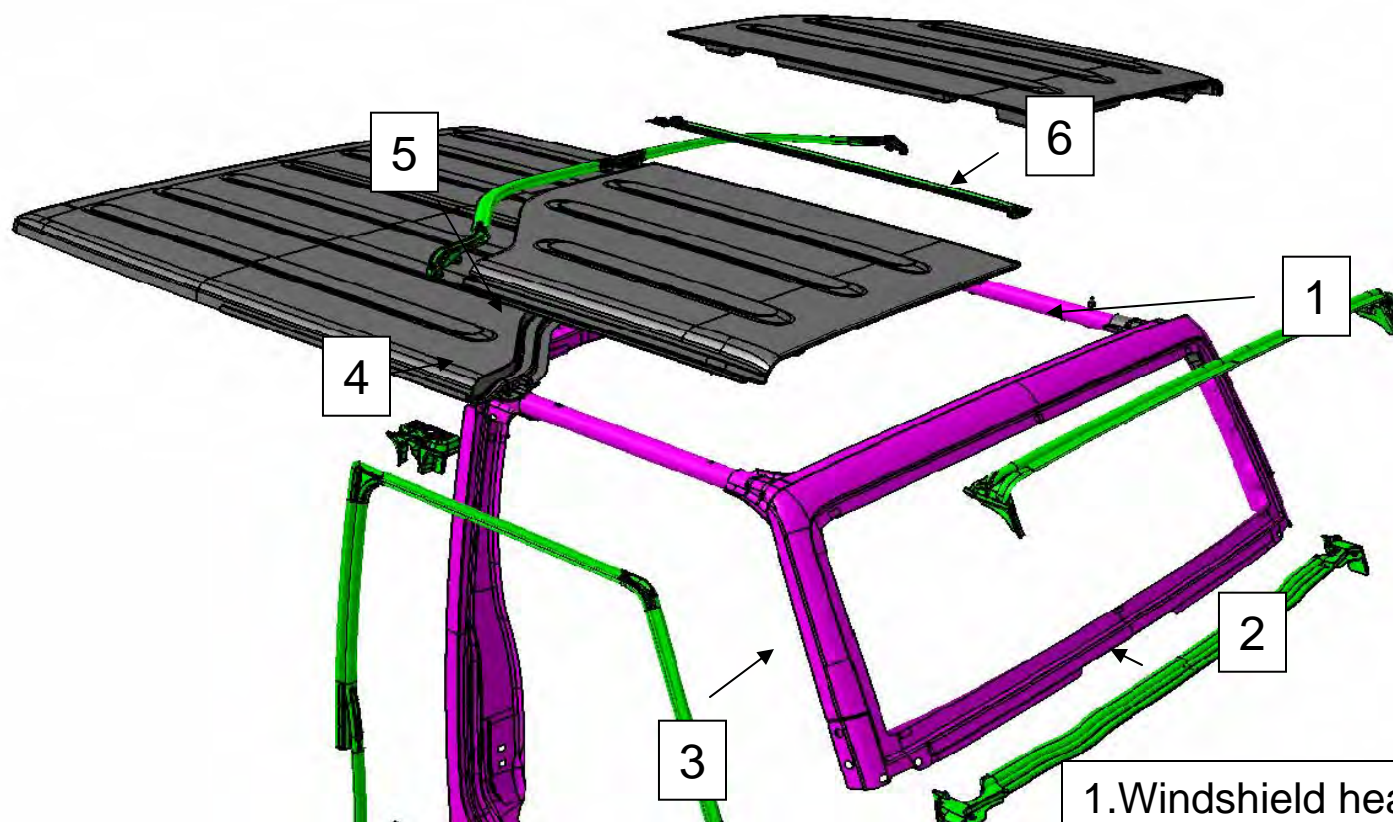
Outside View

- 1. Windshield header seal
- 2. Windshield to cowl seal
- 3. Front door weatherseal
- 4. B pillar mocket
- 5. Hard top seal
- 6. Center freedom panel seal

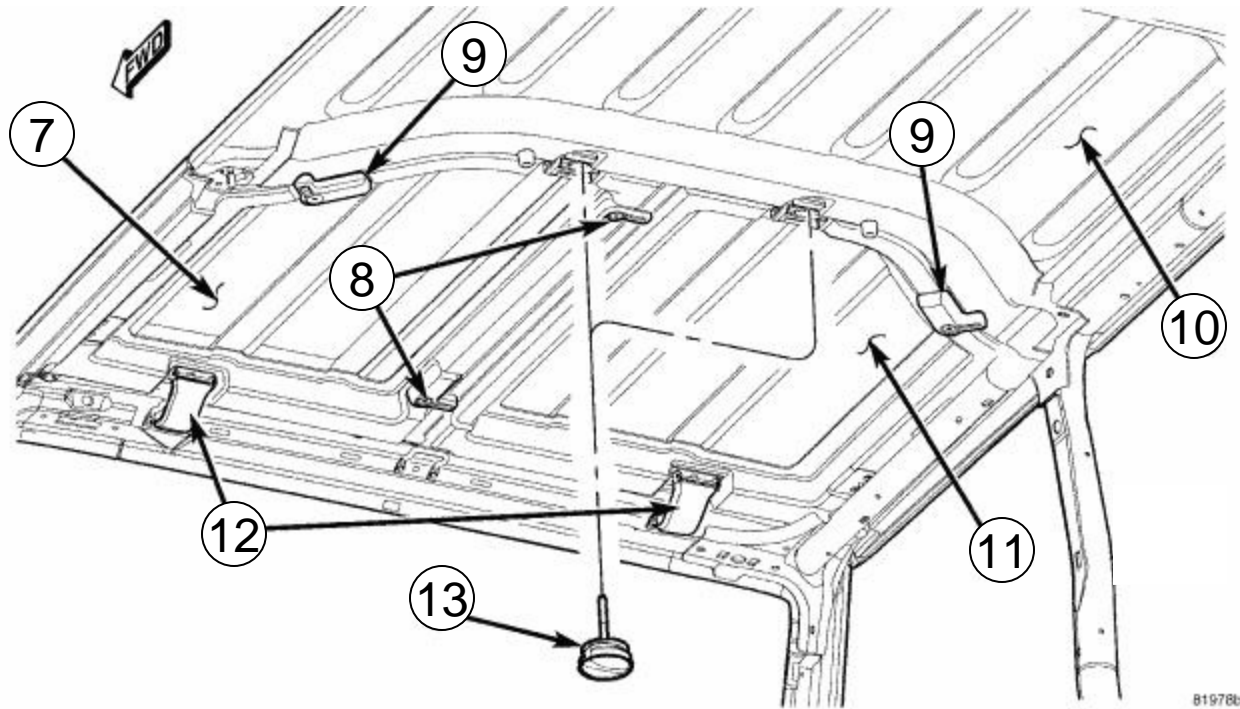
Inside View

- 7. Left Freedom Panel
- 8. Panel to Panel Latches
- 9. Panel to Hard Top Latches
- 10. Hard Top
- 11. Right Freedom Panel
- 12. Latch & Base Assembly 68004562AB
- 13. Sport Bar Thumb Screws

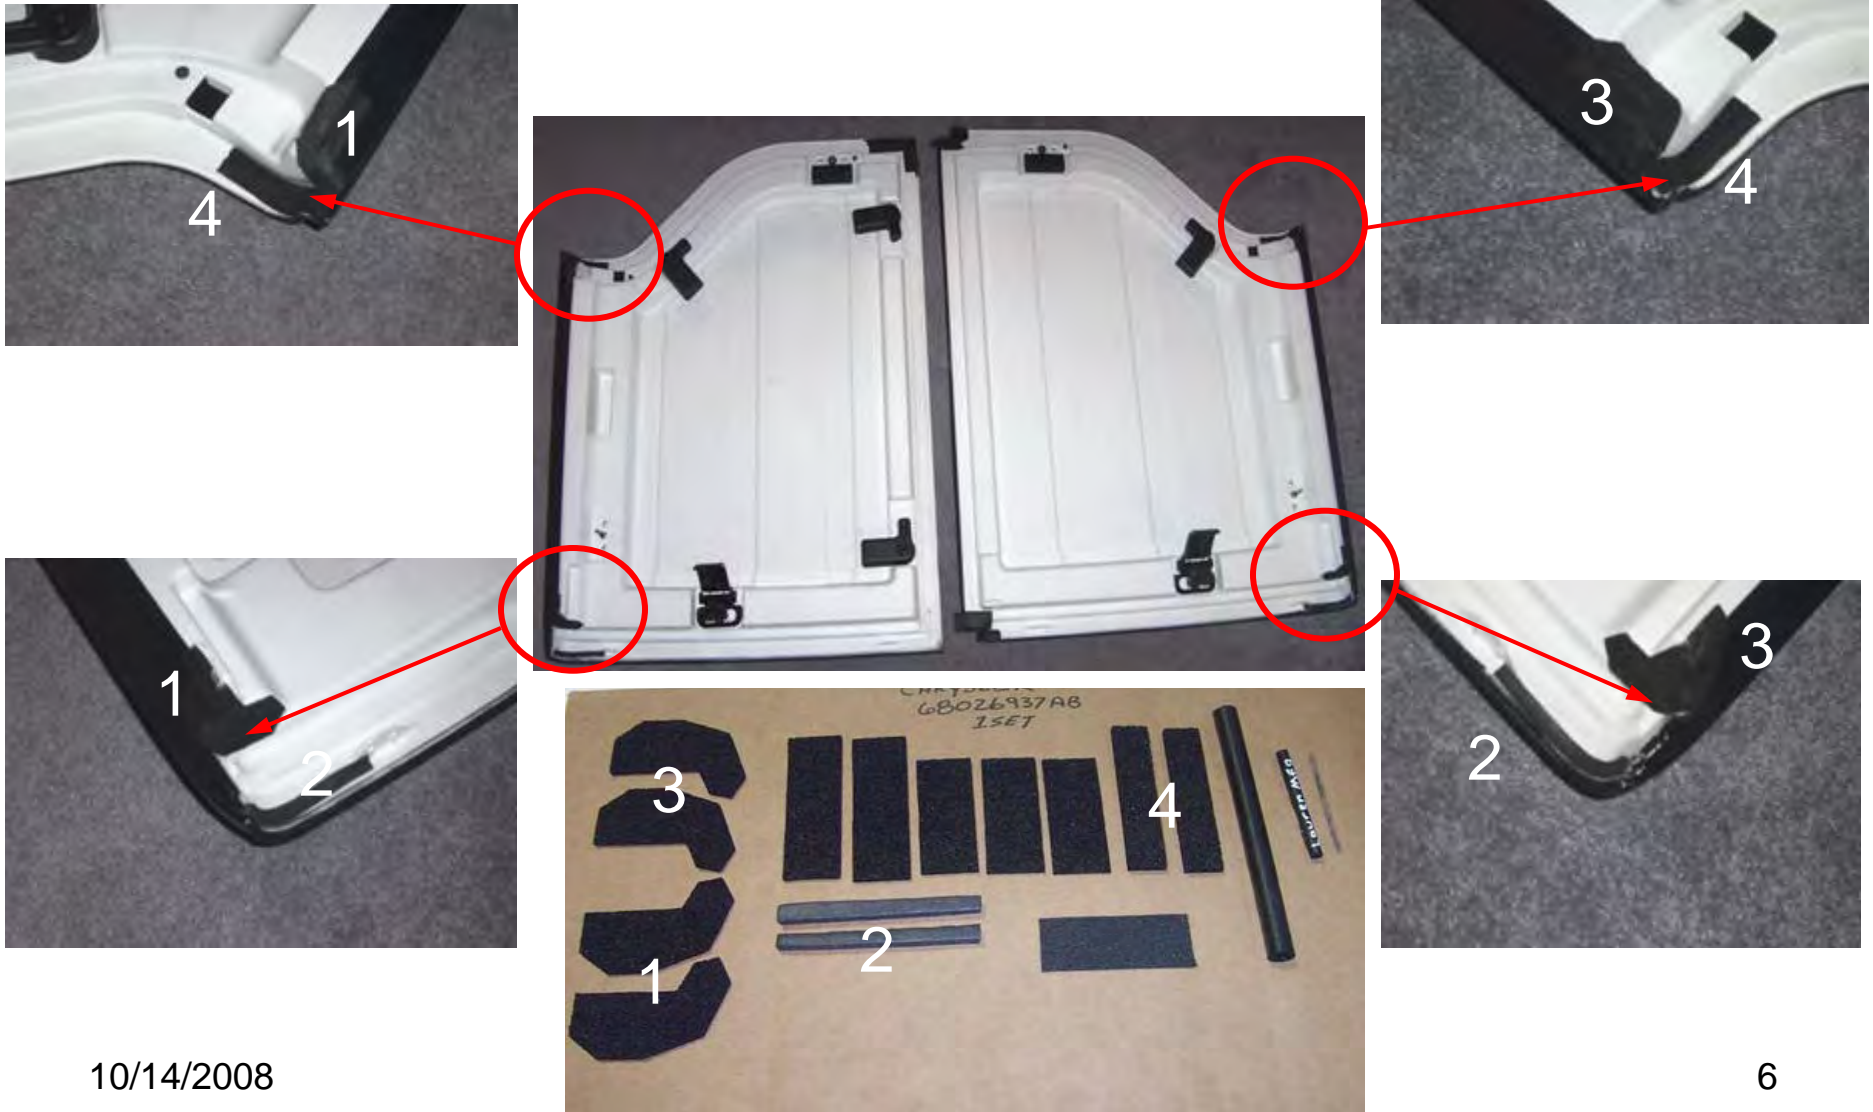
Remove Right Freedom Panel Center Seal

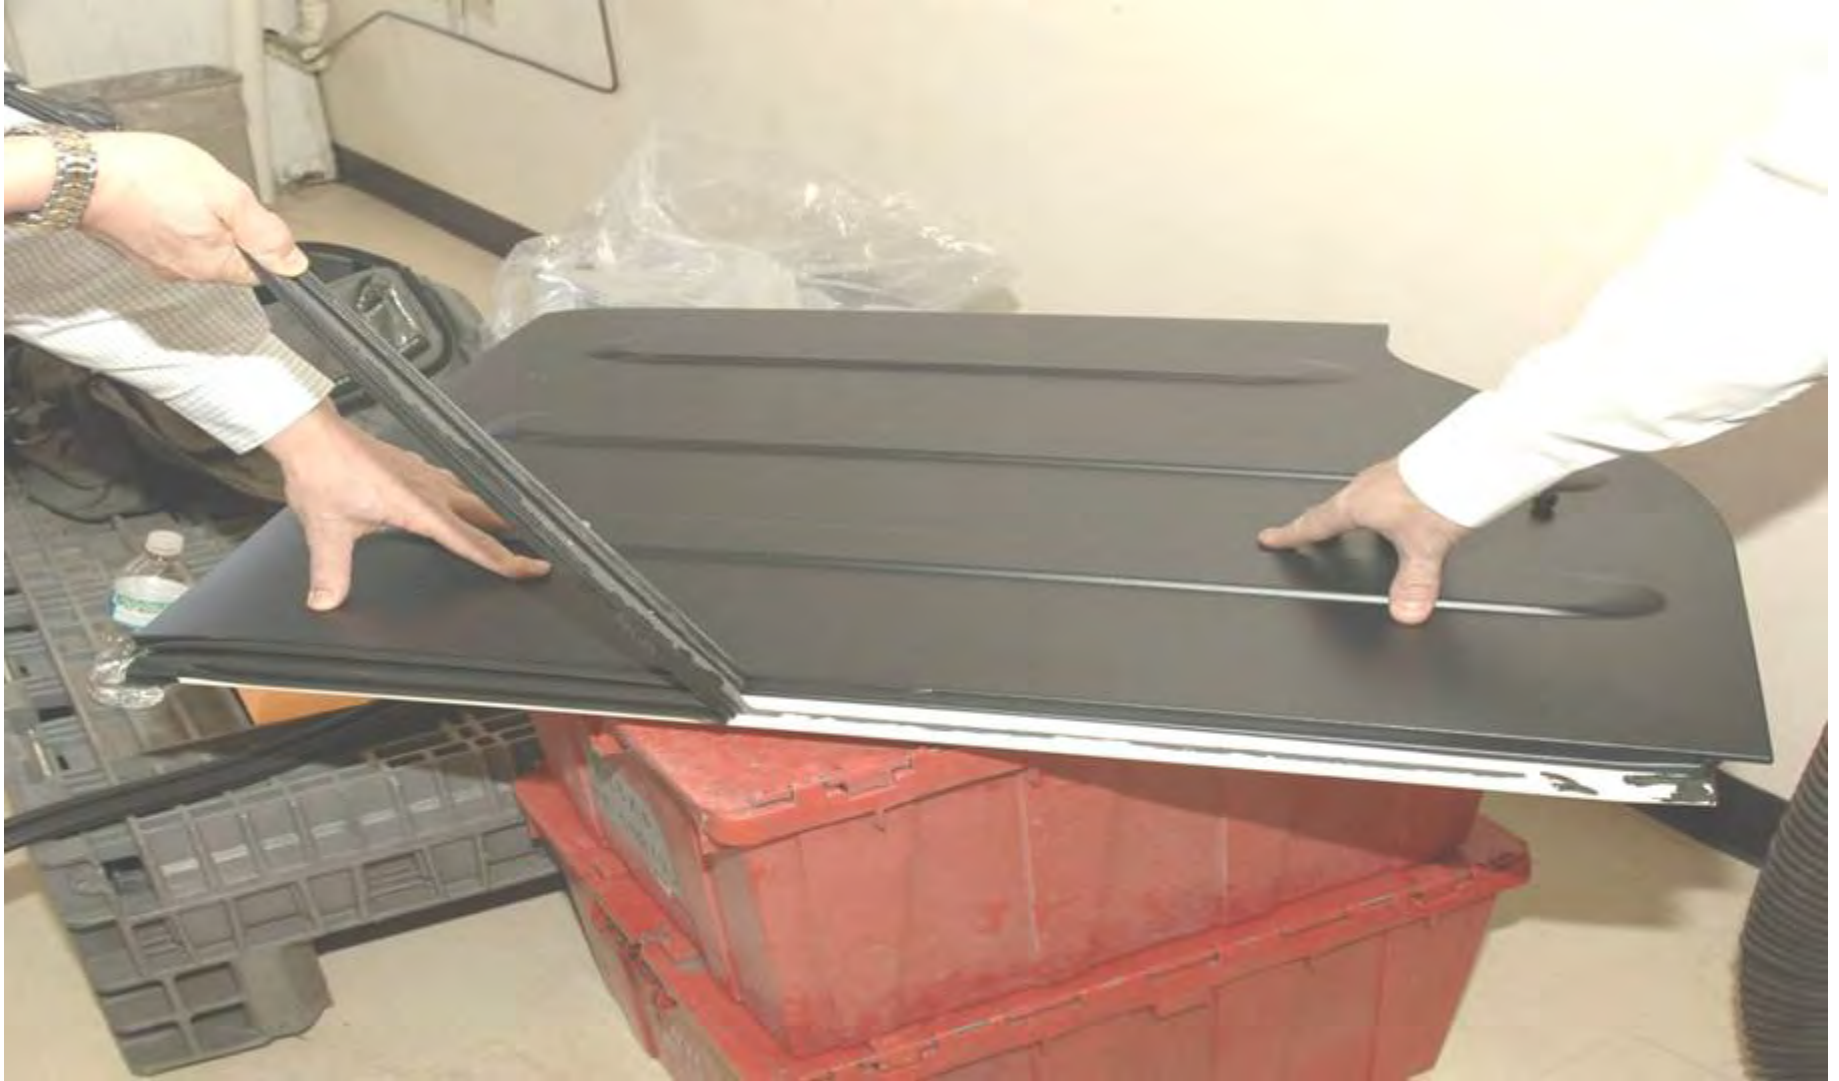
Remove old Butyl & Tape from Right Freedom Panel

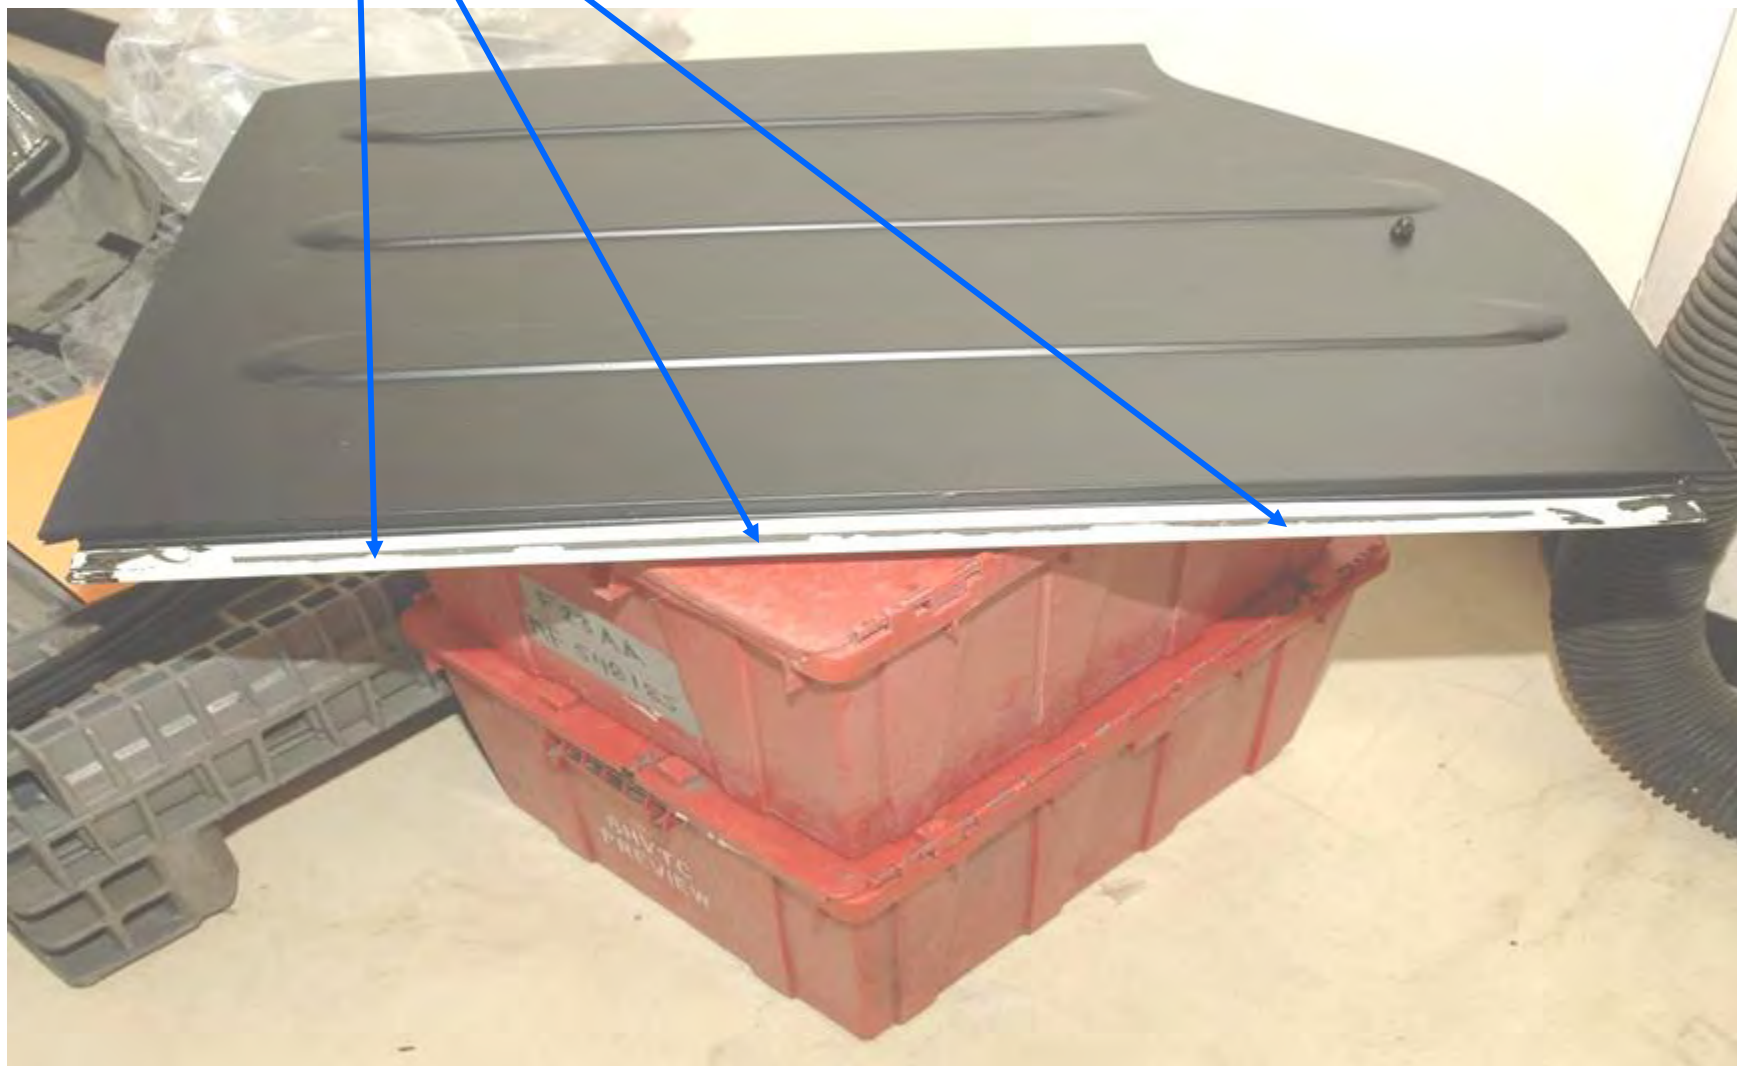
Note: Old Butyl Removed from Right Freedom Panel

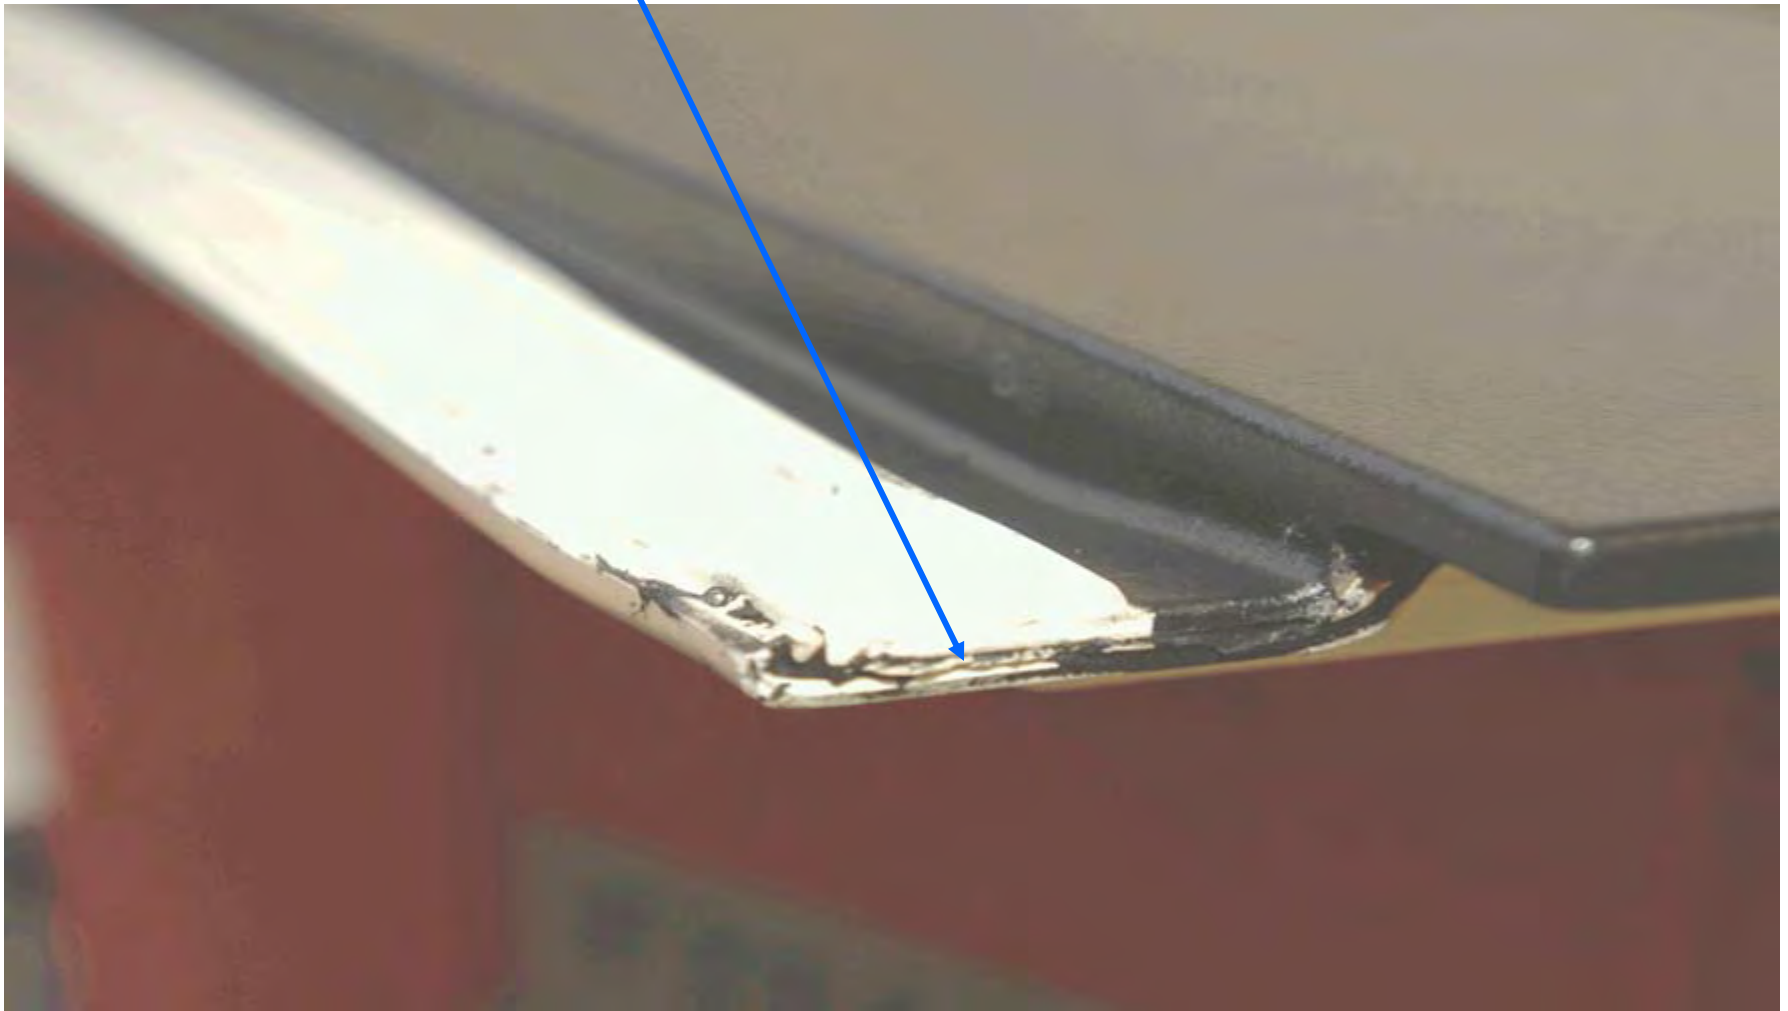
Place **Right** Freedom Panel
Upside down on a covered
work surface to prevent paint
Scratching.
