Jeep Wrangler

Diagnosis & Repair Manual

Water Leaks

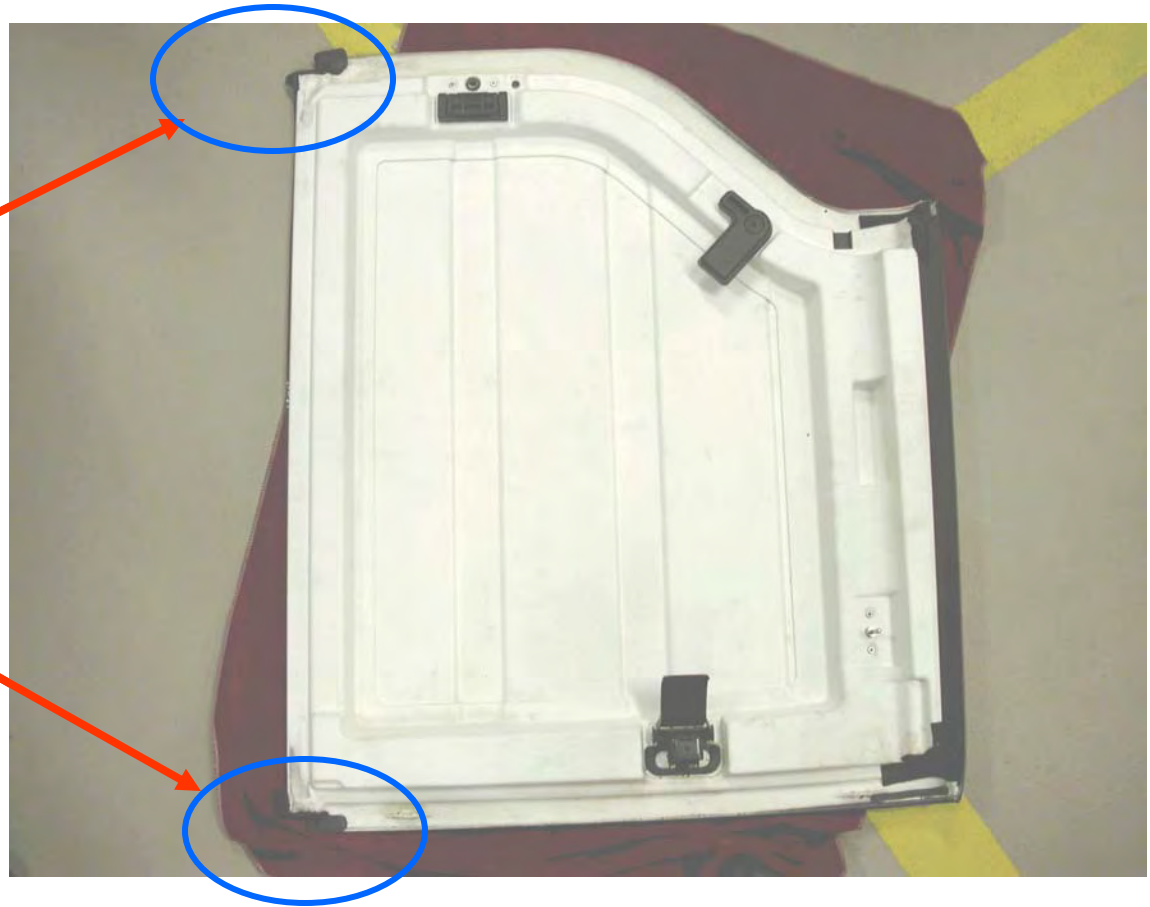
Freedom Panel Weather Strip installation

Align **Rear** edge of NEW Weather Strip, Pt # 55397095AG to Right Freedom Panel Notch. Note: No gap between installed Weather Strip and outer edge of freedom panels.

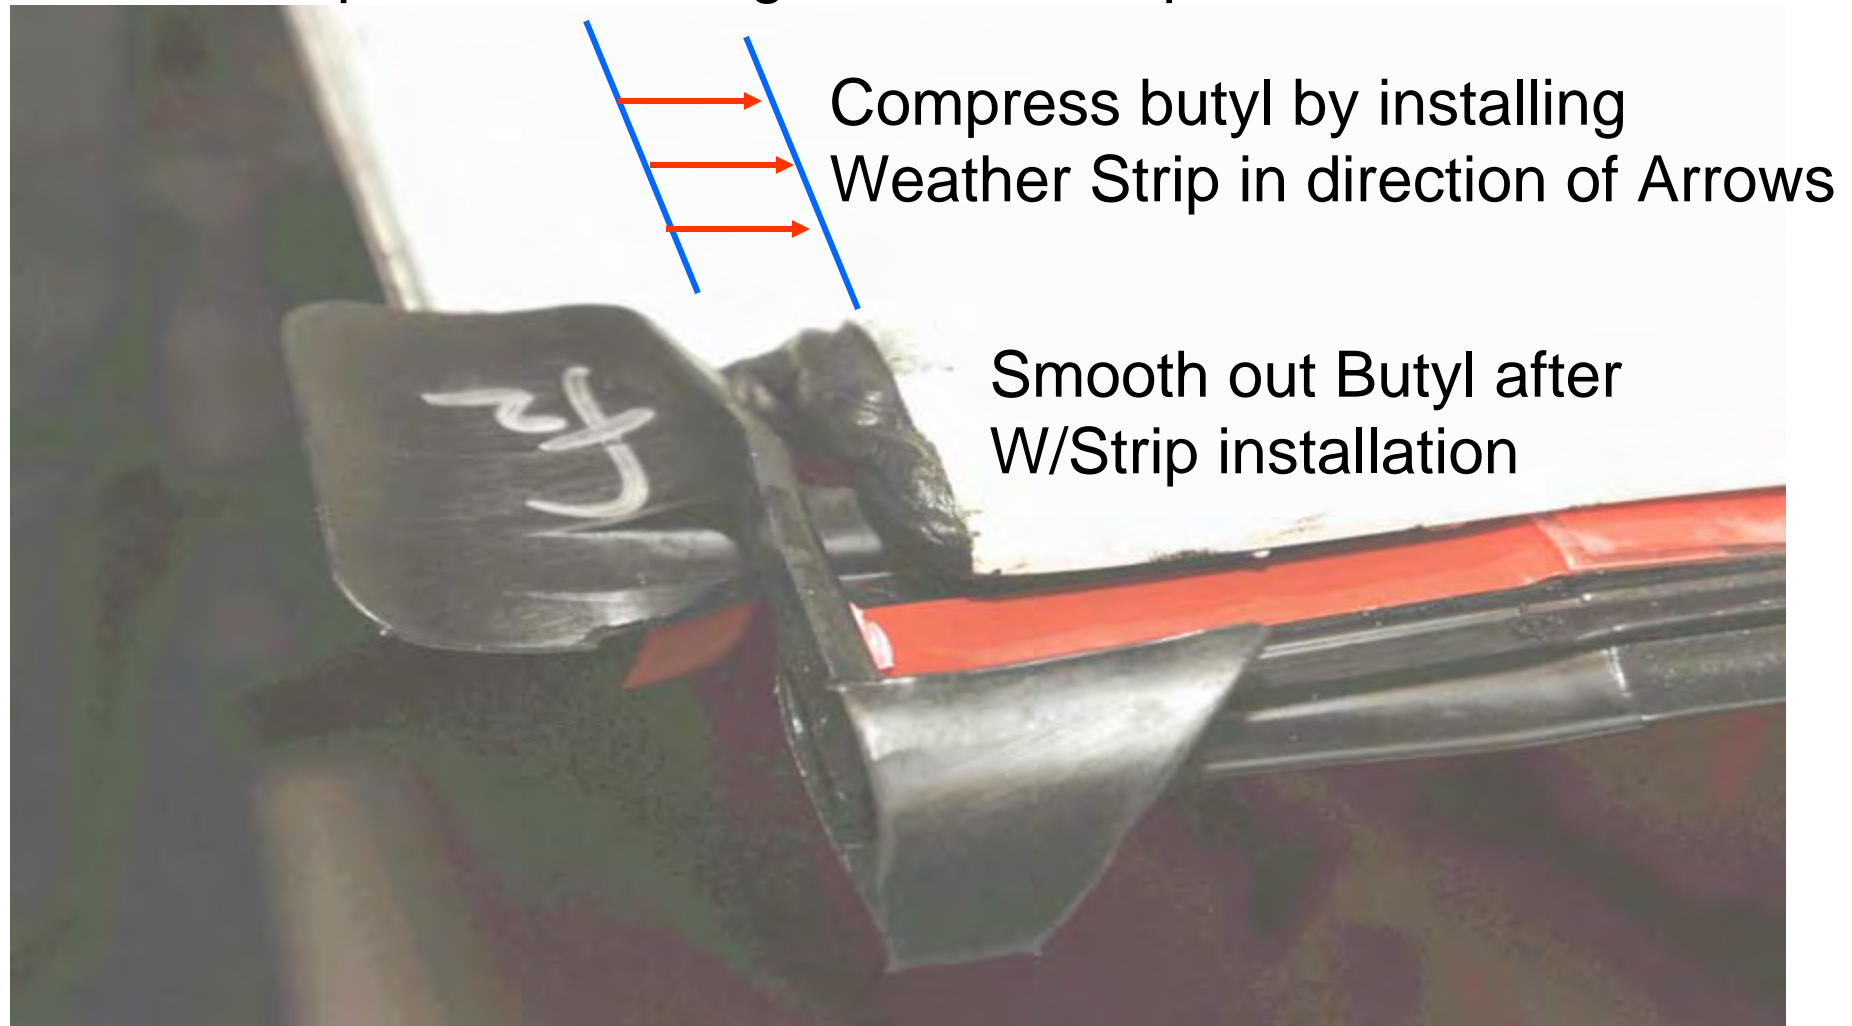
Align **Front** edge of NEW Weather Strip, Pt # 55397095AG to Right Freedom Panel Notch. Note: No gap between installed Weather Strip and outer edge of freedom panels.

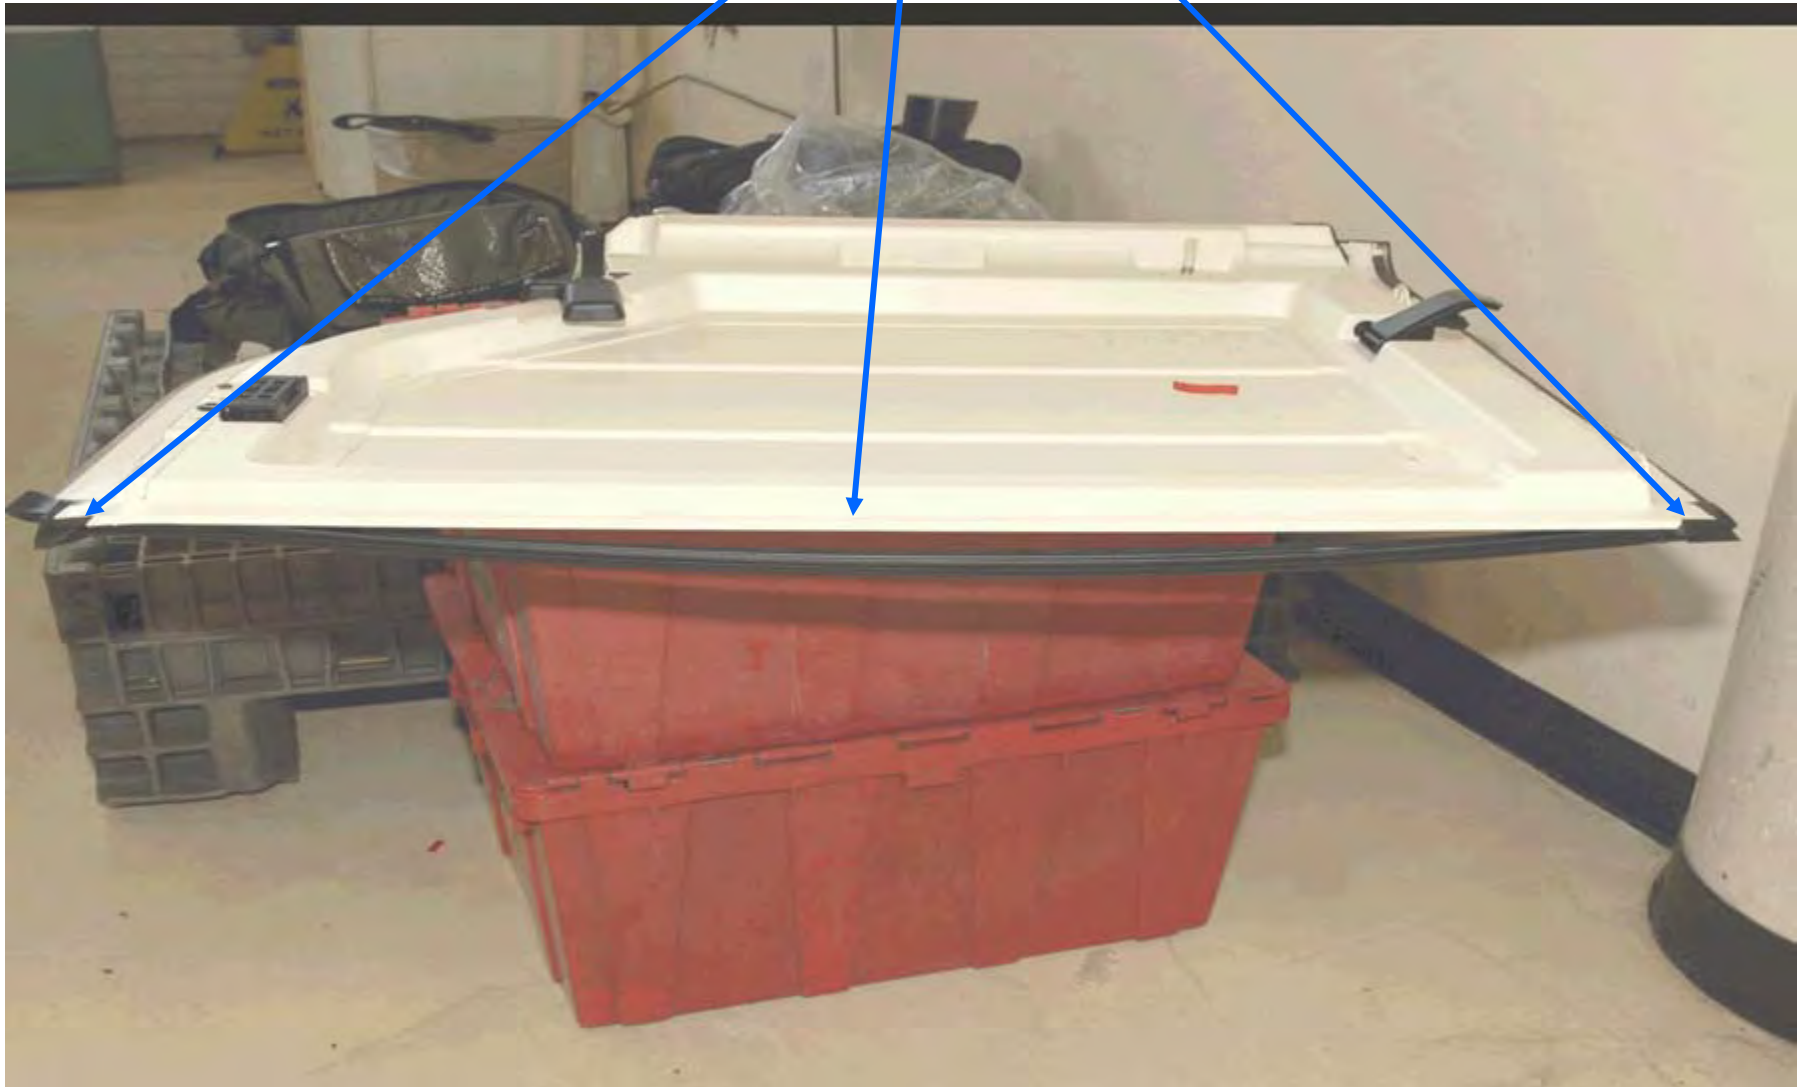
Note: Remove Release tape and Press Weather Strip Firmly in contact with Freedom Panel, **Front AND Rear** .

Note Both Ends of new W/Strip Located and installed to
Freedom Panel Center section still shown unattached

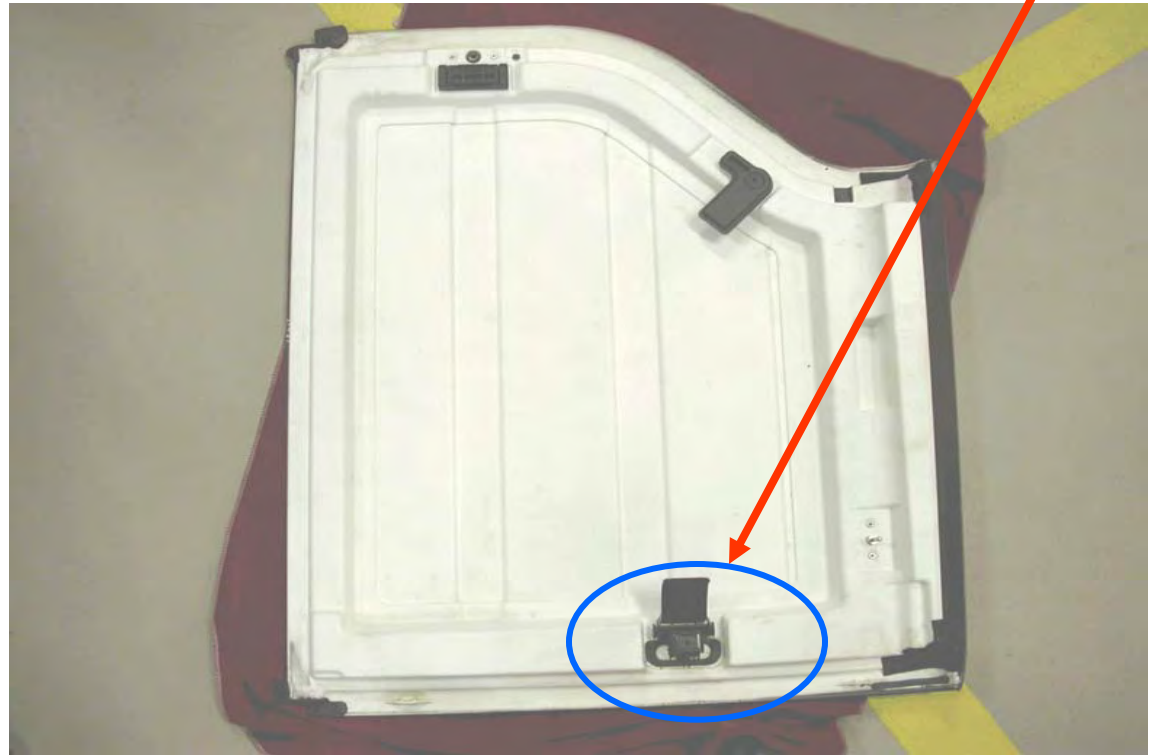
Freedom Panel Latch and Base Assembly
Right and Left

If Vehicle MDH is Before 12/17/07 Replace this Latch on Right & Left Freedom Tops with 68004562AB.

Right Freedom Top Shown

Note: **REMINDER** Refer to Page 20 If Vehicle **MDH** is **Before 12/17/07** . Replace Latch on **Right & Left** Freedom Top with 68004562AB.

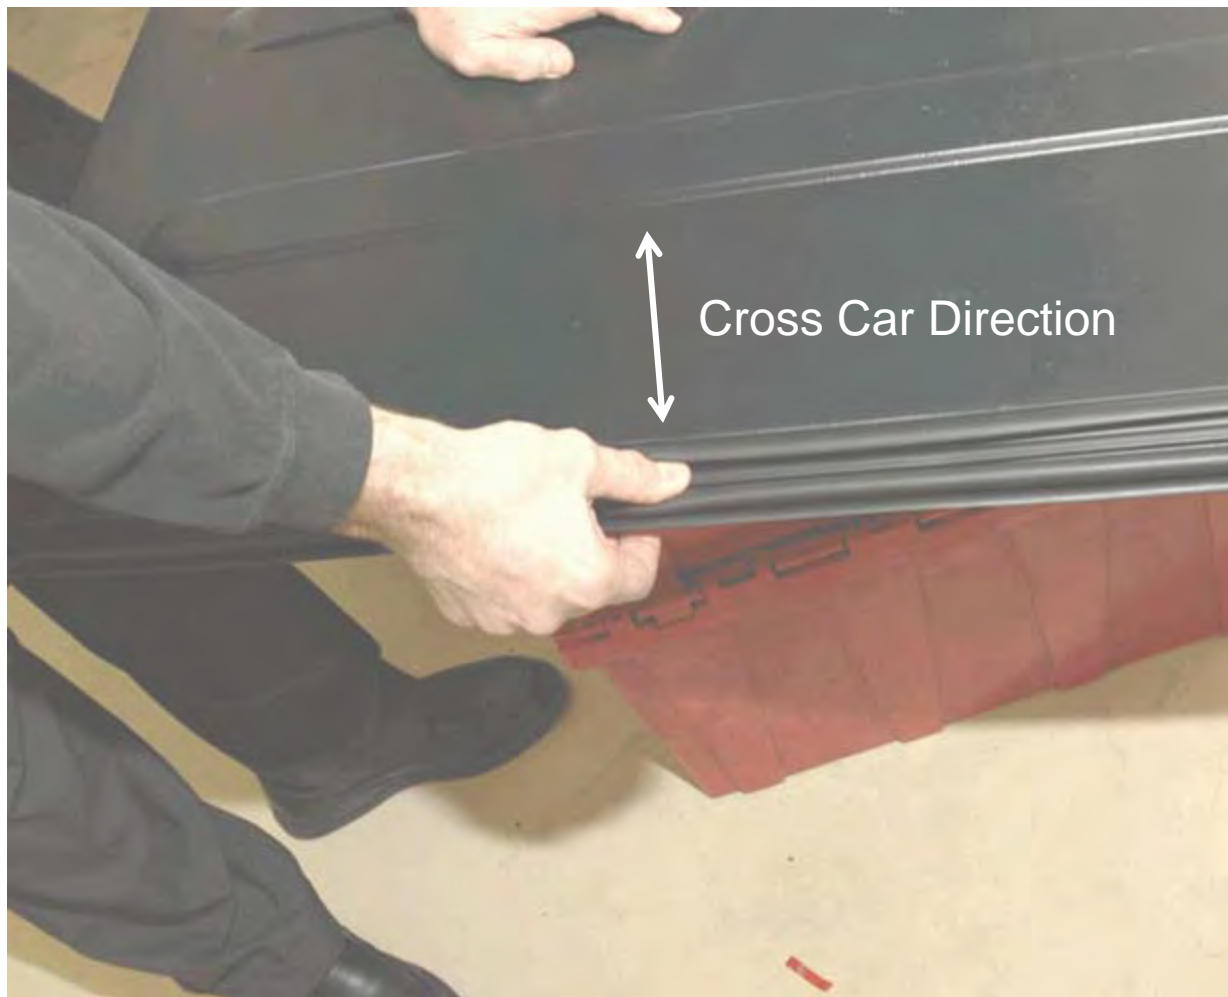
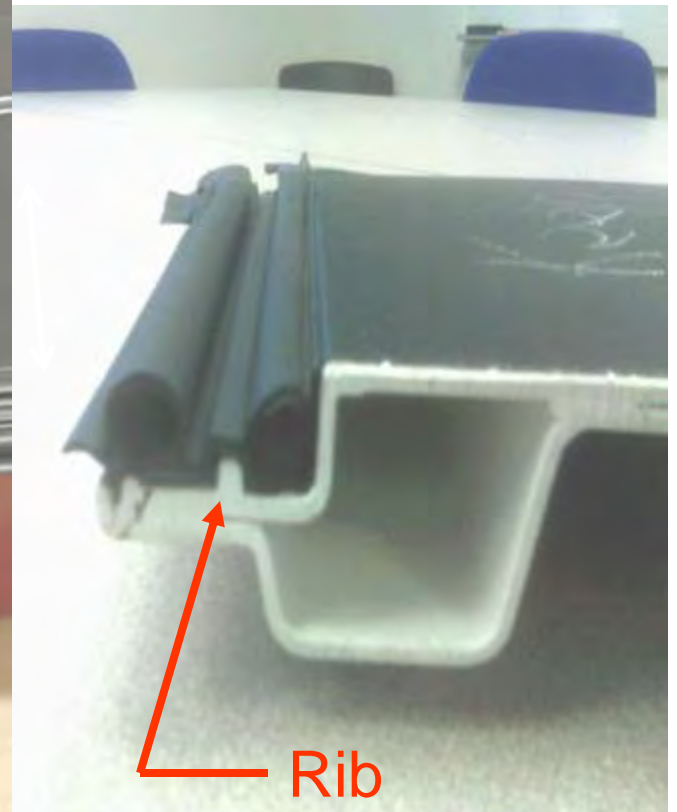
Flip **Right** Freedom Panel
over to complete Weather
Strip installation.

Remove Release Tape, Locate W/Strip cross car against **Rib** in the freedom panel and Pressurize to Freedom Panel **starting at the ends and working toward the center.**

A Small Roller or firm finger pressure should be used to insure the Weather Strip tape is adhered from front to rear,
THIS STEP IS CRITICAL

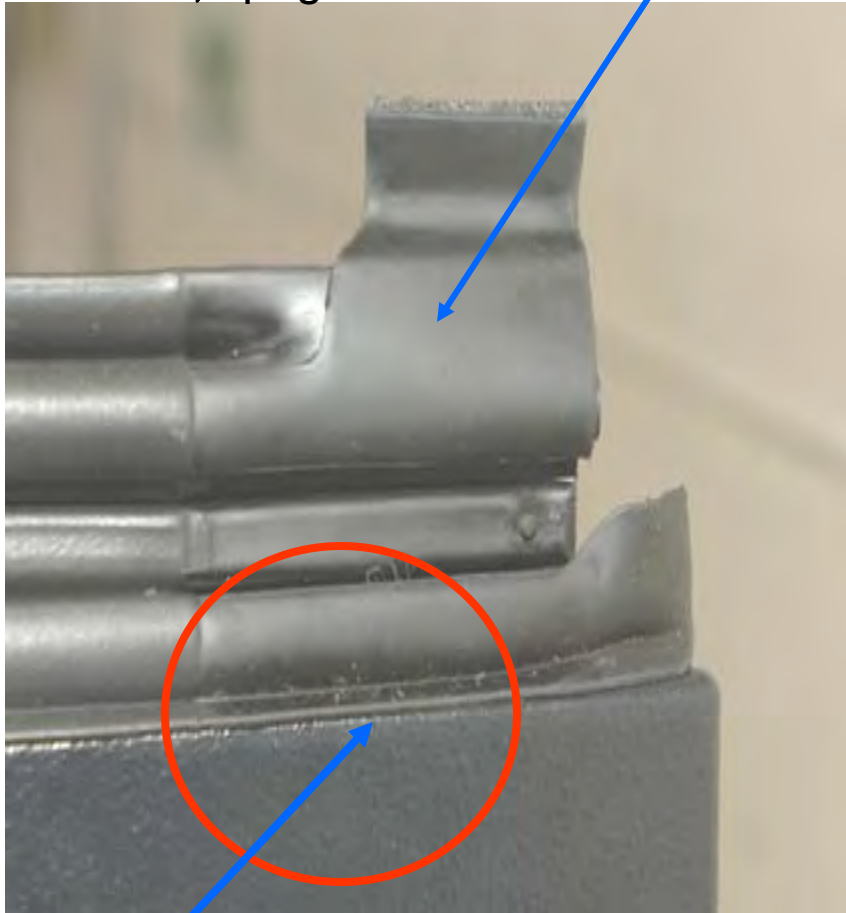
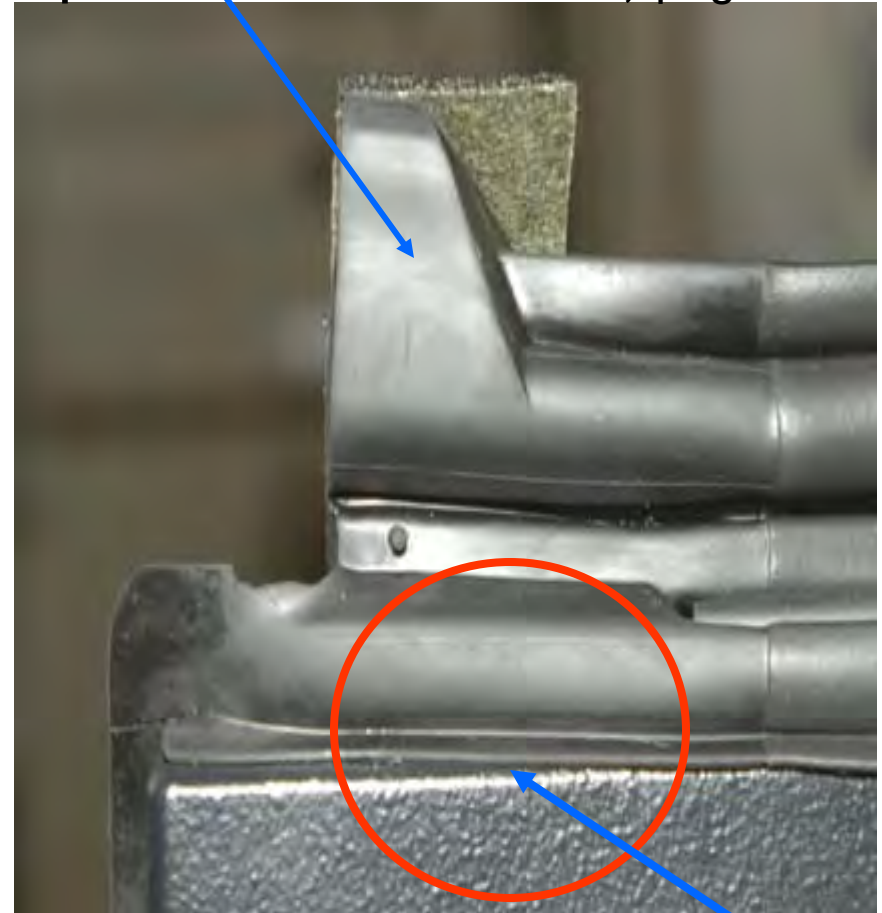
Note: Make sure vertical rubber lip does not roll or get tucked under freedom panel. Correct condition shown is Required at the **Front AND Rear.**

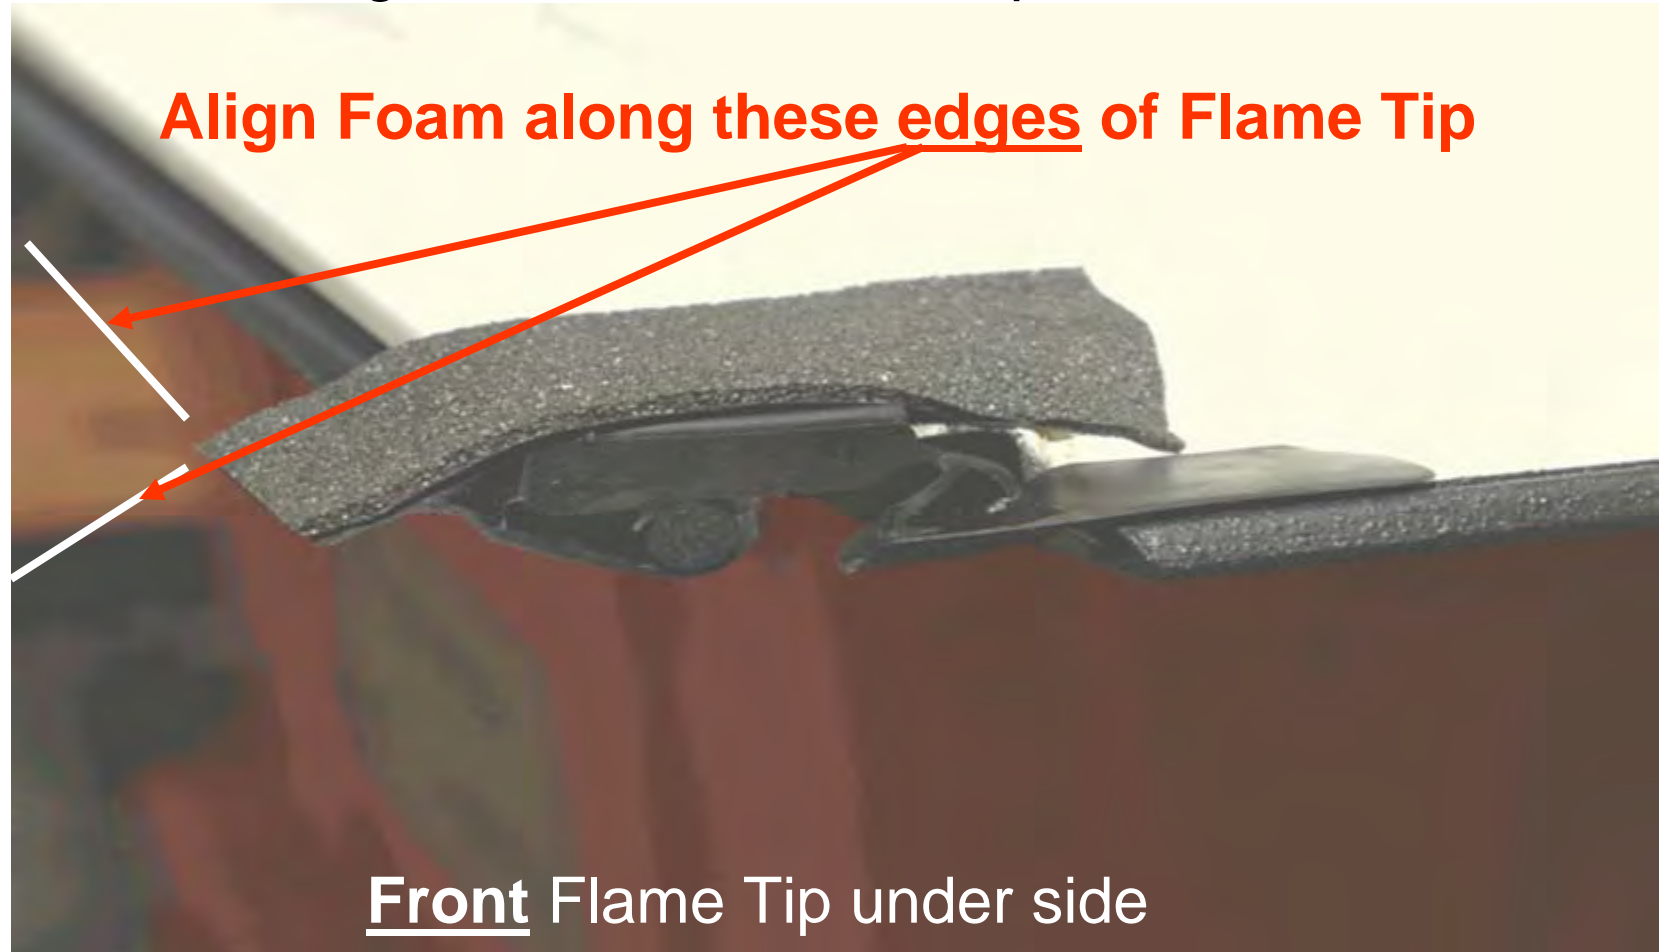
Apply 3M 4298 adhesive promoter on the under side of the flame tip and allow to dry. Align **Gray** 30 X 75 mm Foam from kit along trim lines of Flame Tip.

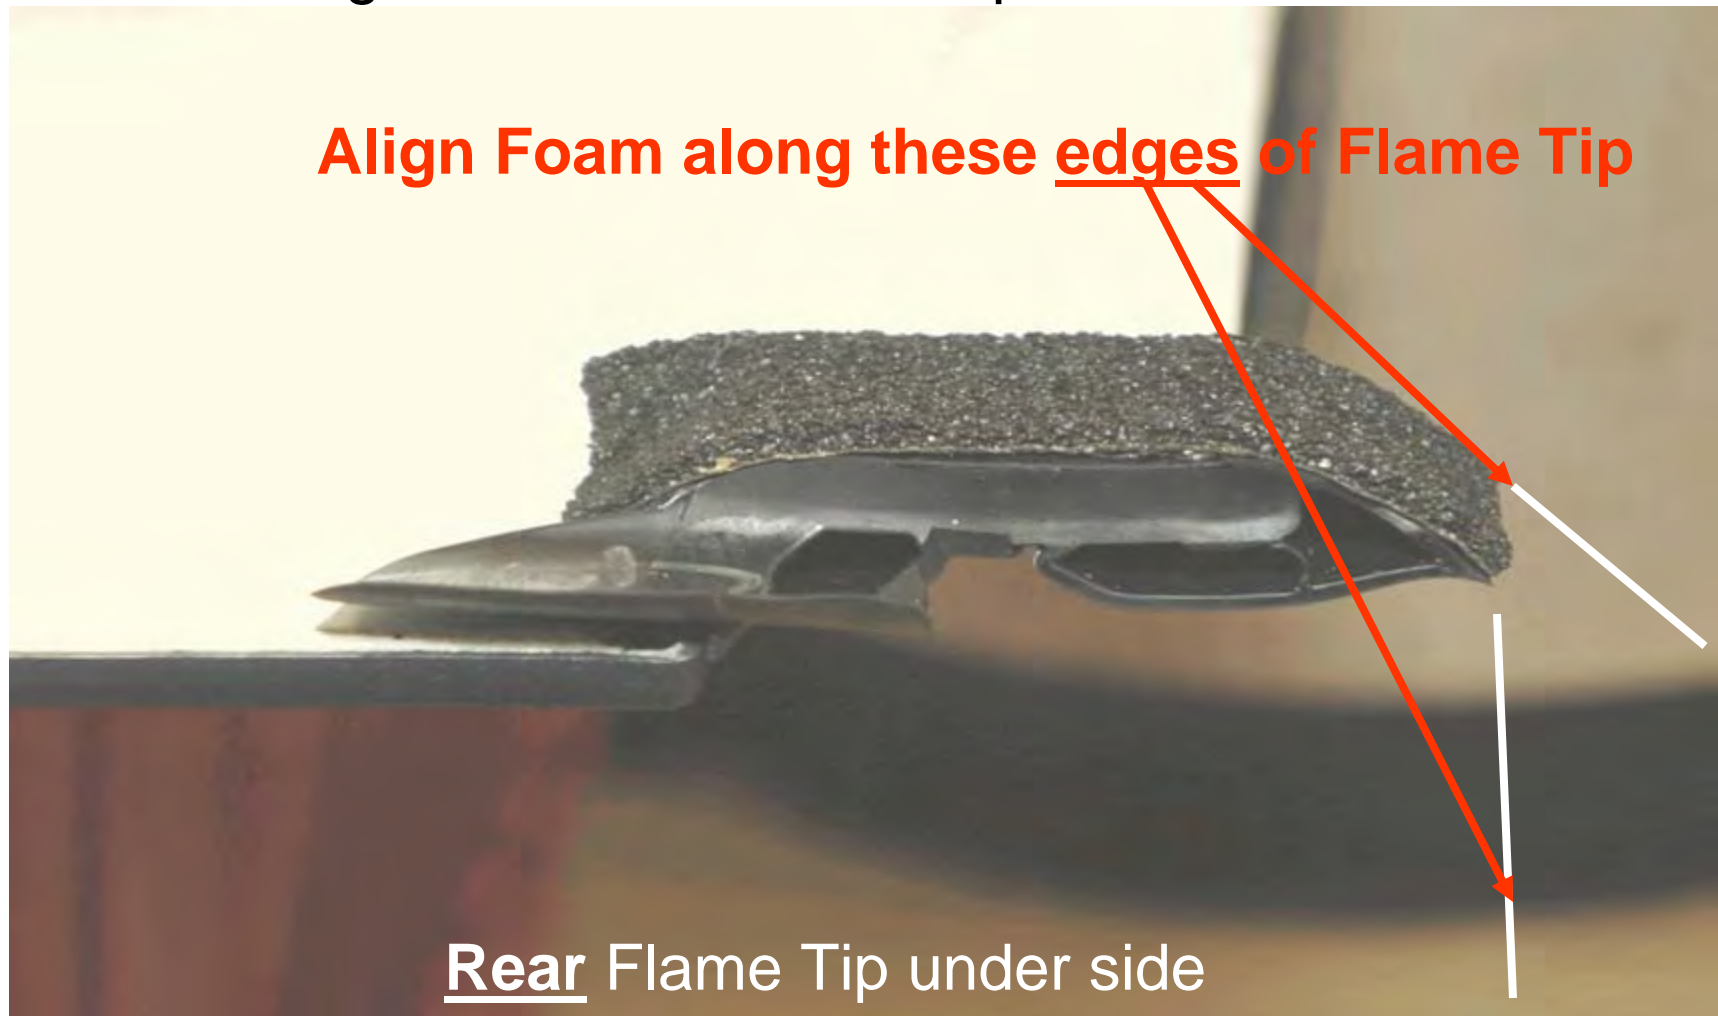
Apply 3M 4298 adhesive promoter on the under side of the flame tip and allow to dry. Align **Black** 30 X 75mm Foam from kit along trim lines of Flame Tip.

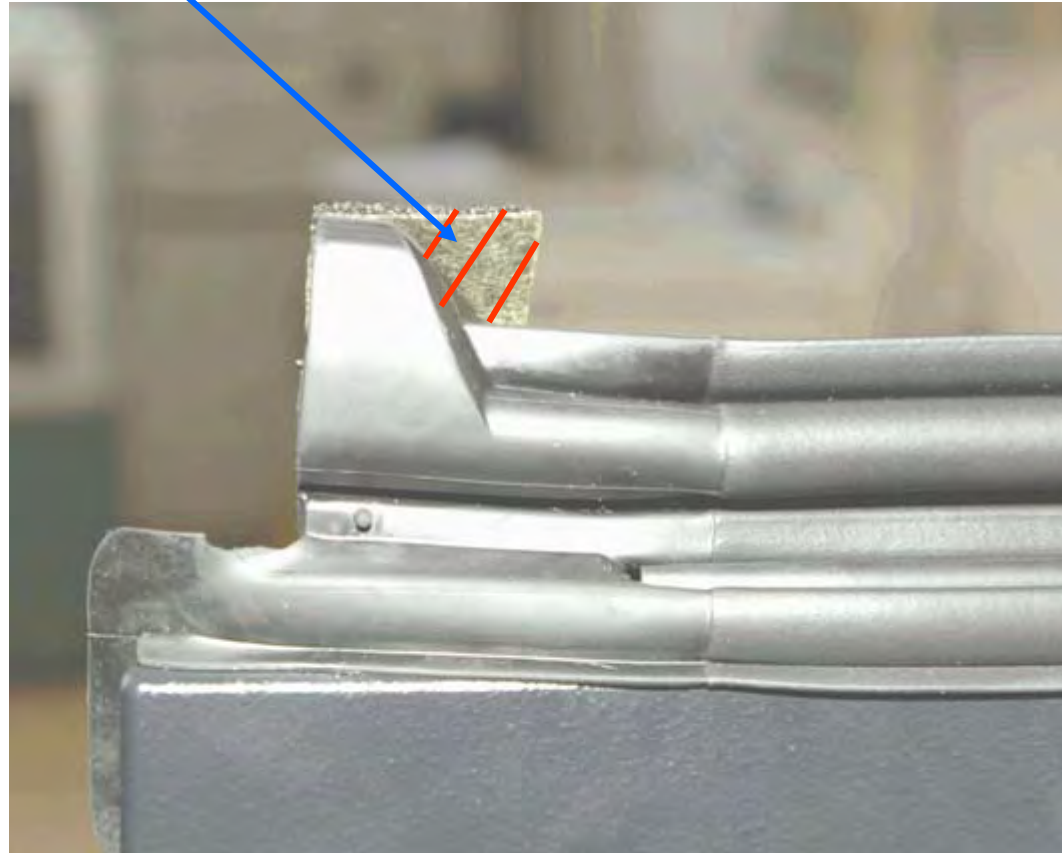
Rear Flame Tip - Top View

Trim away excess **Black** Foam.

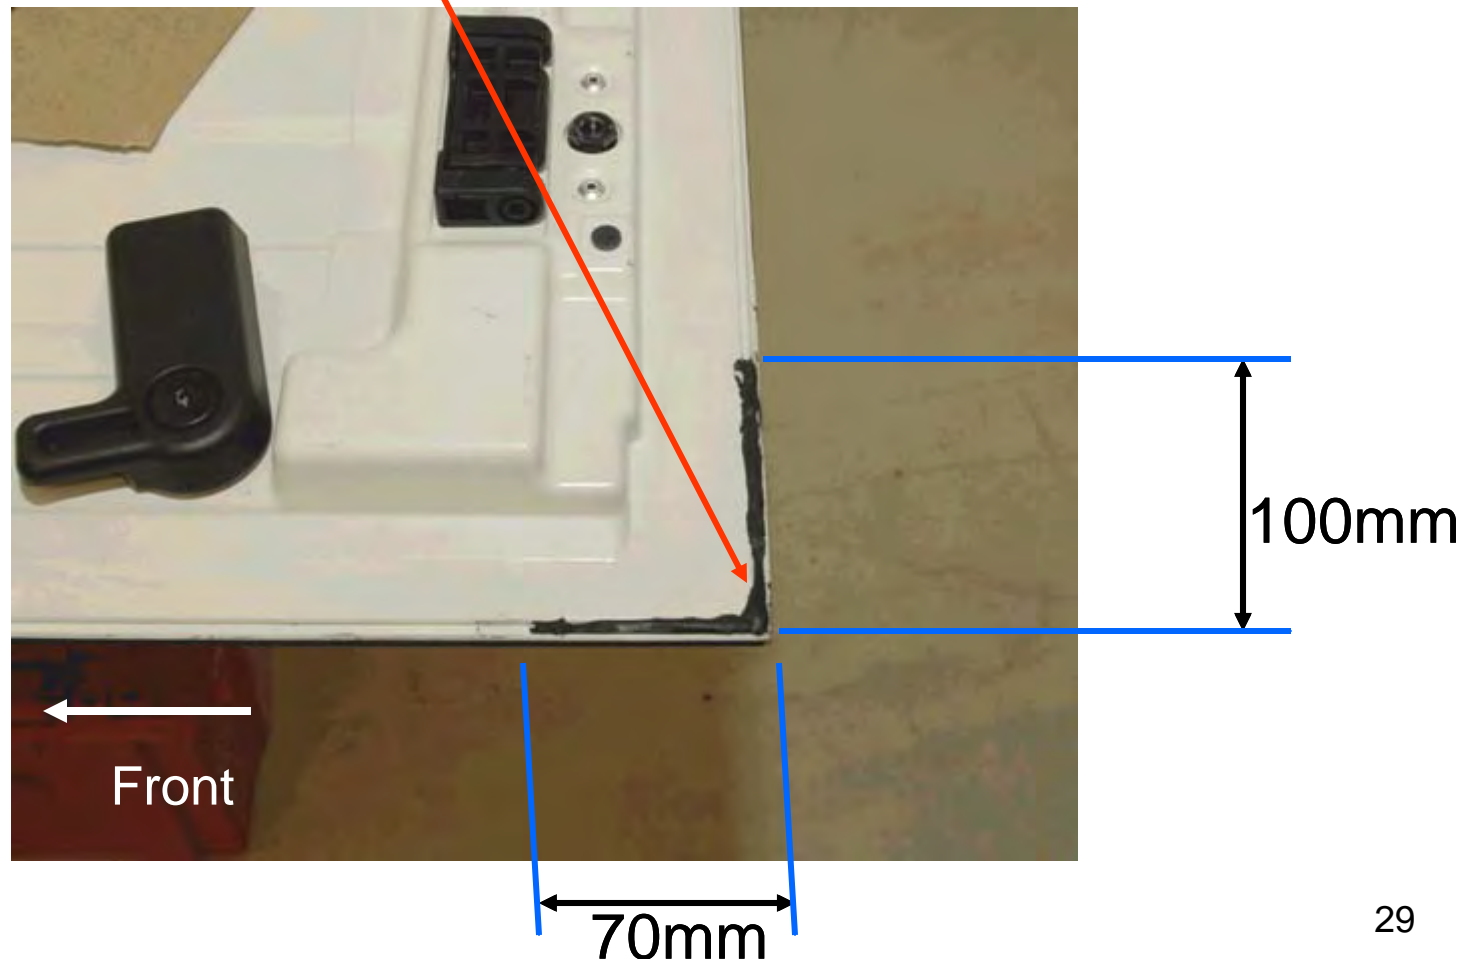
Add 4mm diameter **Butyl**, Pt # 68027813AA to Rear Inboard Corner groove, Left Freedom Panel

Note: Push Butyl Firmly into groove between panels **until Flush**

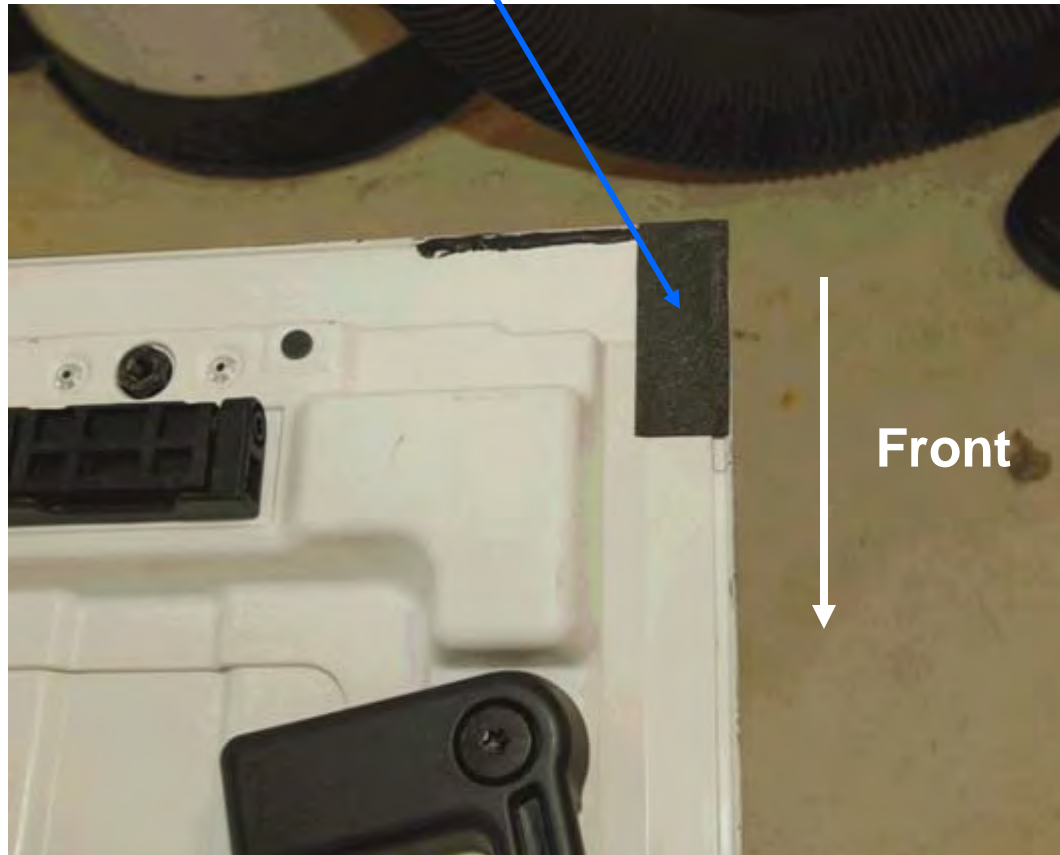
Add 30 X 75 mm **Black** Foam from Kit to cover butyl

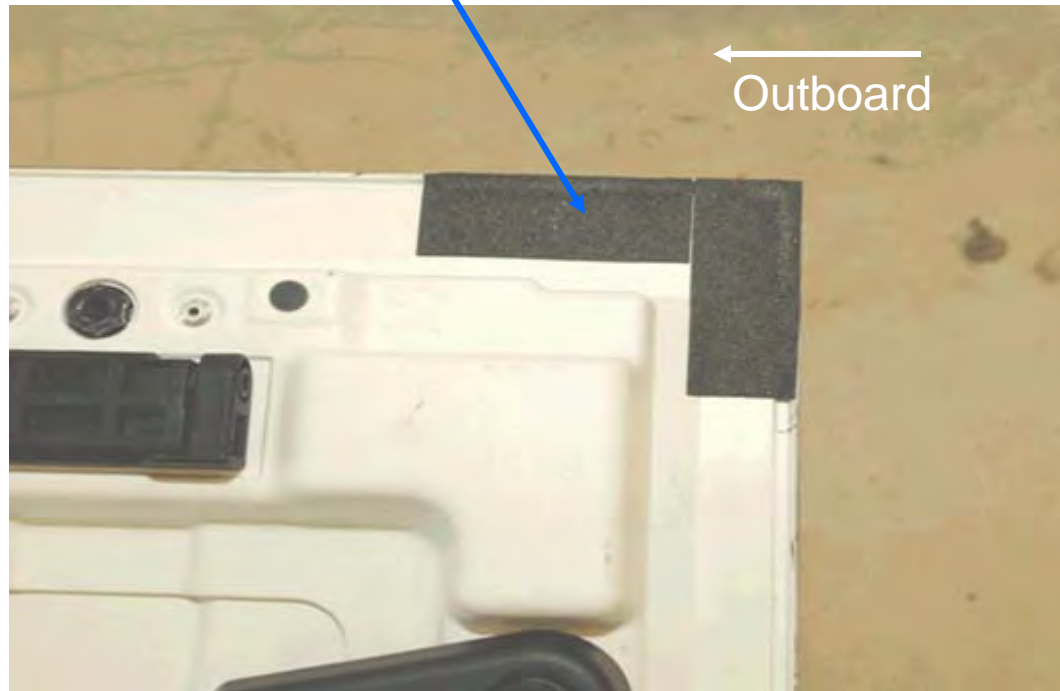
Add 30 X 75 mm **Black** Foam from Kit to cover butyl.

Note Make sure Foam covers Butyl.

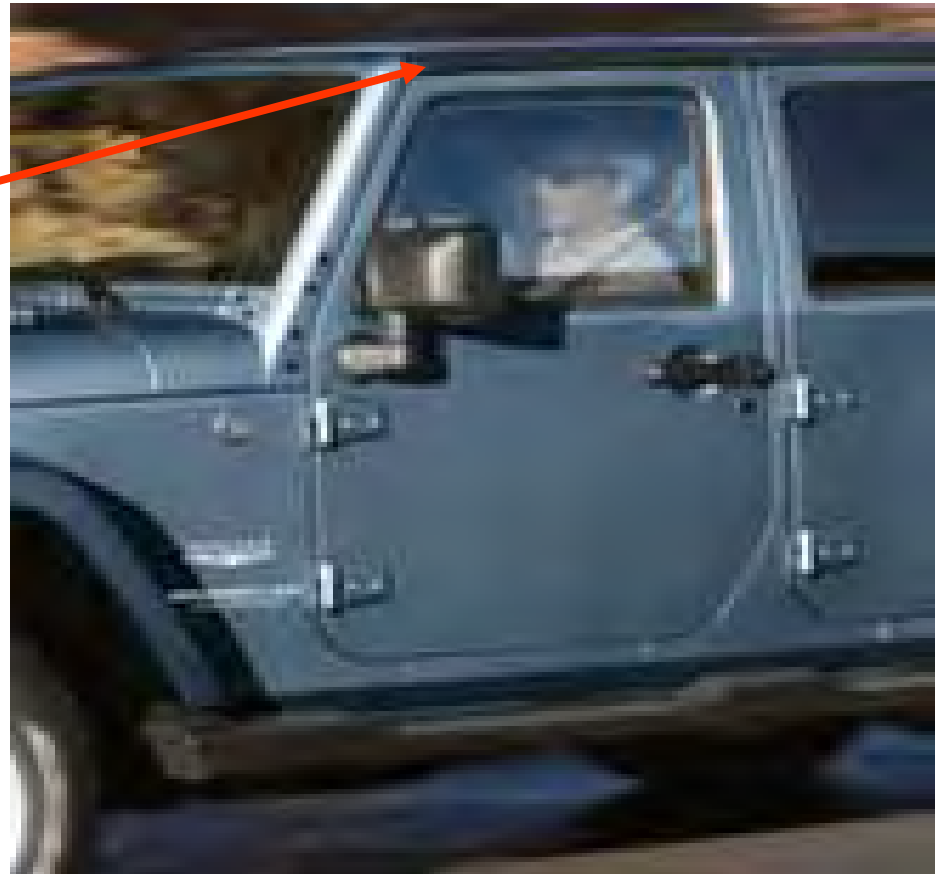
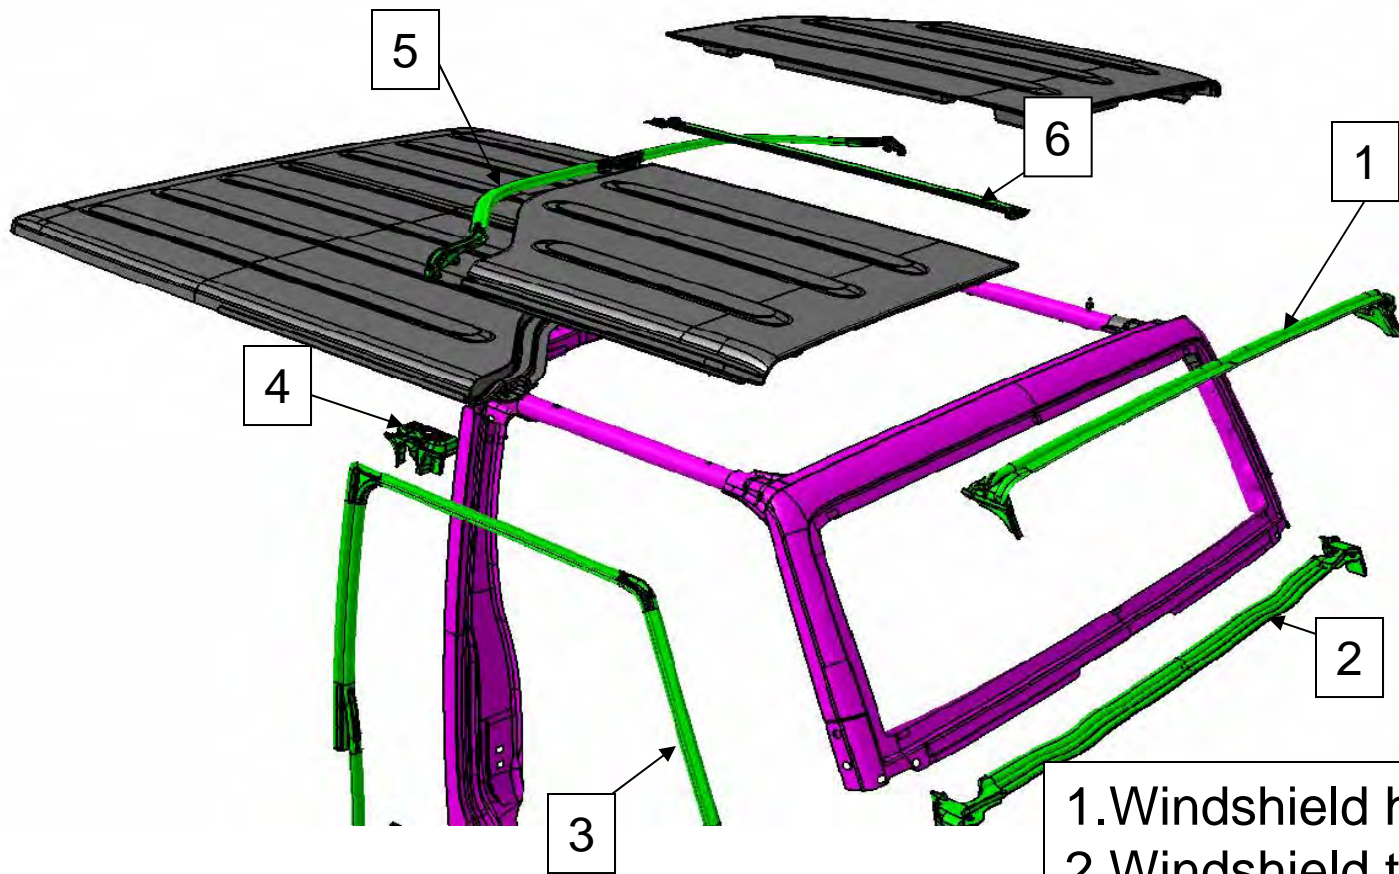
Outside View

- 1. Windshield header seal
- 2. Windshield to cowl seal
- 3. Front door weatherseal
- 4. B pillar mocket
- 5. Hard top seal
- 6. Center freedom panel seal

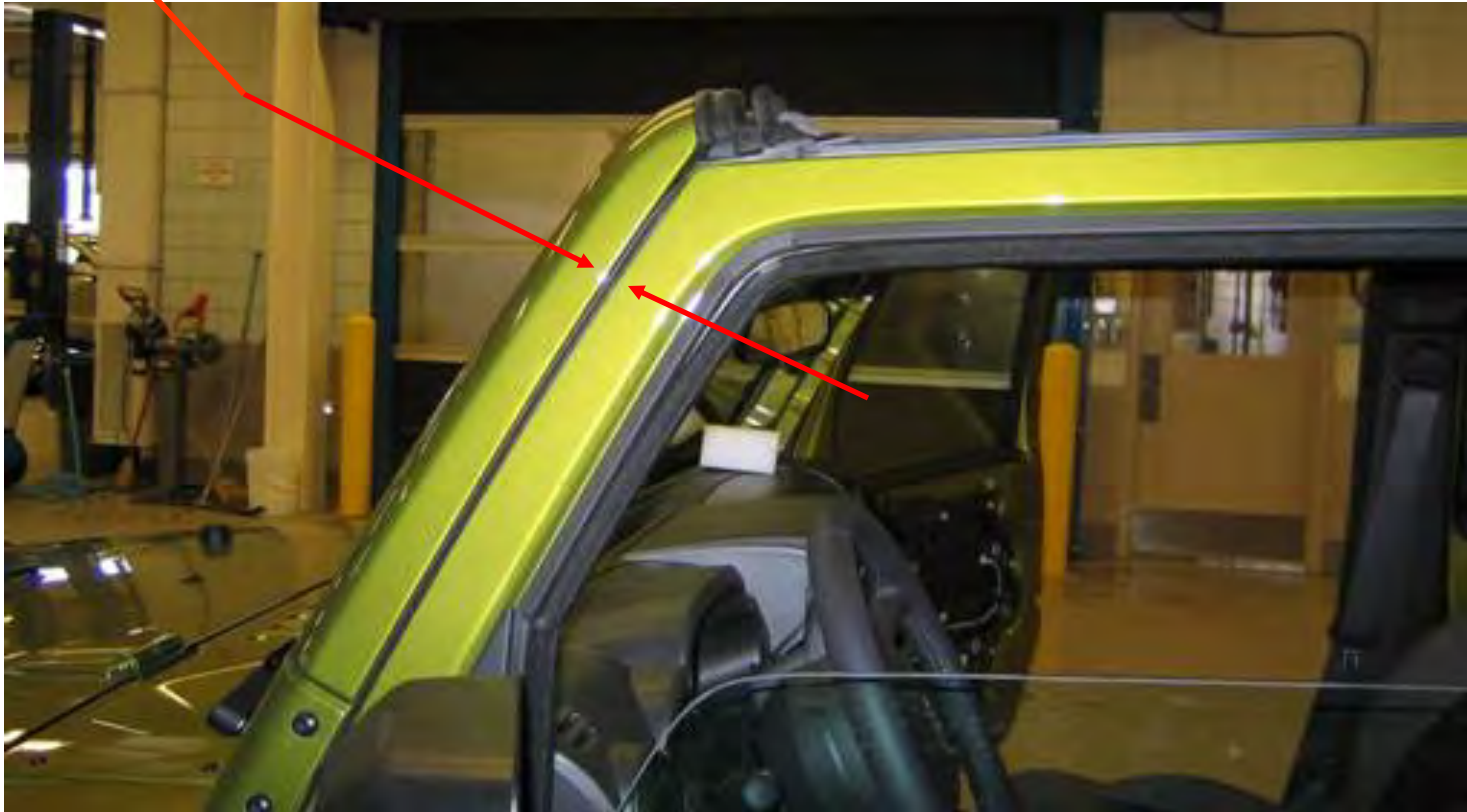
- The door gap spec. is 5 +/-1.5 mm

Door Must be Flush to slightly under flush to A- Pillar

**Adjust door Gap AND Flushness as described in
Body Section 23 of the Service Manual**

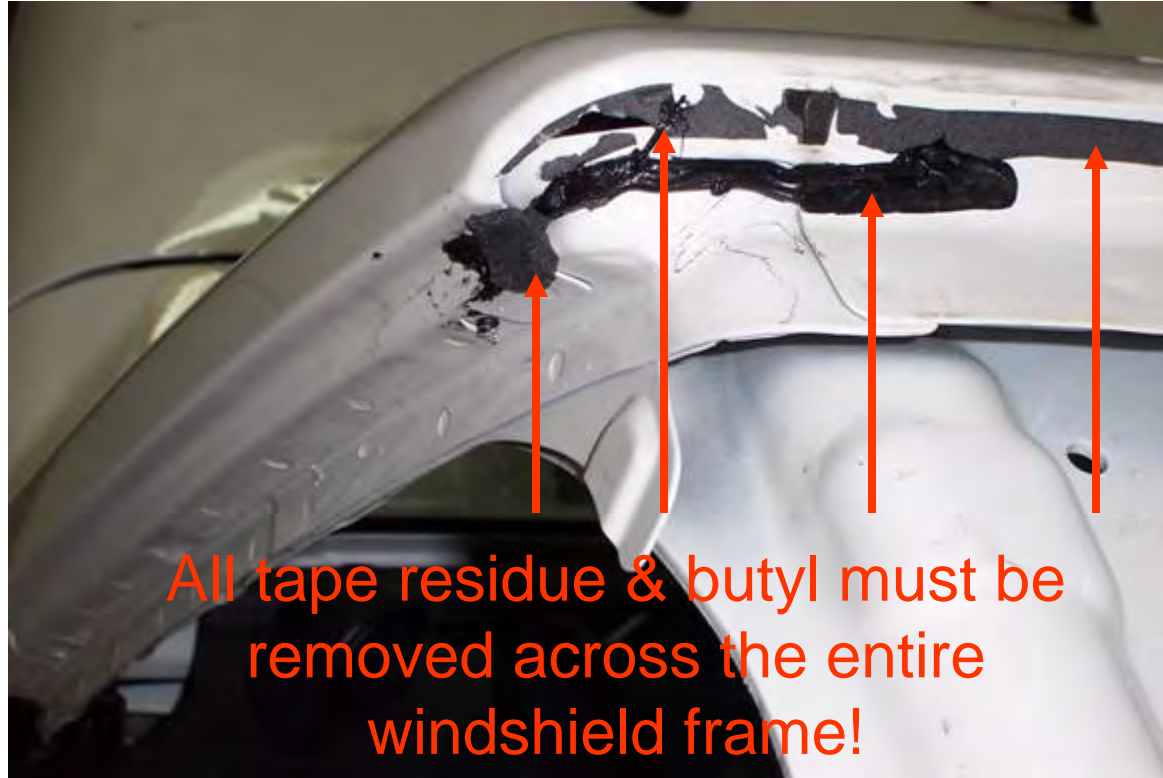
Weather Strip Removal & Butyl Clean Up

Clean up / remove all traces of old Tape and Butyl from painted sheet metal surfaces.

Alcohol wipe the clean sheet metal before installation of butyl bead and new weather strip.

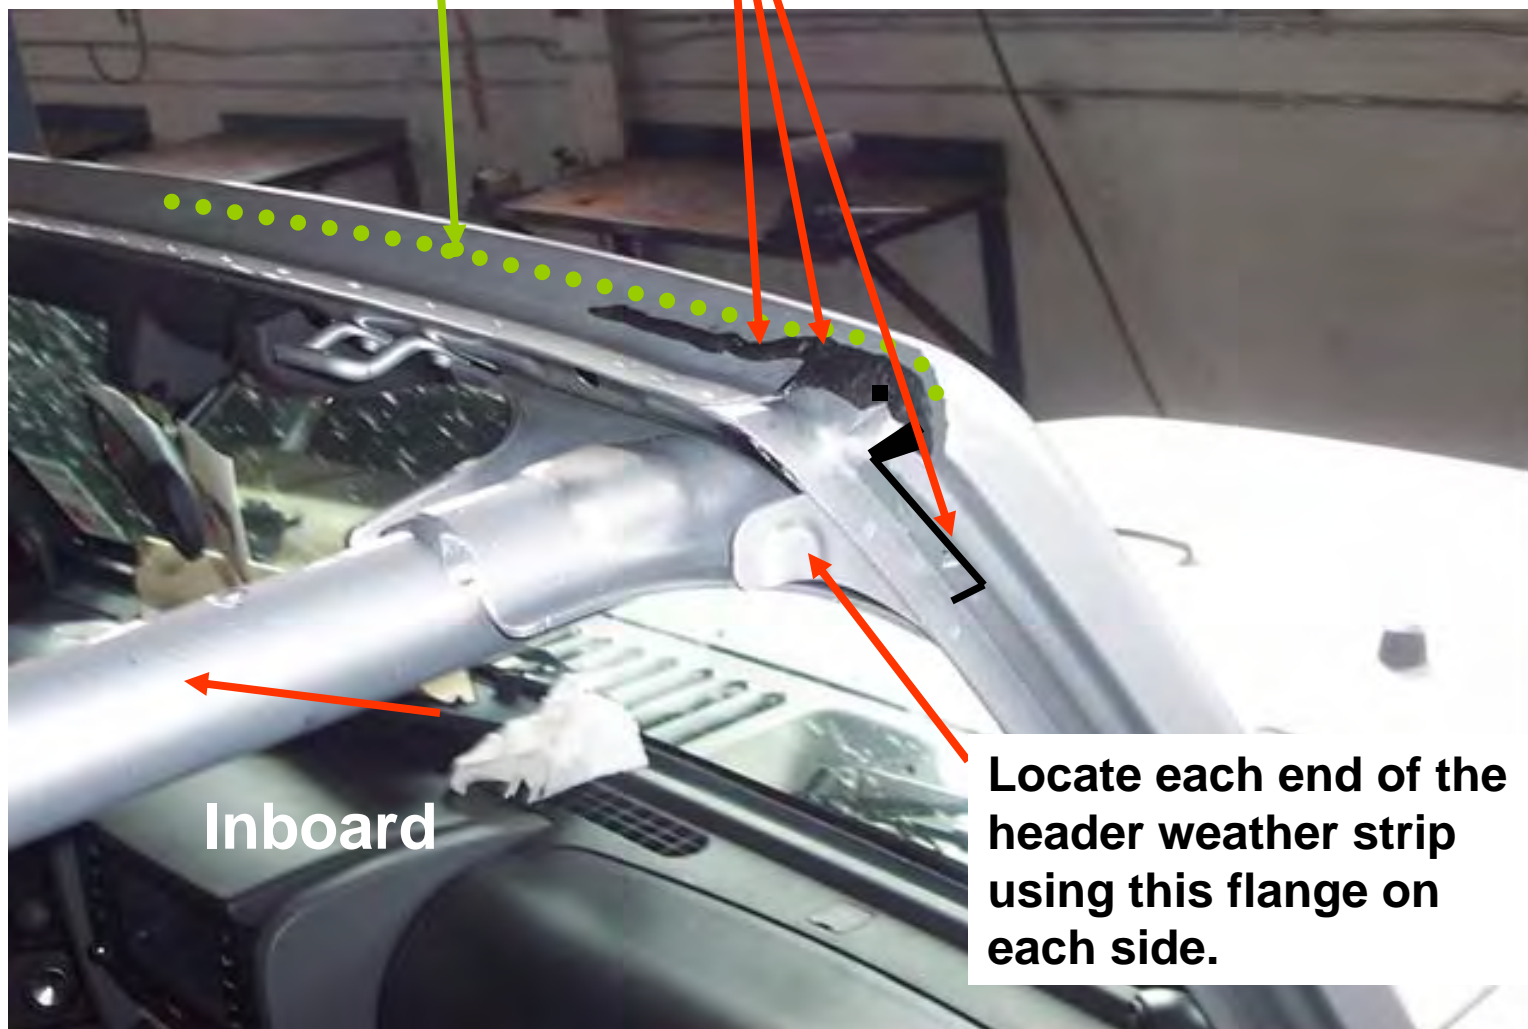
Inboard

Note: Green dots Show the area where the header weather Strip Adhesive Tape is to be located

**4 mm diameter bead 68027813AA
Replacement Butyl Position. See page 9 for Butyl Dimensions**

Locate each end of the header weather strip using this flange on each side.
