Jeep Wrangler

Diagnosis & Repair Manual

Water Leaks

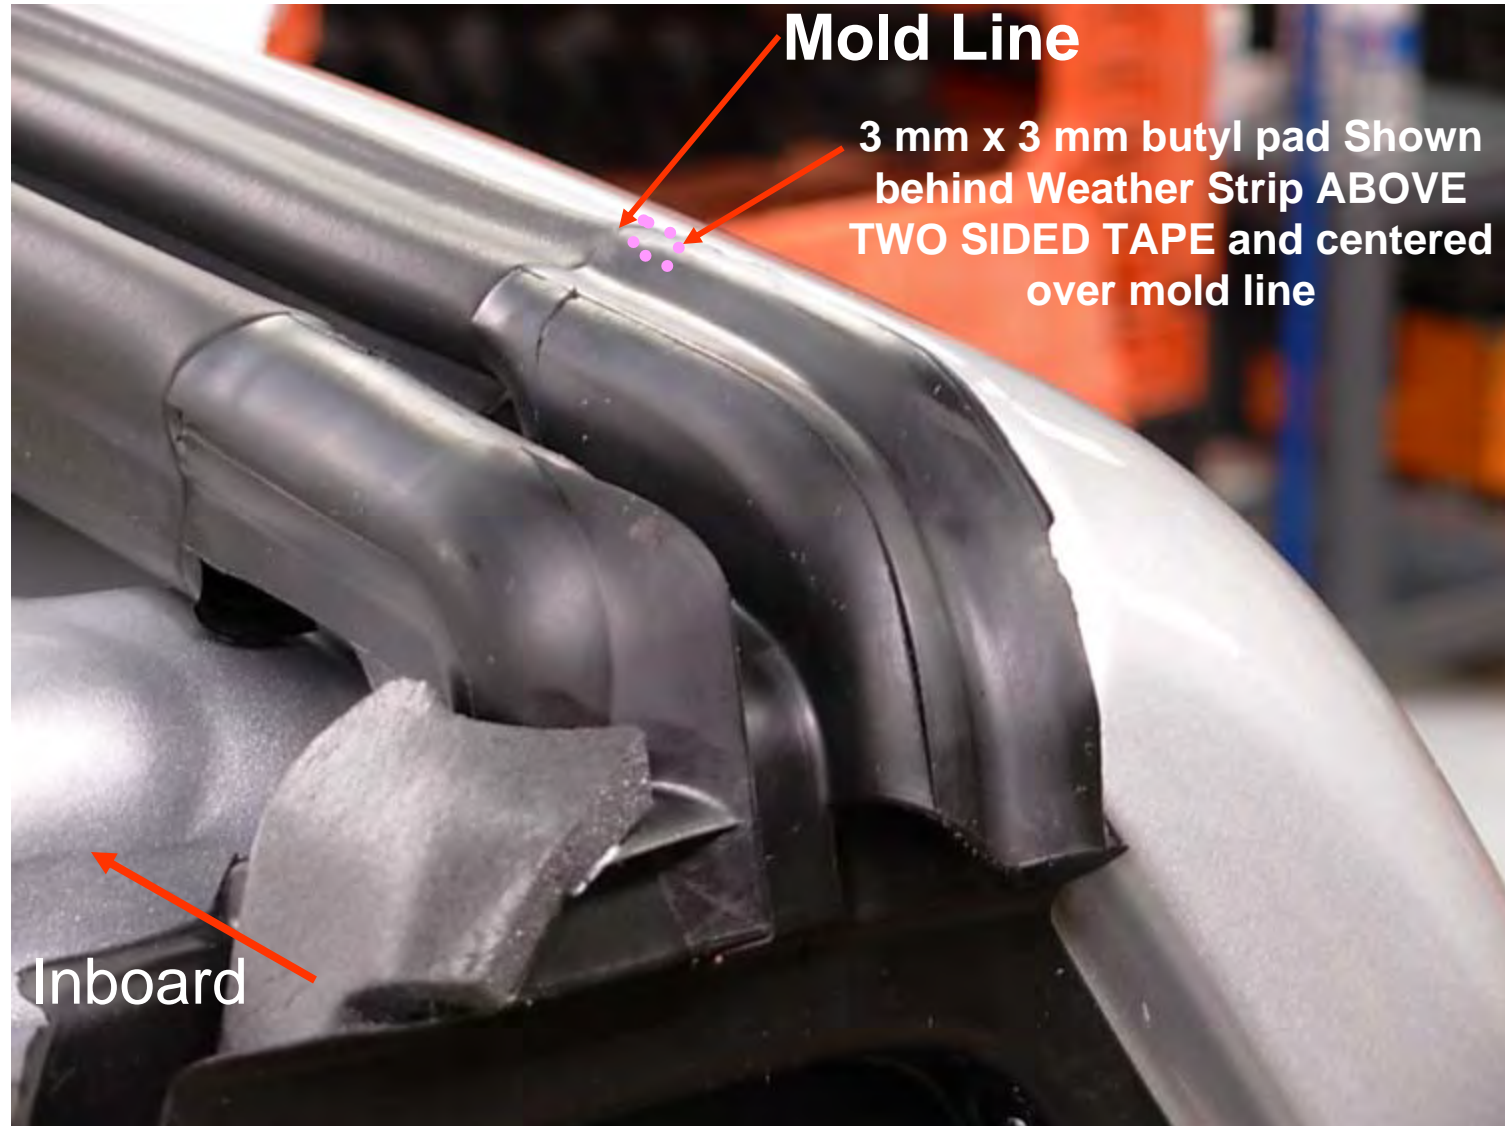
**Right Side A-pillar
Header Seal Installed**

Remove Release tape and Pressurize Weather Strip Firmly in contact with Header Sheet Metal to smooth out adhesive tape and butyl, starting at the ends and working toward the center. A small Roller or firm finger pressure should be used to insure the Weather Strip tape is adhered completely from side to side, **THIS STEP IS CRITICAL**

Gently pull weather strip rearward at mold line shown on page 9 and insert a 3 mm x 3 mm square piece of butyl .

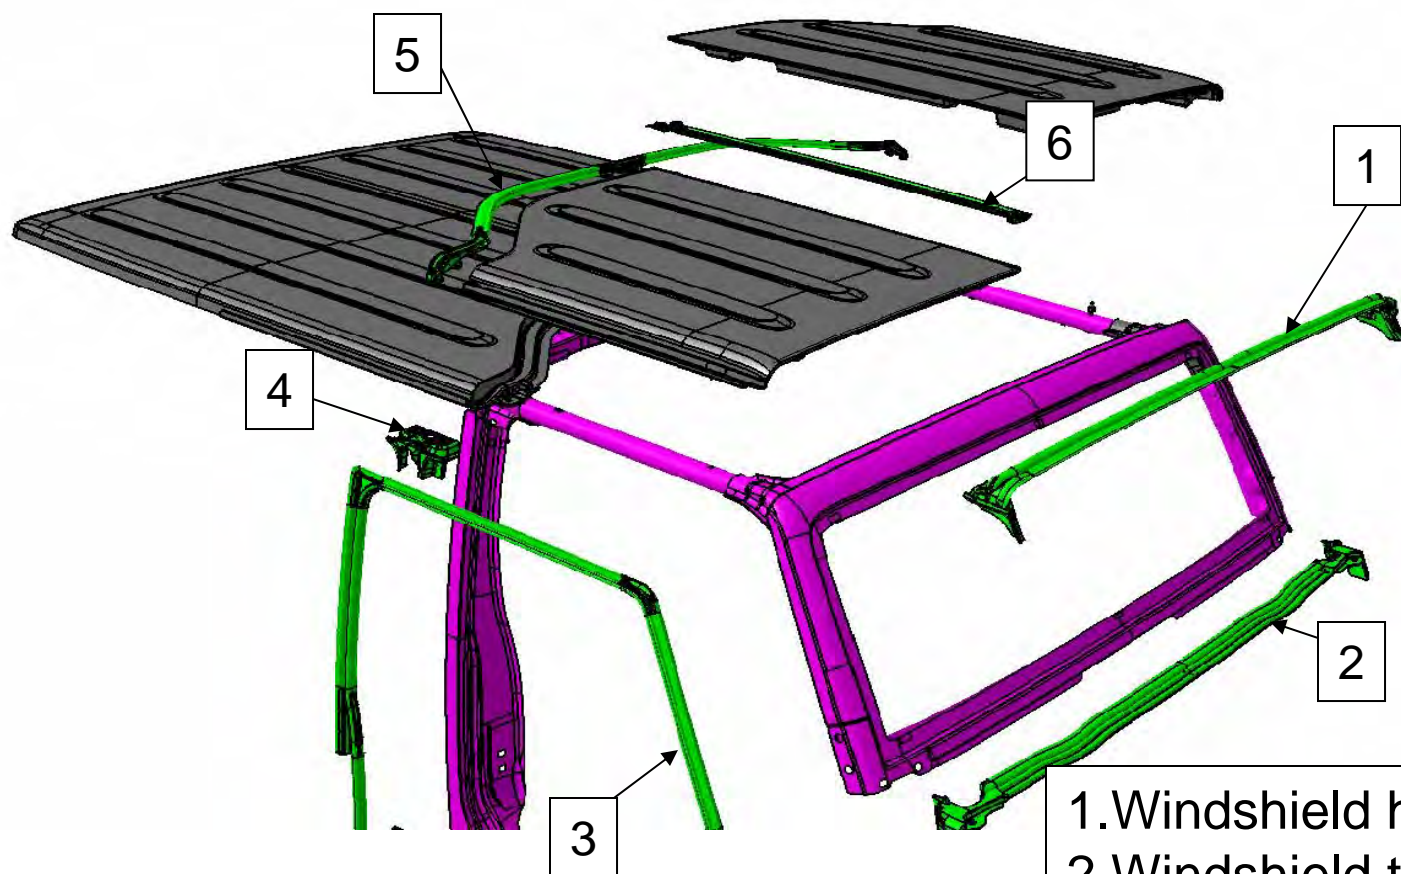
Outside View

- 1. Windshield header seal
- 2. Windshield to cowl seal
- 3. Front door weatherseal
- 4. B pillar mocket
- 5. Hard top seal
- 6. Center freedom panel seal

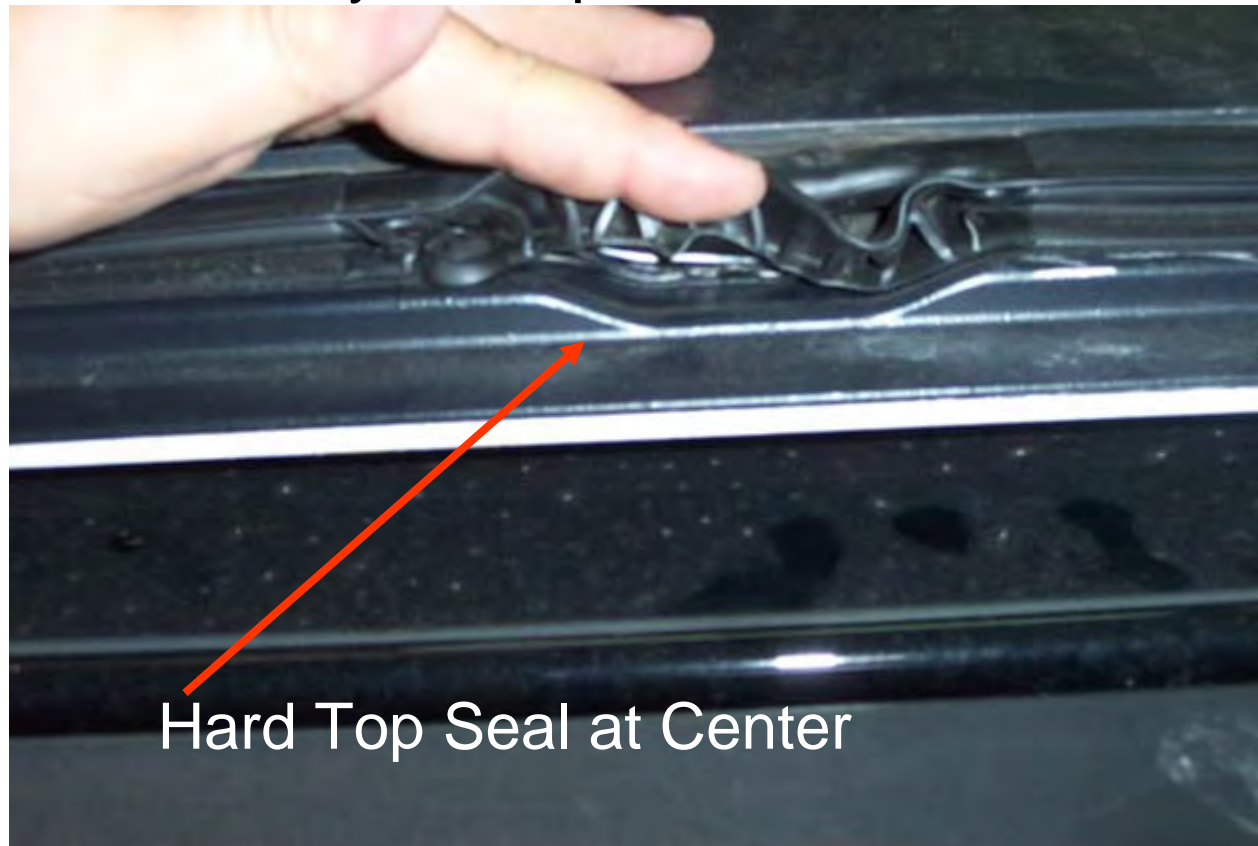
Hard Top Seal at Center

Note Seal Shown with sealer skips allows water behind seal. This requires the need for additional Butyl to be placed to fill in these voids

W/Strip Repair -Try this step Prior to Replacement

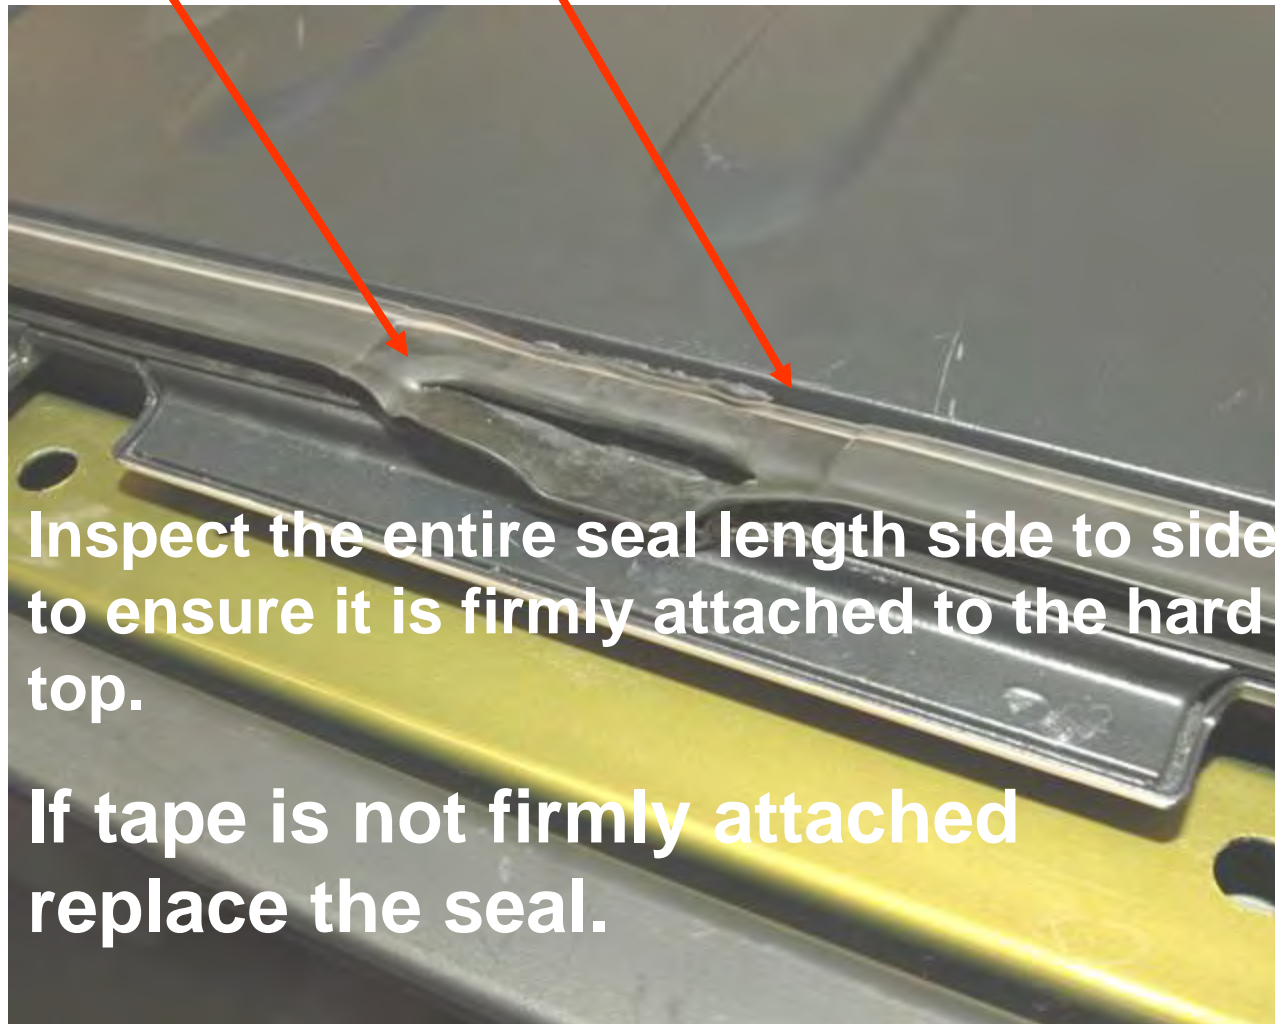
Hard Top Seal at Center

Note Seal Shown gapping to roof allows water behind seal. **This requires the seal to be replaced**

Inspect the entire seal length side to side to ensure it is firmly attached to the hard top.

If tape is not firmly attached replace the seal.

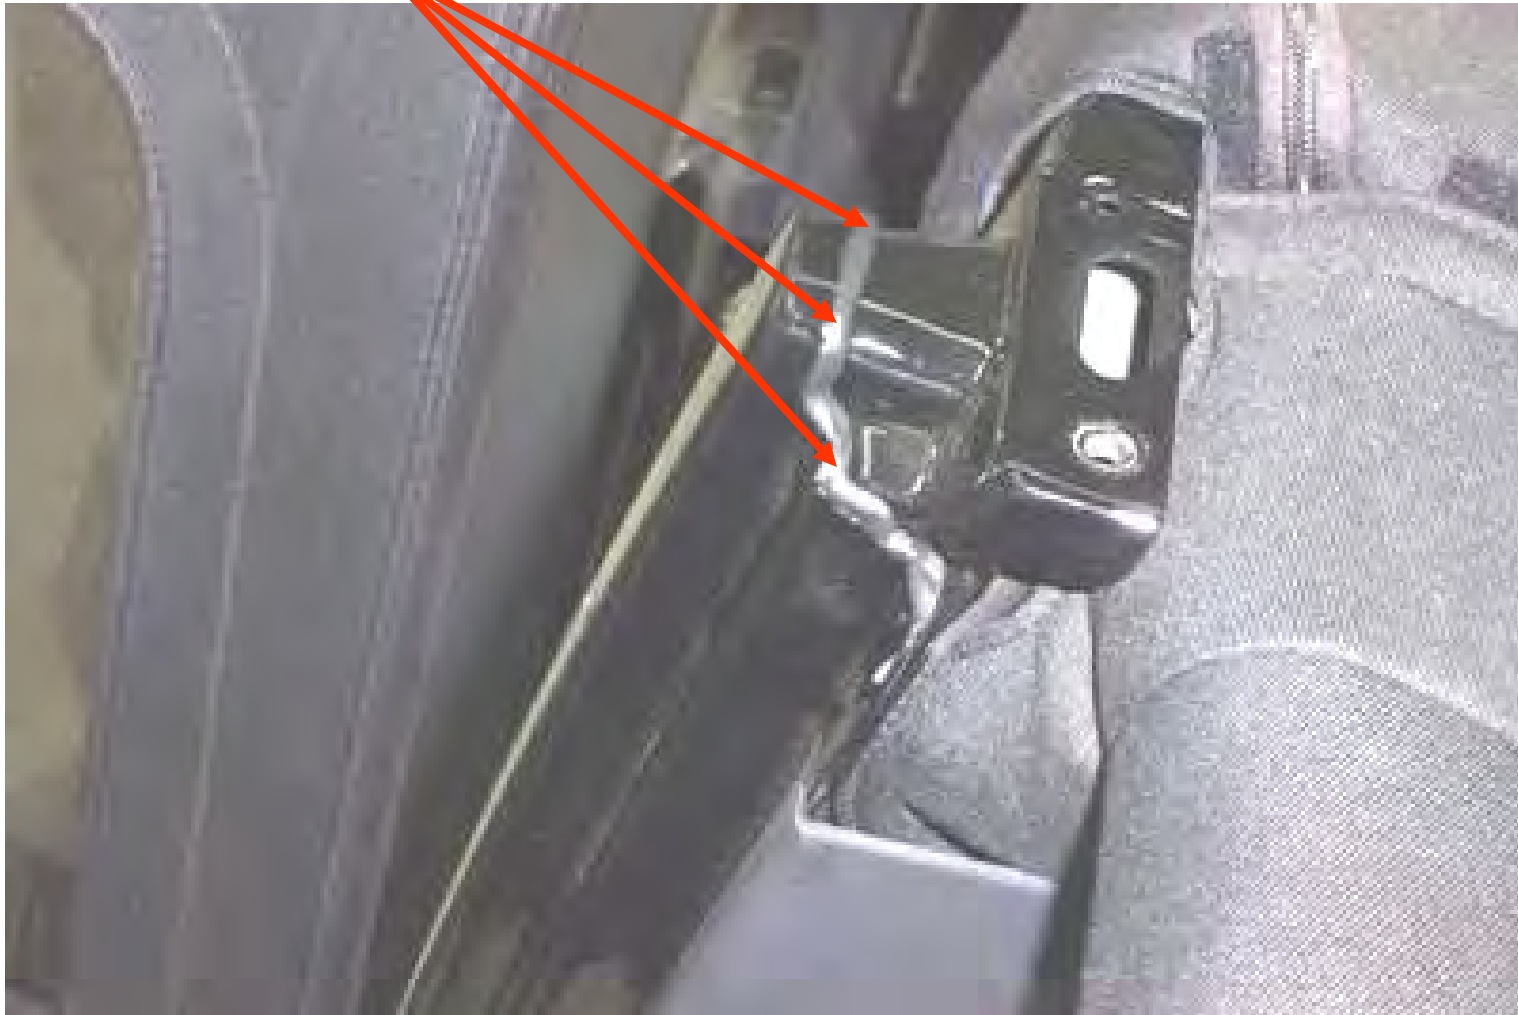
Top of Right B – Pillar With Mocket Seal removed

**Add a 4 mm diameter bead of Butyl 68027813AA
as shown to fill in sheet metal gaps.**

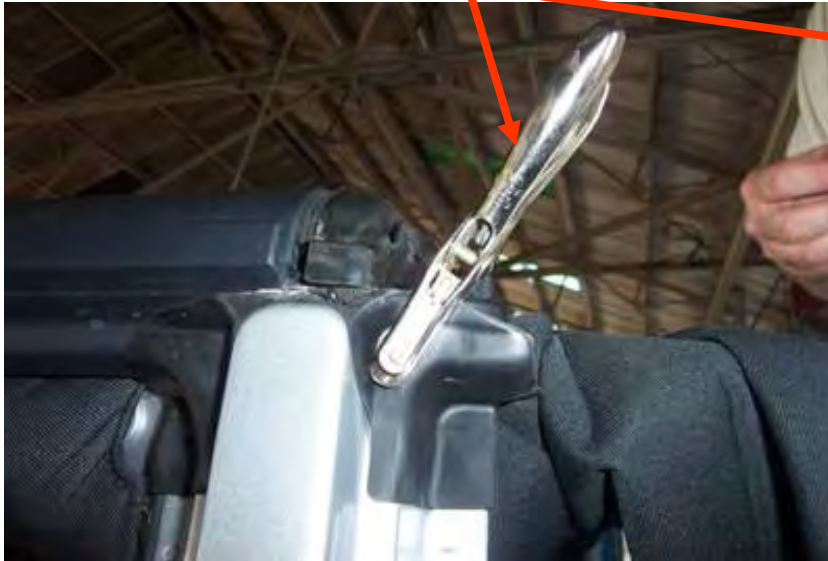
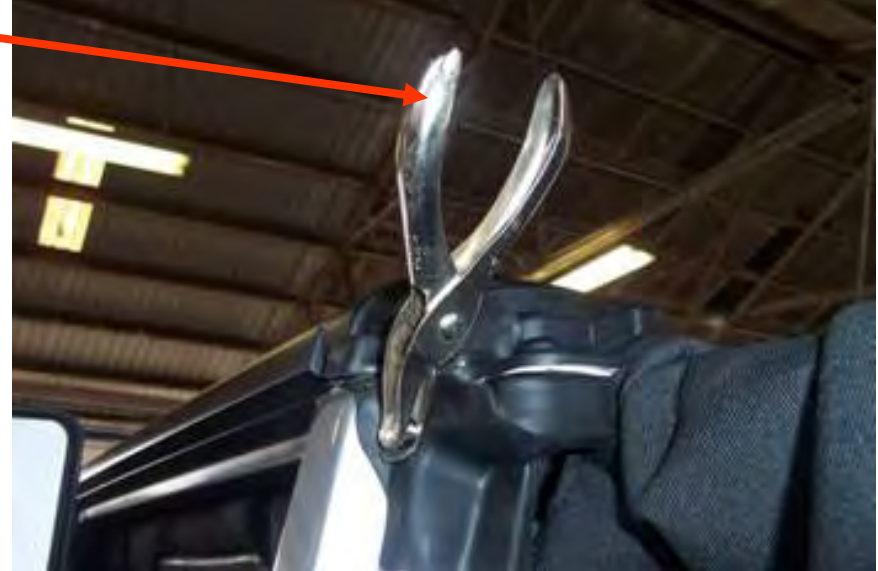
Note Single hole paper punch used to add Drain Hole

**Hole Shown
located at the
rearward /
lowest position
possible**

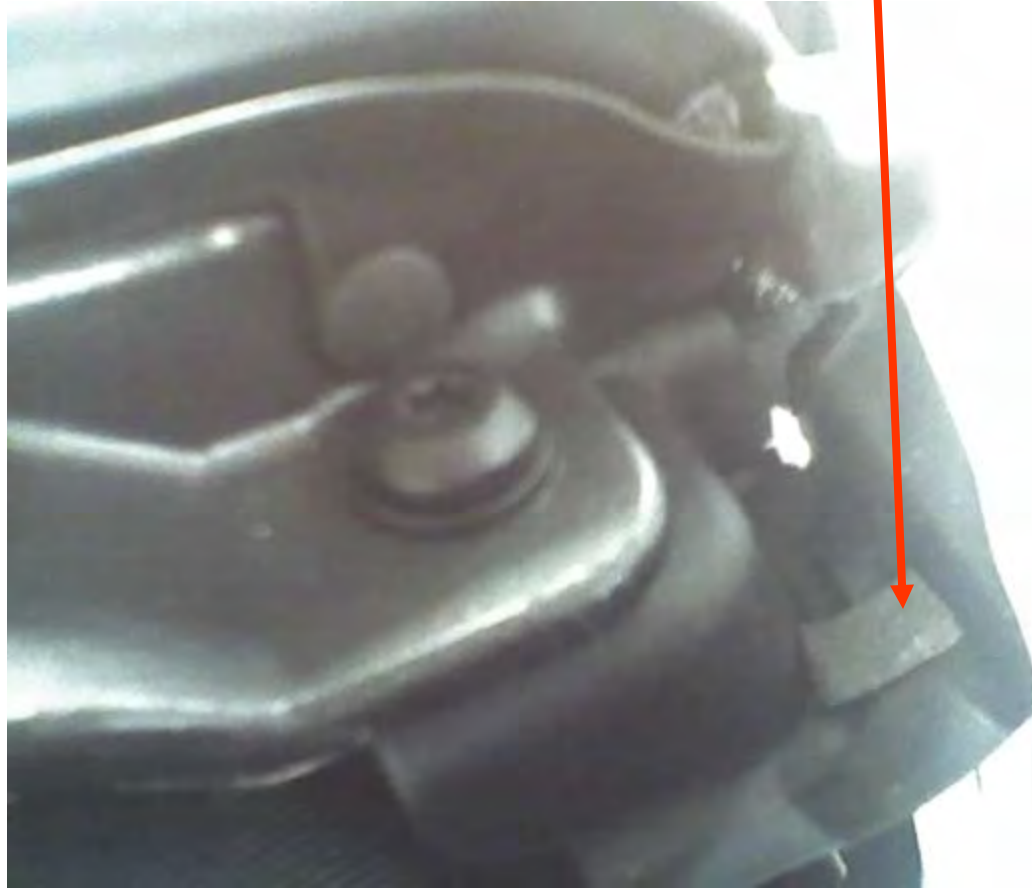
Left B – Pillar TOP VIEW

Foam Tape must be adhered to the front portion
of the drain cup as shown to act as a dam

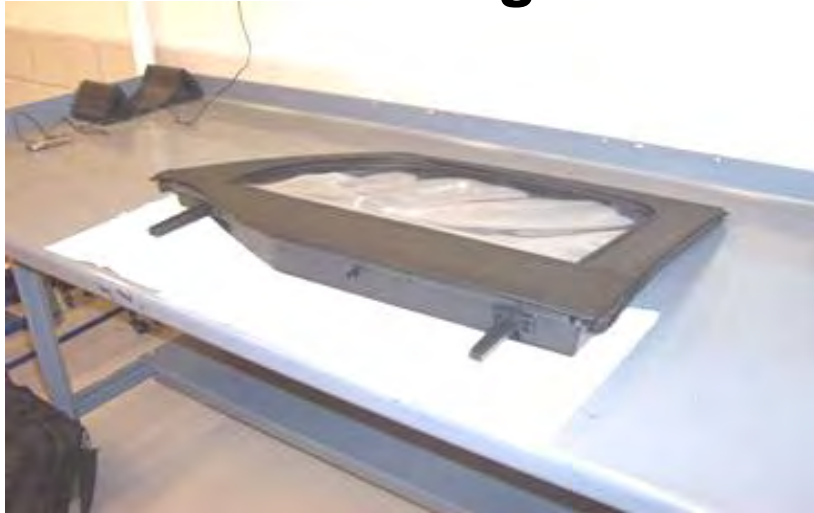
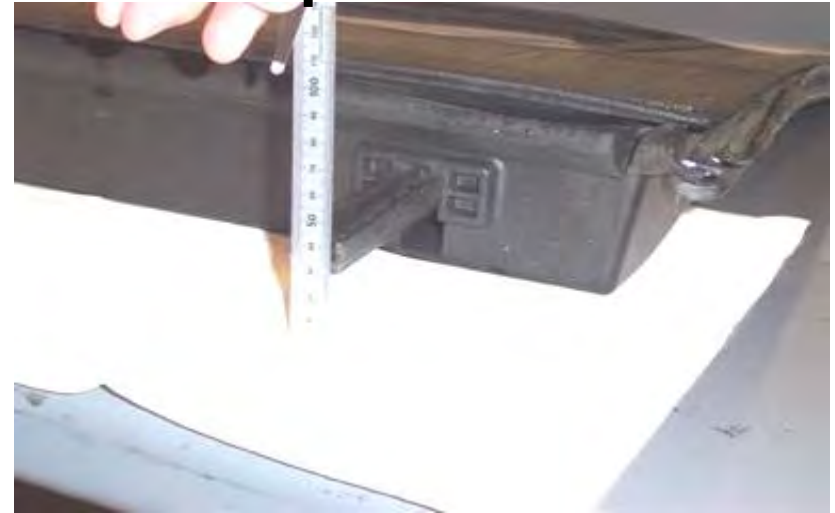
Measuring of Door Posts For Proper Preload

1. Lay Door on Flat Clean Surface.
2. Measure Posts.
3. Use Heat Gun to Heat up Posts as shown on page 3.
4. Slide Pipe over Posts and Bend to Correct Dimension as shown on page 3.

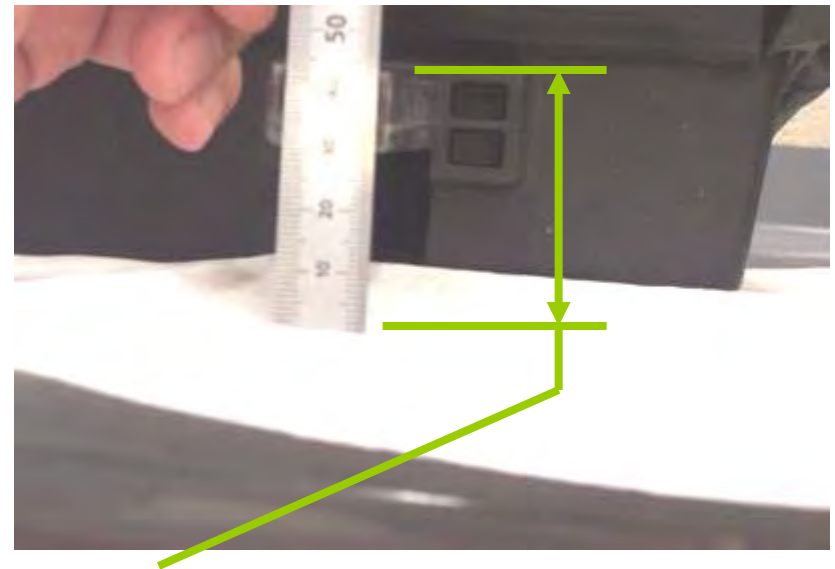
Set this dimension as shown to the upper edge of each peg to the dimensions shown on page 3

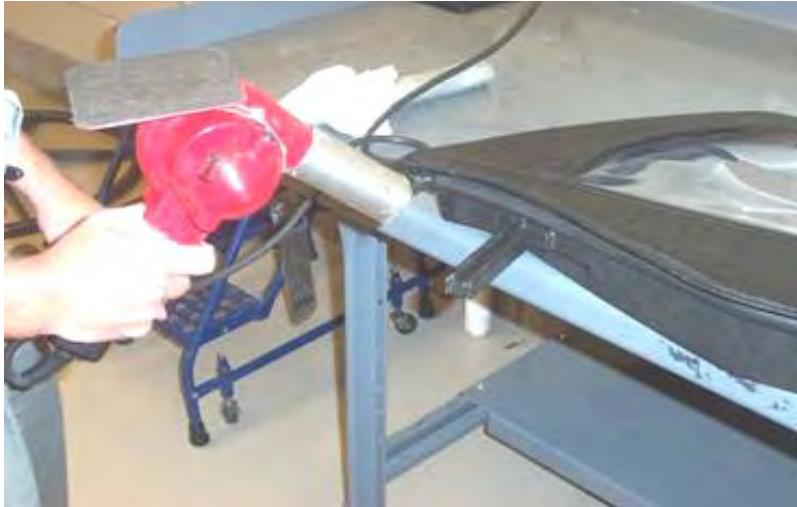
Heat Post: Caution too much heat will melt Door, Maintain 12 inches for 2 Min. Max

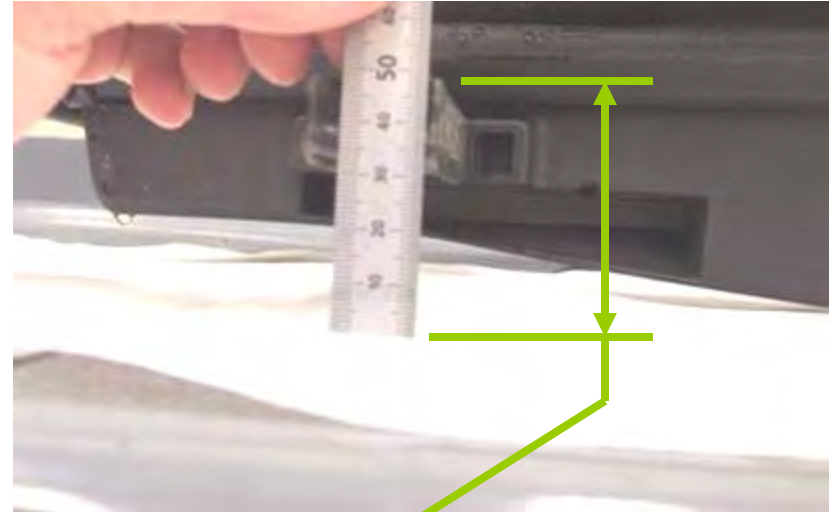
Once heated Slide Pipe Over Post and Bend Post to Correct Dimension

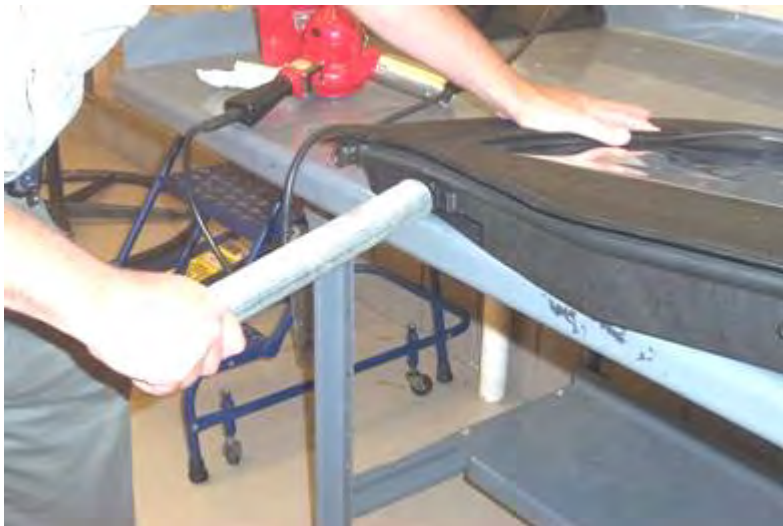
Front Door Post Dimensions (R & L)

Front Post 46.0mm

9/4/2008 **Note: Dimensions are from flat surface to the top of post.**

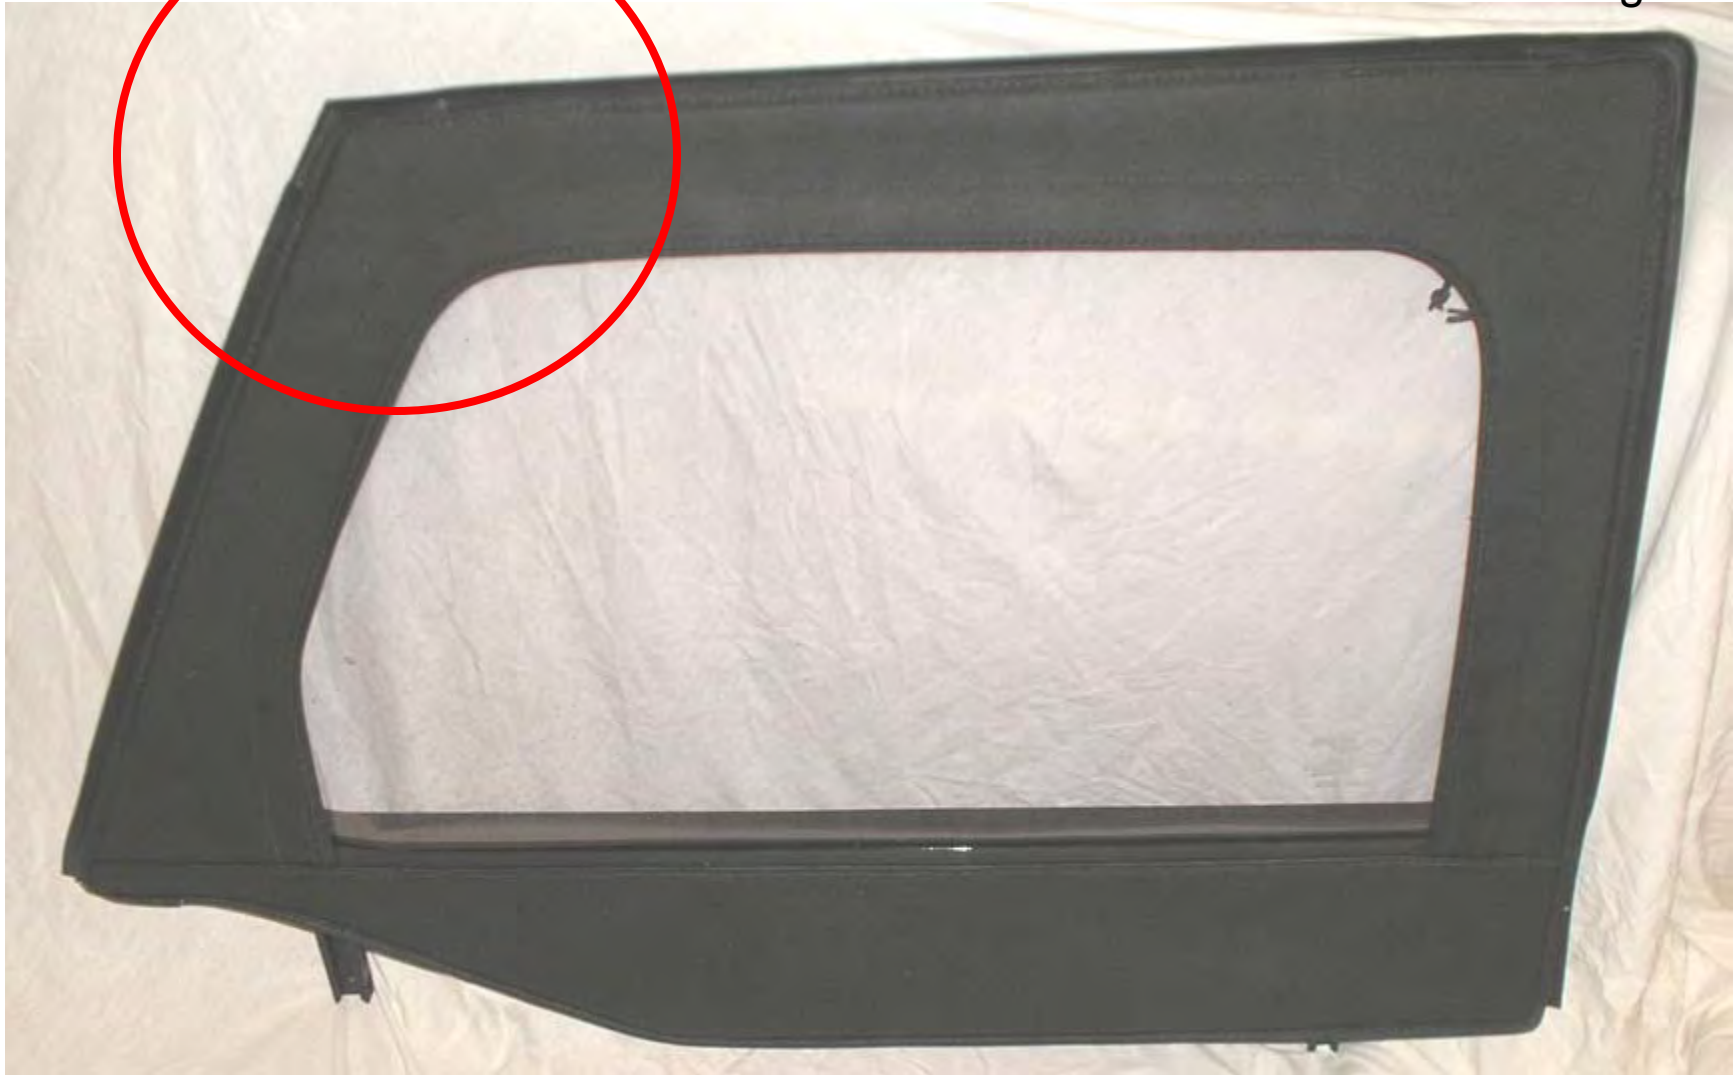
Front Door Upper "A" Pillar Corner

Add **4 mm diameter bead 68027813AA** Butyl
Between Door Seal and door as shown on Page 5.

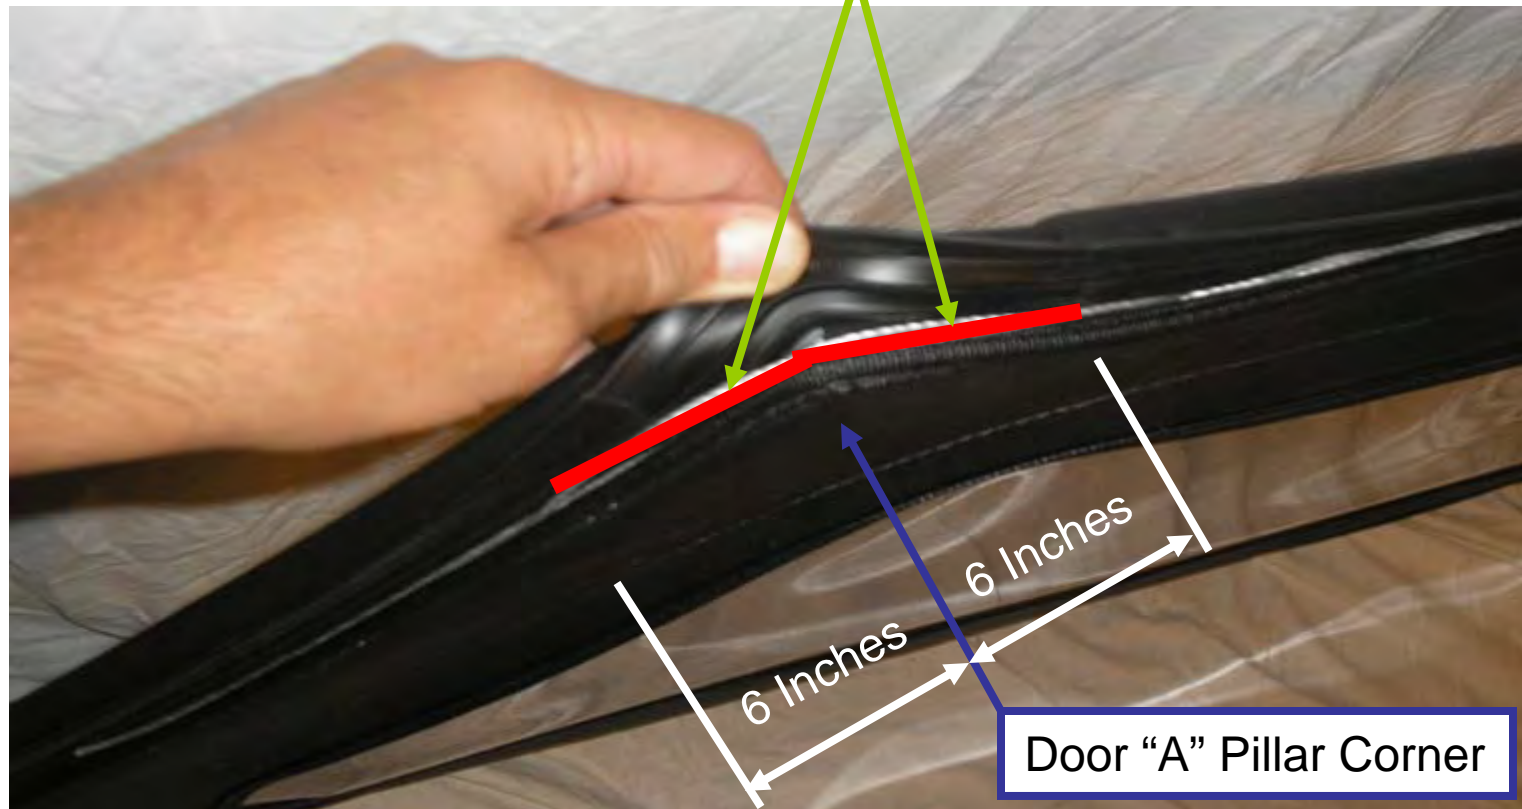
Close up view of area circled on page 4

Add 4mm Diameter Butyl bead 6 inches forward, and 6 inches rearward as shown in RED

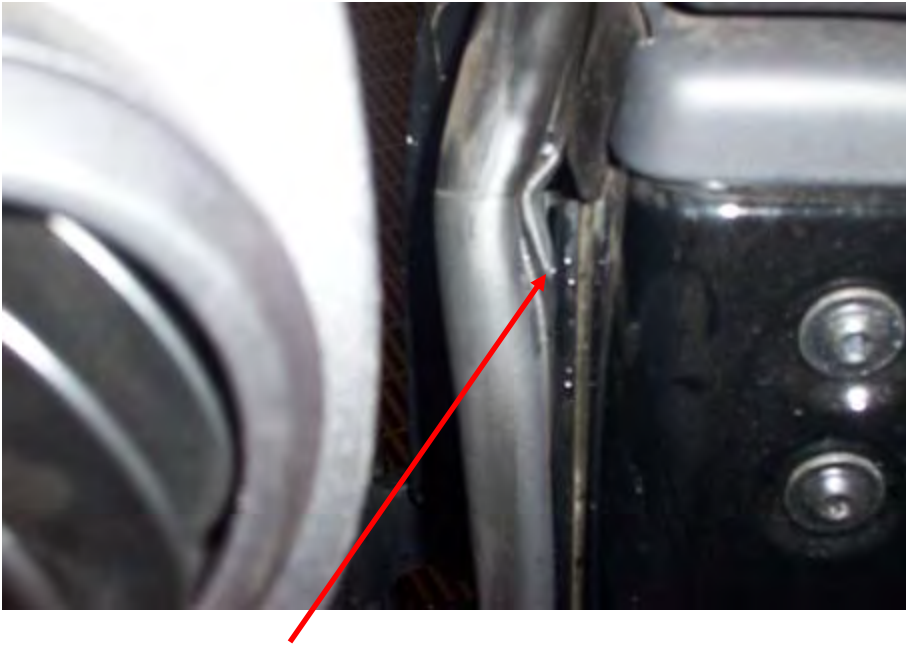
Seal is not seated in channel

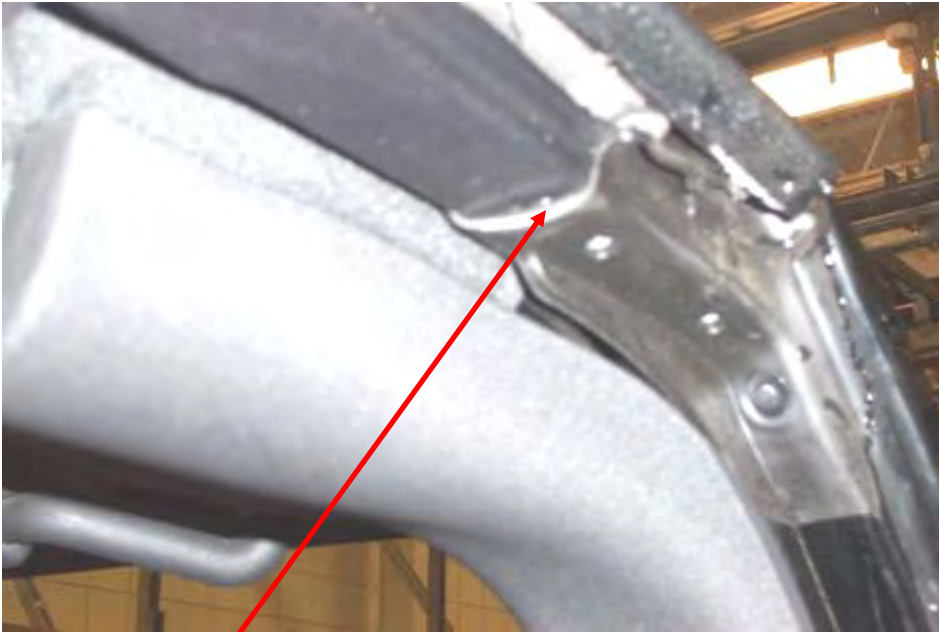
Header Seal Cup Folded under

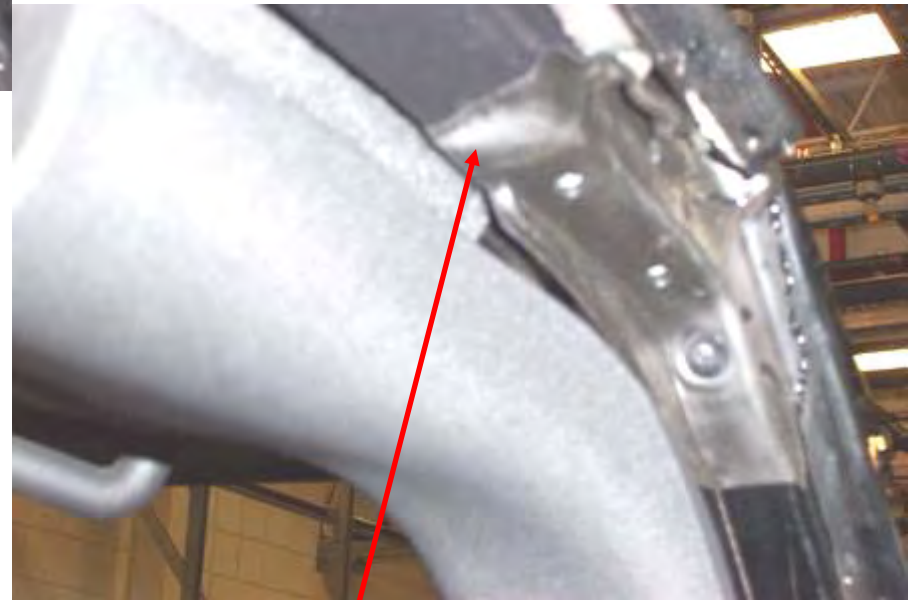
Correct

Proper Quarter Window Installation

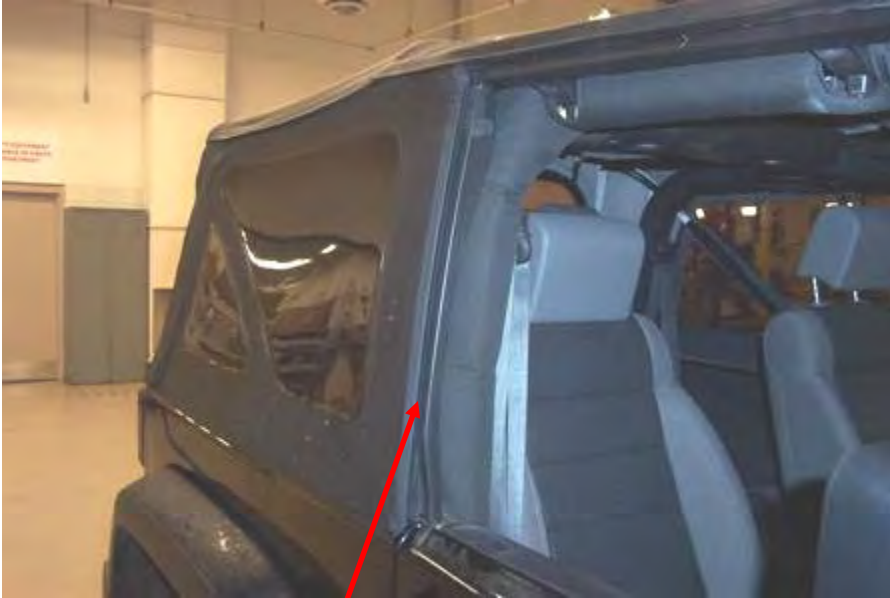
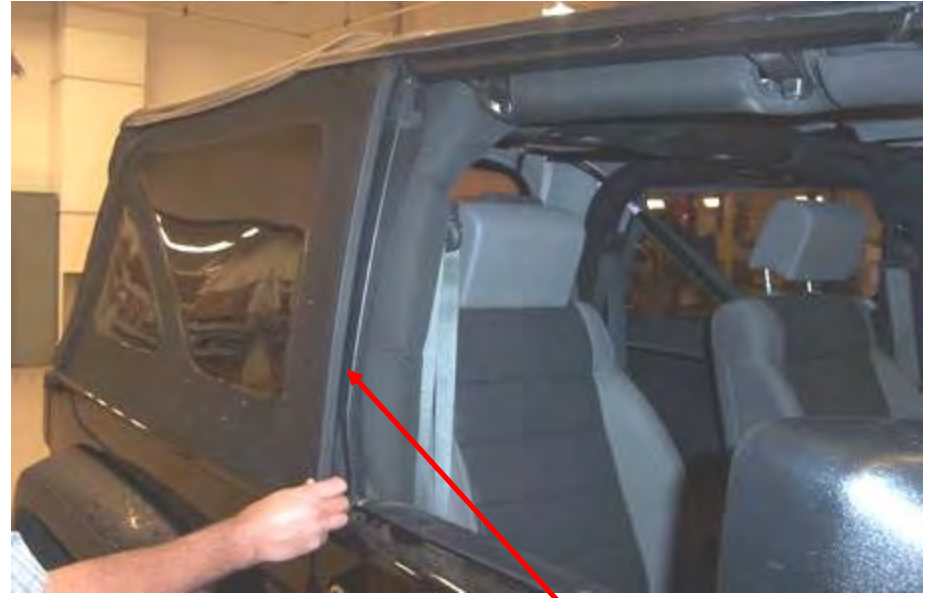
Incorrect – Retainer Not Rolled into Door Rail

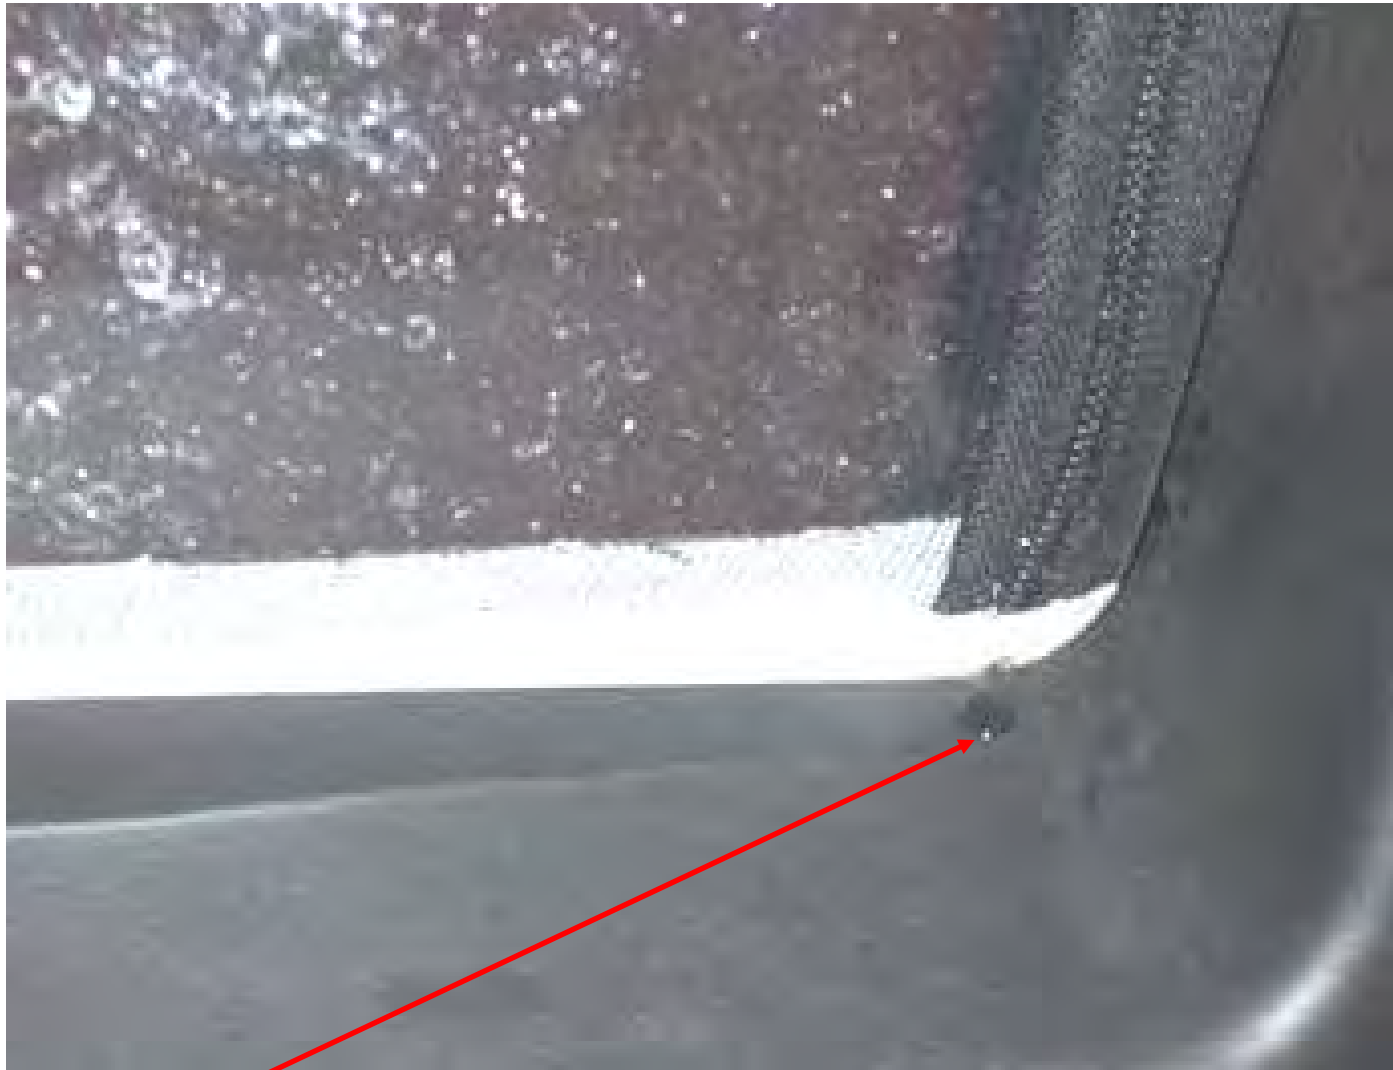
**Half Door, Side Curtain, or Rear Window Zipper Leaks
Can Be repaired by using Beeswax or Snow Seal as a
sealant.**

Water Seeping Through Zipper
Tape or Zipper Teeth

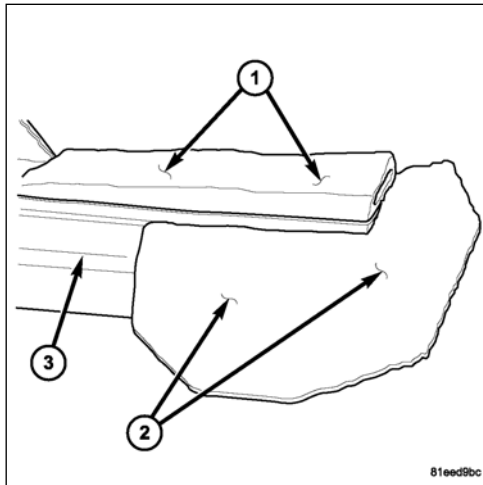
Figure 1 – Rough Position of Foam on Right Door Rail. Reference location 1 on both left and right sides of vehicle.

- (1) – Door frame rail foam
- (2) – New black foam (**Red** highlighted foam). One piece left handed and one piece right handed. Loose fit to door frame rail.
- (3) – Plastic door frame rail - Leading end/edge removed from vehicle to affect repair.

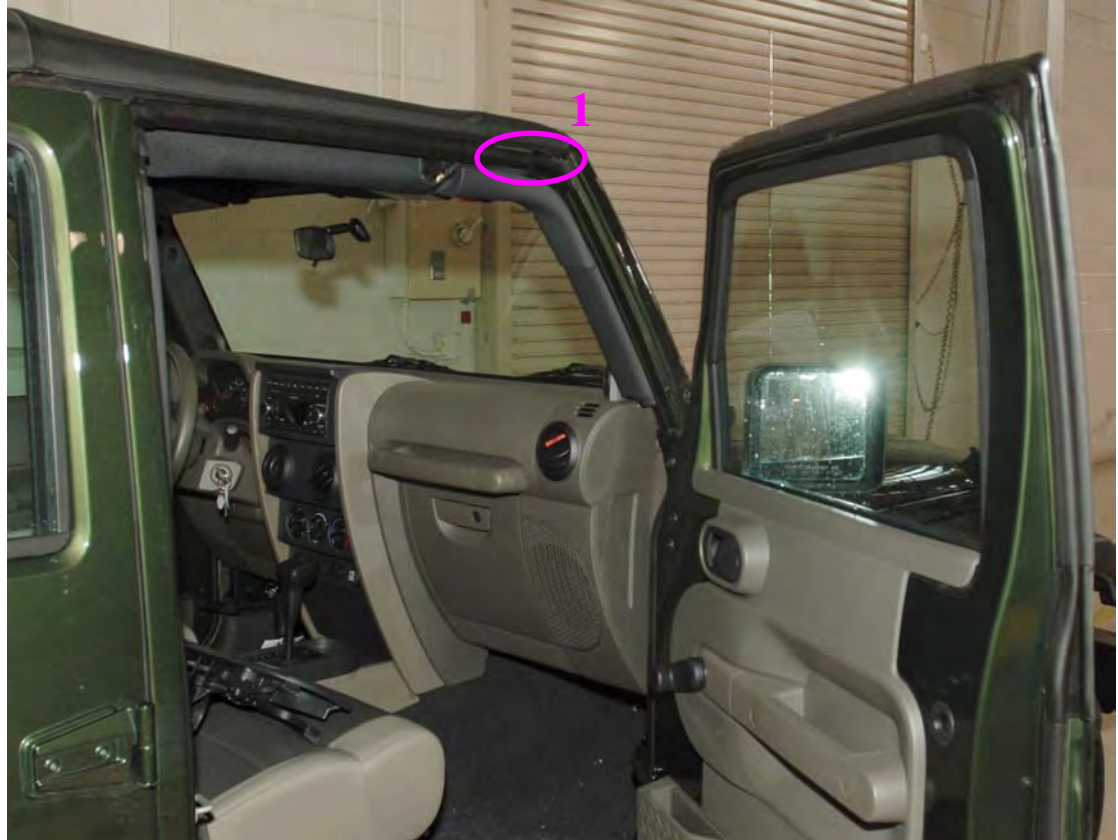
← **Figure 2** – Black Foam Fully Seated

Note – Ensure that header seal is not pinched under foam when re-installing the door rail.

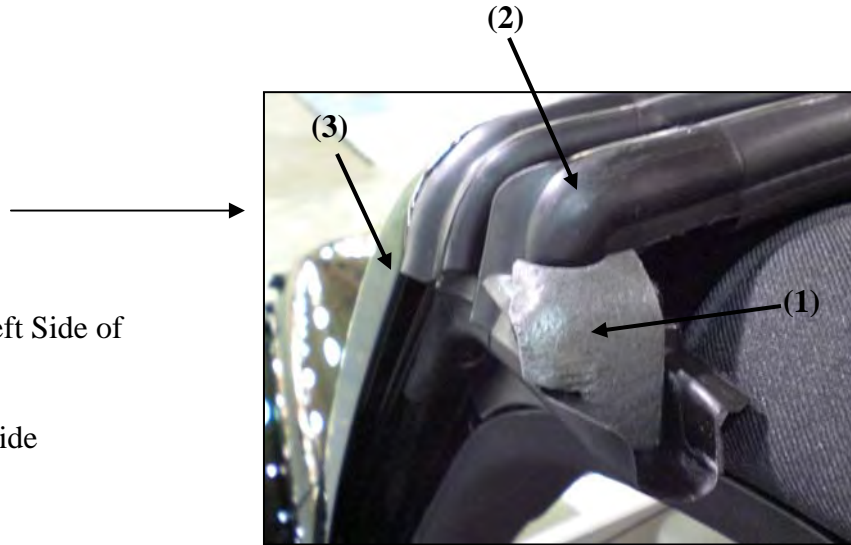
Figure 4 – Rear of left Freedom Panel shown.
Reference locations **B1** & **B2**.

- (1) – **Blue** highlighted foam
- (2) – 2-way freedom panel locator
- (3) - **Red** highlighted foam

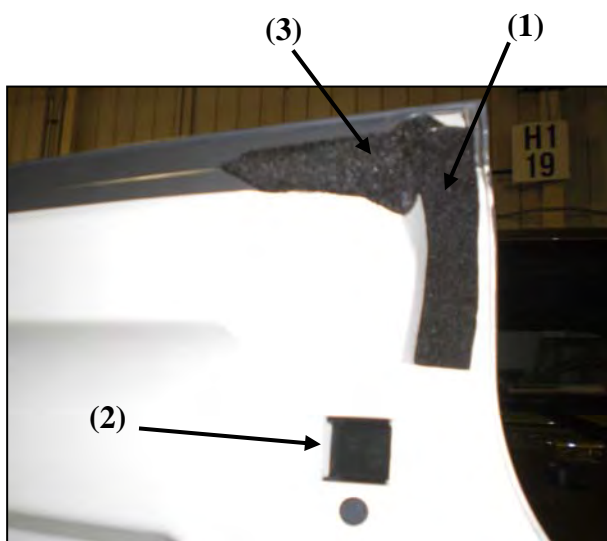
Figure 5 – Front of left Freedom Panel shown. Reference locations **A1** & **A2**.

- (1) - **Orange** highlighted foam
- (2) - **Red** highlighted foam

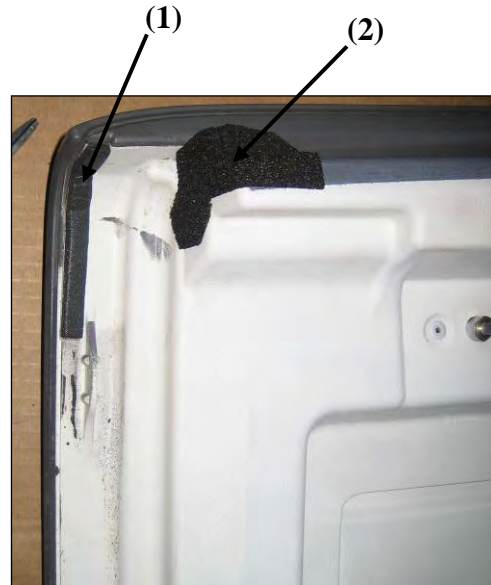
Figure 6 – Rear of right Freedom Panel shown.
Reference location **D**.

- (1) – **Dark green** highlighted foam

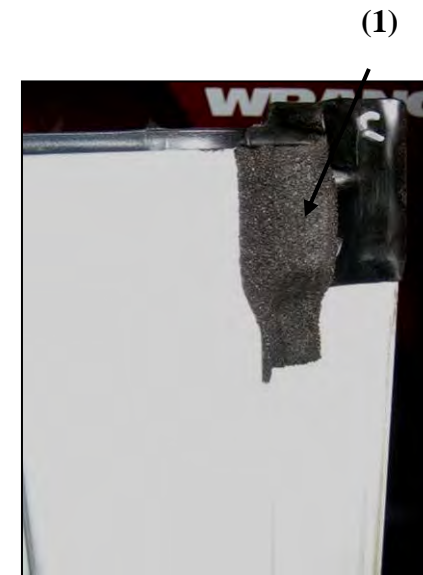
Figure 7 – Front of **left** Freedom Panel showing one additional foam, required only on vehicles built prior to 3/01/07. Reference locations **A1** & **A2**.

(1) – **Turquoise** highlighted foam

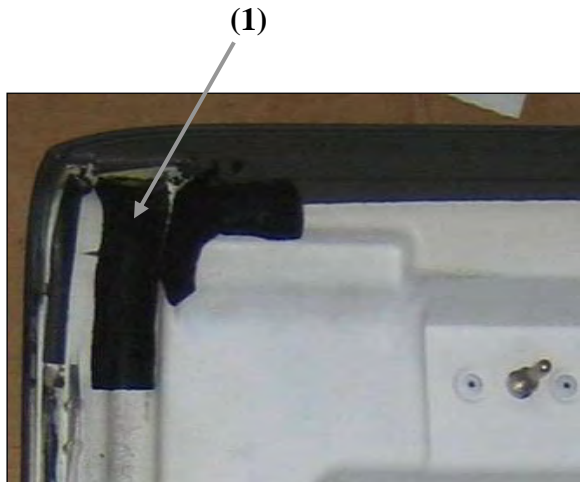
Figure 8 – Front of **right** freedom panel showing one additional foam, required on vehicles built prior to 3/27/07, unless a new seal was installed as shown by photos on side. Reference location **C**.

(1) – **Purple** highlighted foam
