Jeep Wrangler

Diagnosis & Repair Manual

Water Leaks

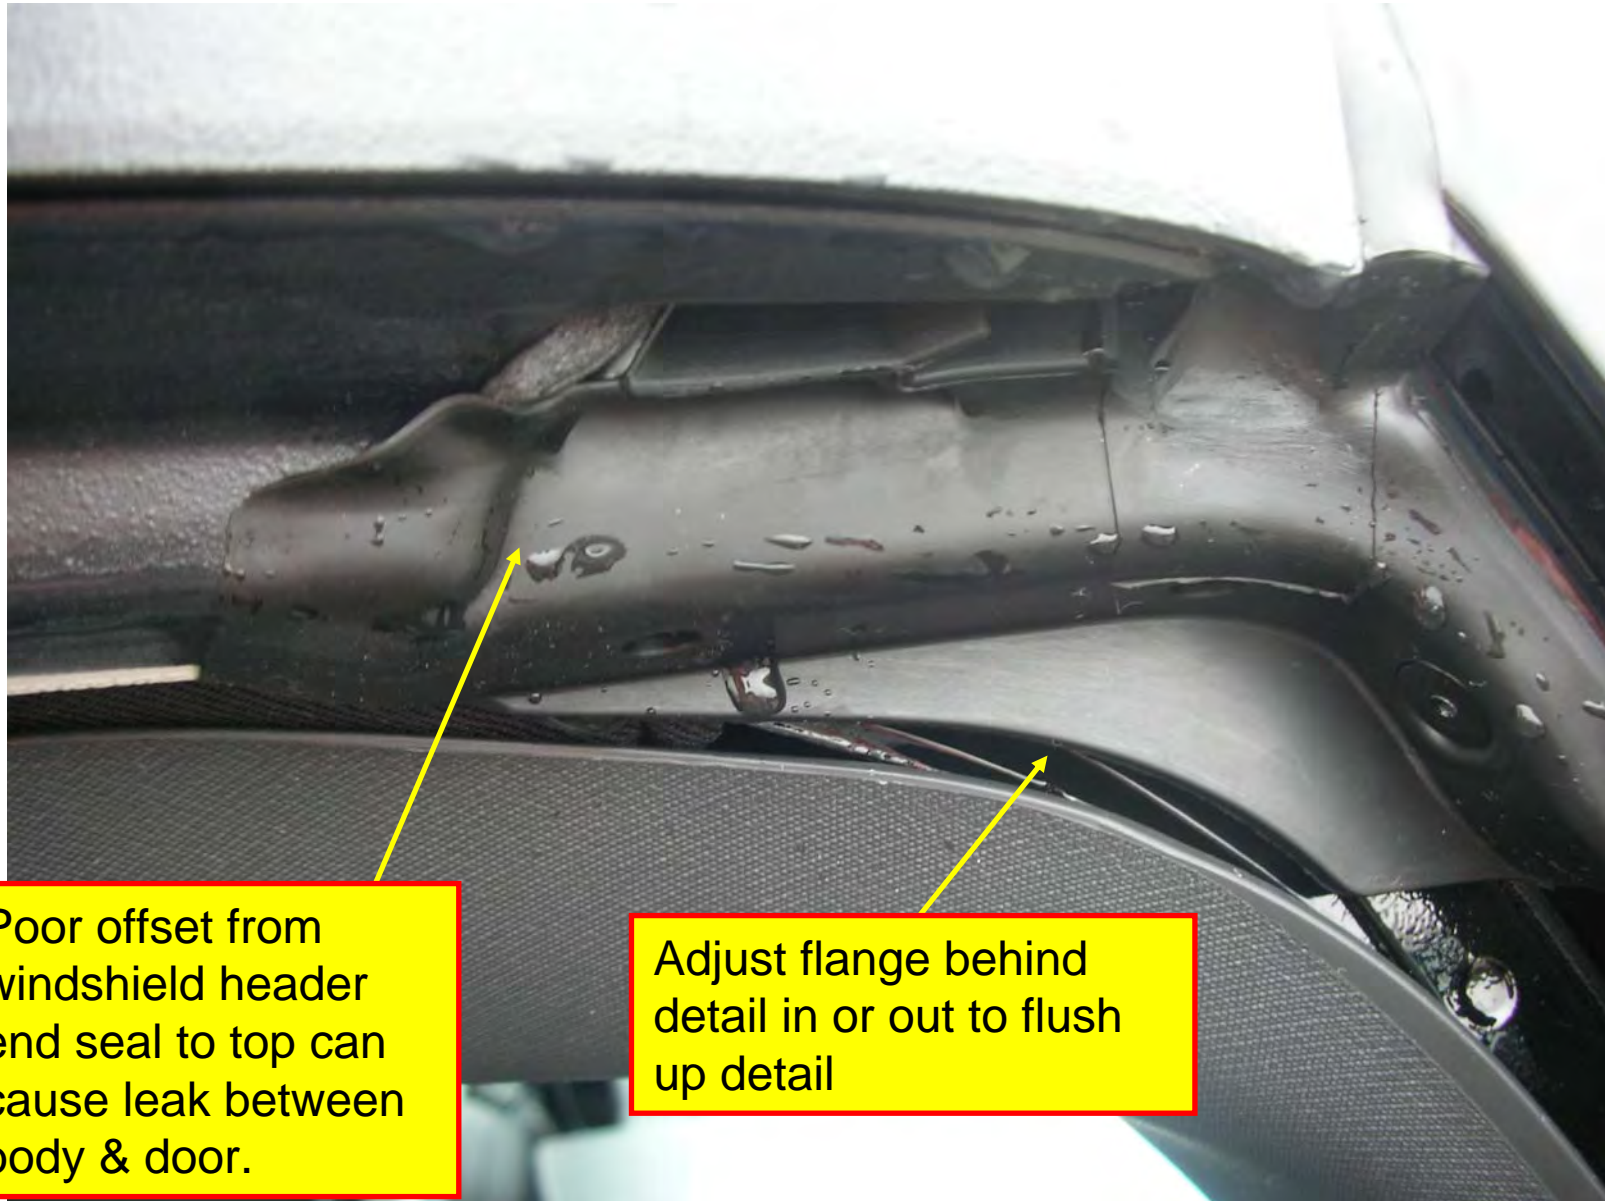
Poor offset from windshield header end seal to top can cause leak between body & door.

Adjust flange behind detail in or out to flush up detail

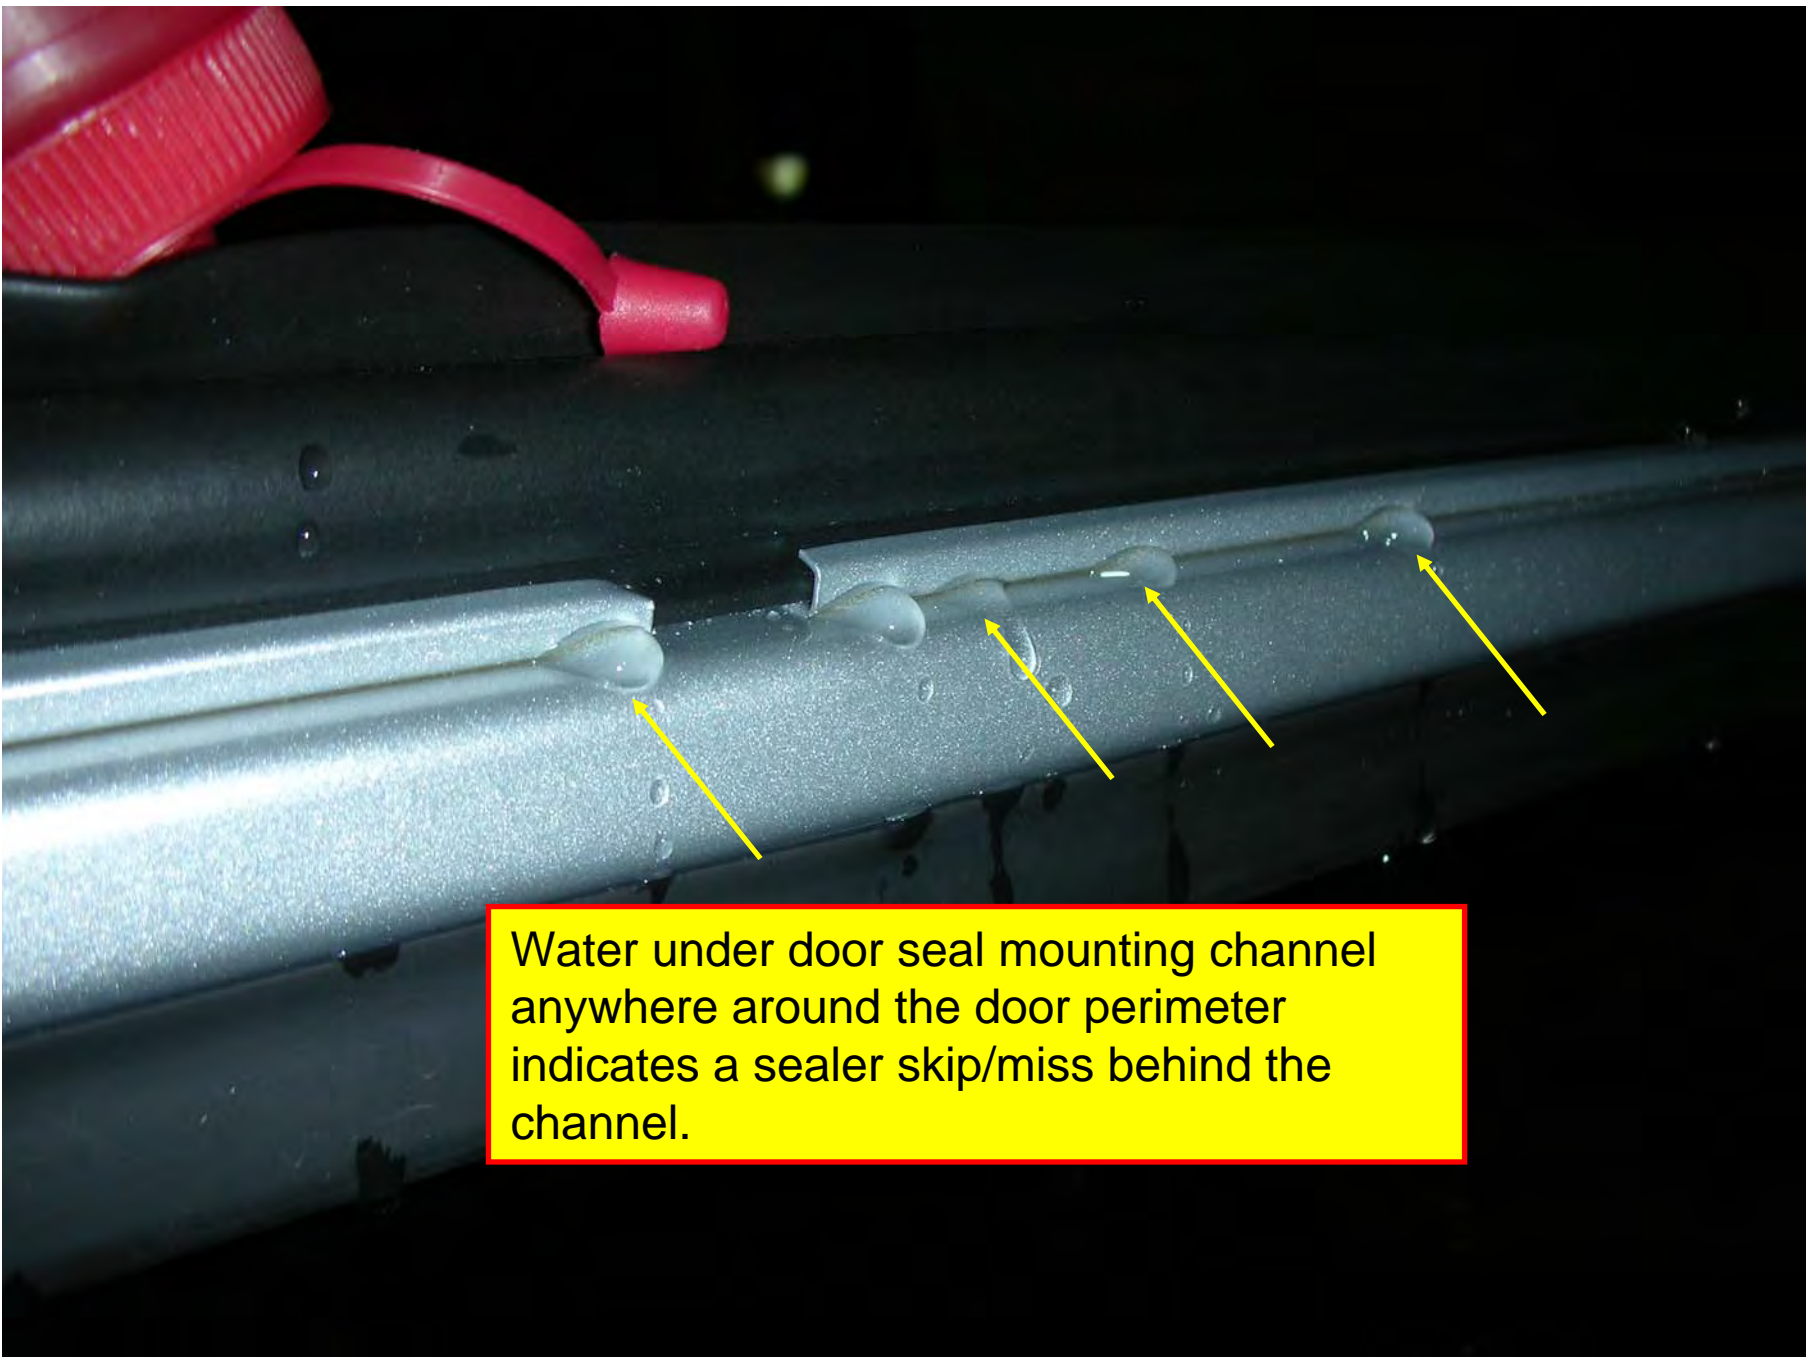
Water under door seal mounting channel
anywhere around the door perimeter
indicates a sealer skip/miss behind the
channel.

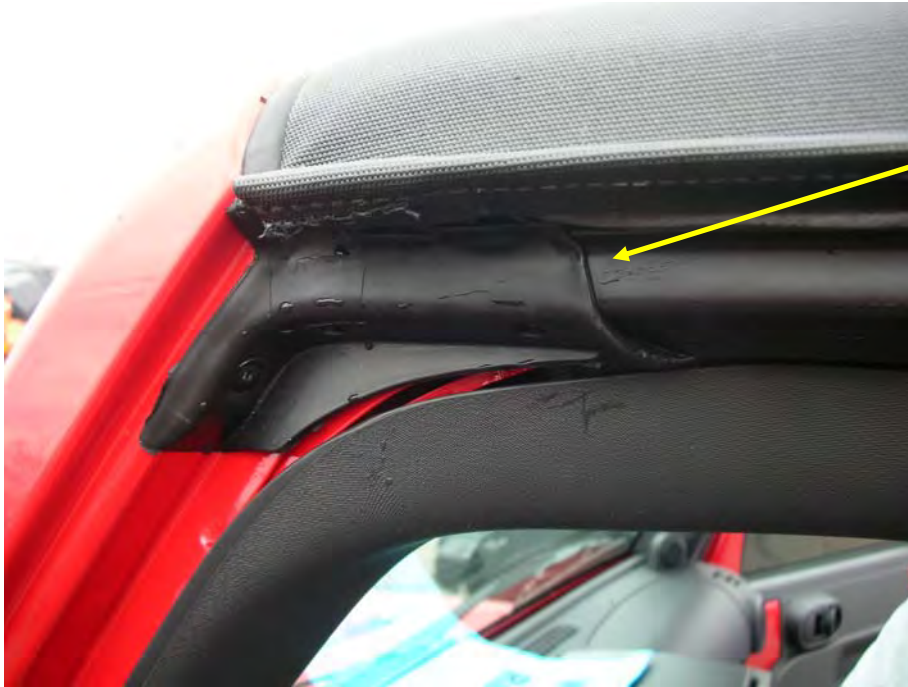
“Rolled” or distorted windshield header end seals can cause leaks by making a poor transition for the primary seal to seal against.

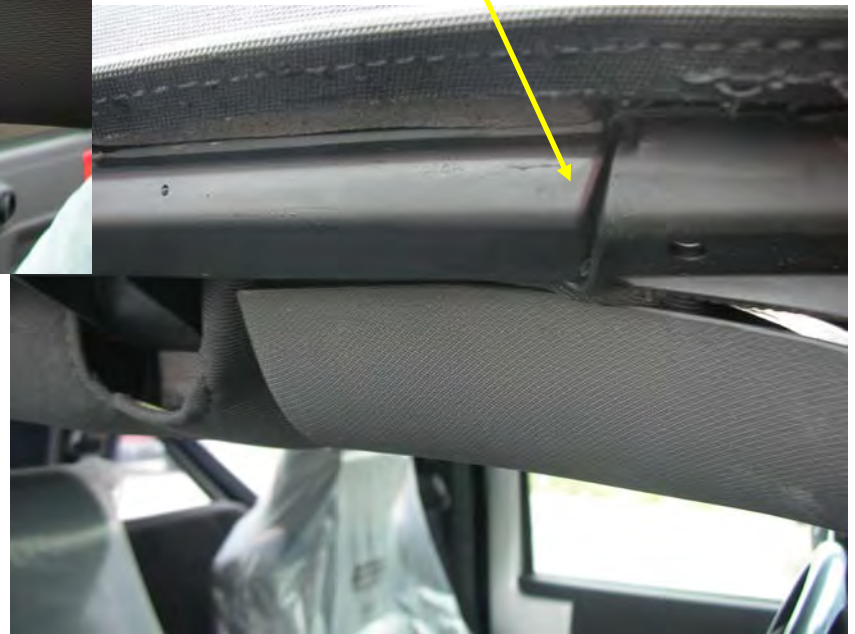
“Rolled” or distorted B-pillar mocket seals can cause leaks by making a poor transition for the front or rear door primary seal to seal against.

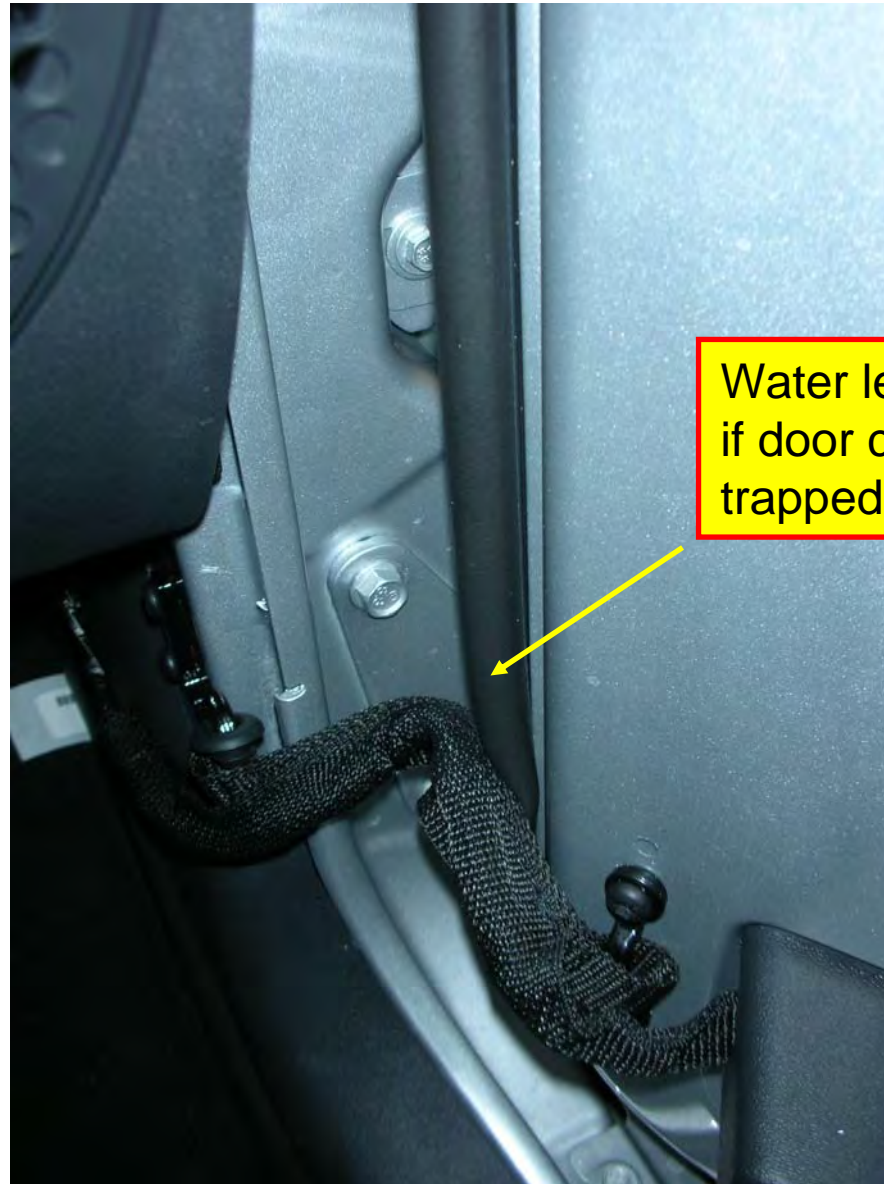
Water leak can occur
if door check strap
trapped in seal

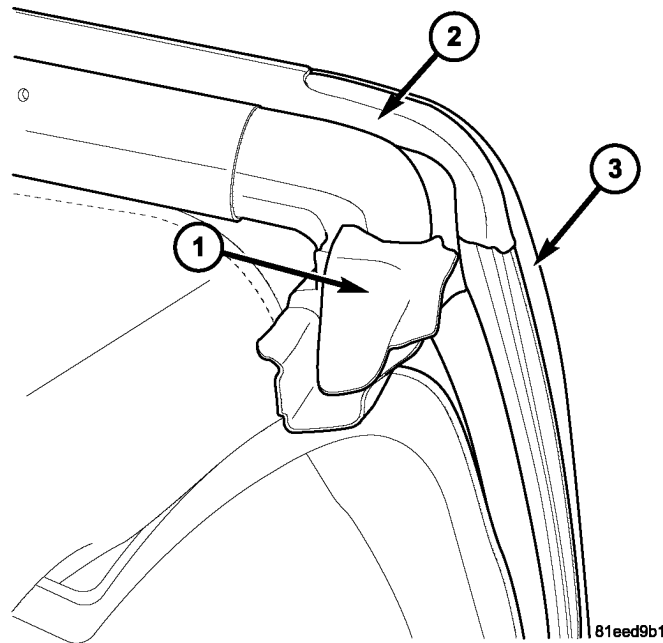
Fig. 1 DARK GRAY FOAM - HEADER SEAL

- 1 - Dark Gray Foam At End Of Header Seal - Right Side Of Windshield Frame Shown
2 - Windshield Header Seal
3 - Windshield Frame - Upper A-Pillar - Right Side

1. Fold back the entire soft top.
2. Remove the front left and right plastic door rail frame from the vehicle body.
3. Inspect the windshield header seal molded details to ensure that the dark gray foam is present and not damaged. The dark gray foam is located at each outer end of the windshield header seal. If the dark gray foam is damaged, remove the old foam and replace with new dark gray foam from the Replacement Foam Repair Kit ([Fig. 1](#)).

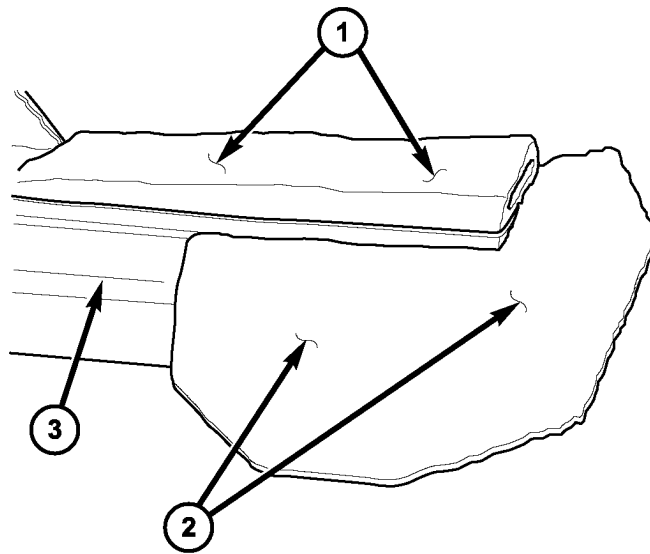
Fig. 2 BLACK FOAM - LOOSE FIT

- 1 - Door Frame Rail Foam
- 2 - New Black Foam (One Piece Left Handed and One Piece Right Handed) - Loose Fit To Door Frame Rail
- 3 - Plastic Door Frame Rail - Leading End/Edge - Removed From Vehicle To Effect Repair

4. Obtain the black foam piece from the Replacement Foam Repair Kit. The black foam pieces are handed (one for the left side and one the right side). Select the correct side black foam piece.
5. Temporarily line up (loose fit) the perimeter of the black foam piece to the front edge of the door rail ([Fig. 2](#)).

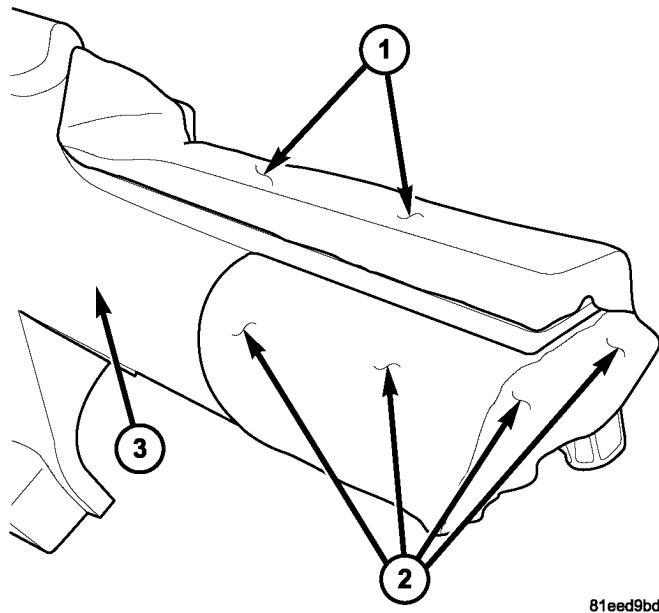
Fig. 3 BLACK FOAM - FULLY SEATED

1 - Door Frame Rail Foam

2 - New Black Foam Piece From Replacement Foam Kit - Fully Seated To Door Frame Rail End And Side

-
6. Remove the white protective backing from the black foam piece and attach the black foam to the door rail.
 7. Wrap the black foam around the front edge of the door rail ([Fig. 3](#)).
 8. Complete the installation of the black foam the to door rail by wrapping the foam onto the underside of the door rail.
 9. Repeat the above procedure for the opposite side.
 10. Raise and install the soft top to the vehicle. It is important to install the soft top in the correct installation sequence as referenced in the Owners Manual.

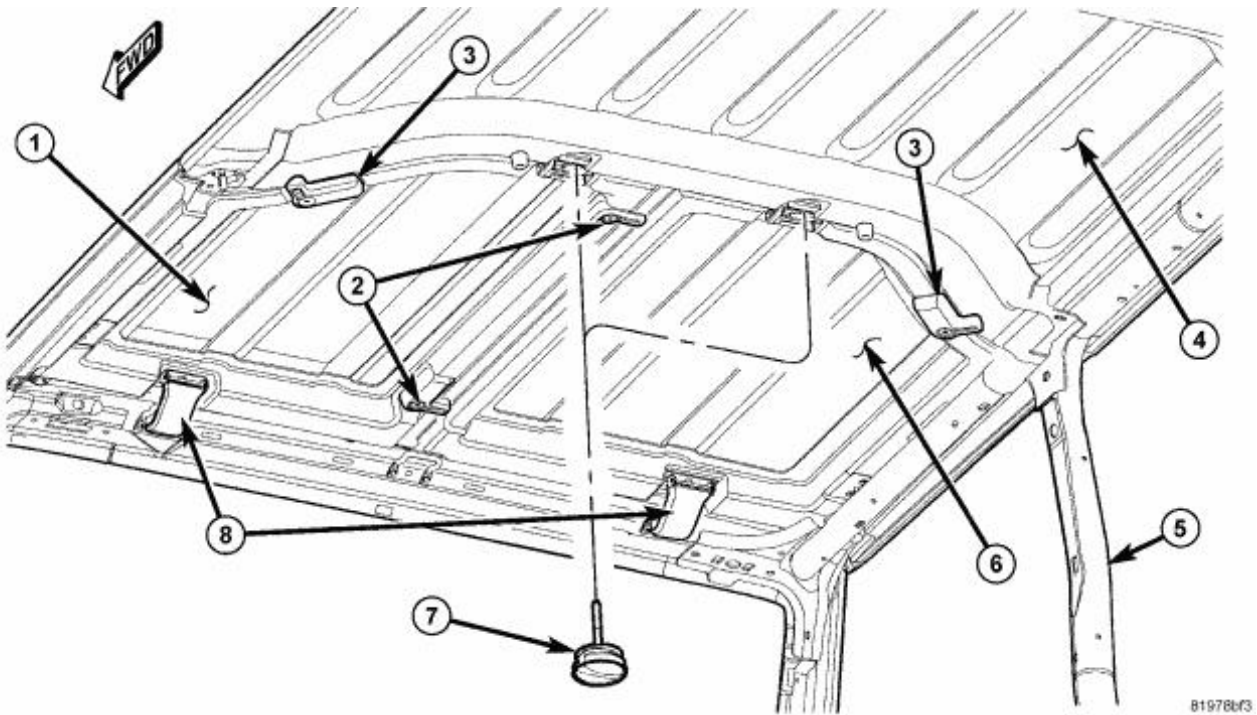
Fig. 1 HARD TOP INSIDE FULL VIEW

- 1 - Left Freedom Top Panel
- 2 - Center L-Shaped Locks - Left Freedom Top Panel
- 3 - Rear L-Shaped Lock at Seat Belt Anchorage - Left and Right Freedom Top Panel
- 4 - Hard Top
- 5 - B-Pillar
- 6 - Right Freedom Top Panel
- 7 - Rear Fastener (Dial) Knobs - Left and Right Freedom Top Panel
- 8 - Windshield Header Latch - Left and Right Freedom Top Panel

3. Inspect the Freedom Top panels to ensure that they are installed correctly (Fig. 1). If not, then note this condition so that the correct procedure for installing the Freedom Top panels to the hard top can be reviewed with the customer. To ensure that the panels are installed correctly perform the following steps in order. **When installing each Freedom Top panel always close the windshield latch first .**
